FROM: Iowa FACE Program

Case No. 3IA57

Report Date: Aug. 24, 2004

SUBJECT: Warehouse Forklift Operator Crushed Against Rack Beam

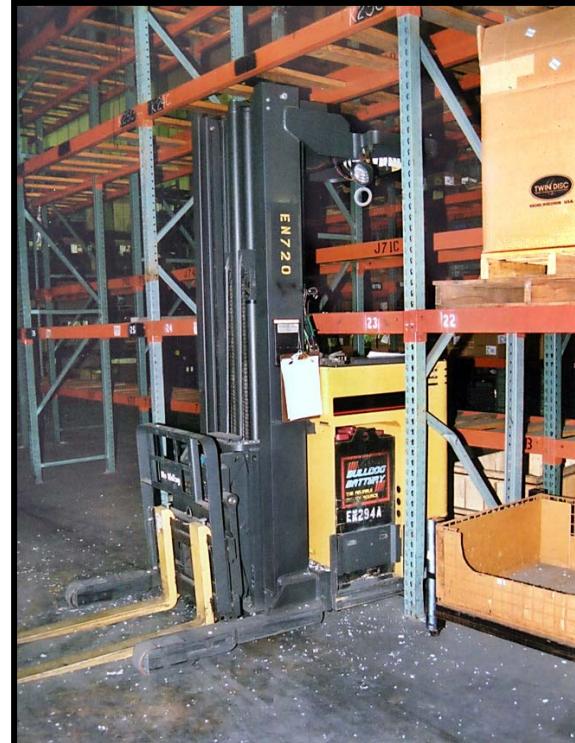
Photo 1 – Left-front view of the forklift, positioned as it was found under the empty metal rack beam.

Behind the forklift, at the end of the T-intersection was an open and empty metal rack beam, the lower edge of the beam at a height of 54 inches. The victim was driving with the forks down when he slammed into the empty rack beam, which instantly crushed him against the rear of the mast section of the machine, causing fatal internal injuries (see Photo 4). There was no indication that the victim was in the midst of a turn or was braking when he crashed into the beam, therefore, it is assumed he was simply distracted while driving or not watching where he was going. The height of the machine console was 52 inches, which perfectly fit underneath the empty beam. The forklift did not have any vertical corners / posts at the rear of the machine or other means to prevent a horizontal shelf or rack beam from entering the operator's work area.

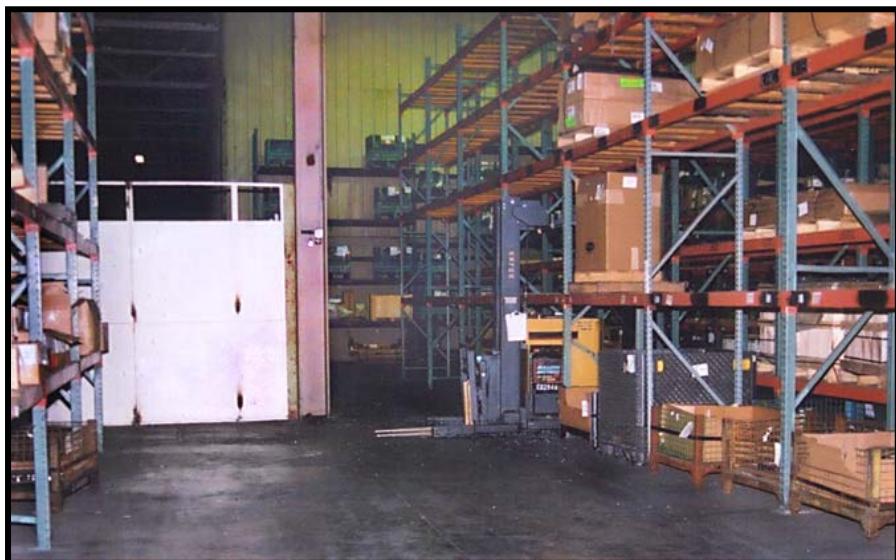
Photo 2 – Wide view from the left of the forklift, showing the T-intersection.

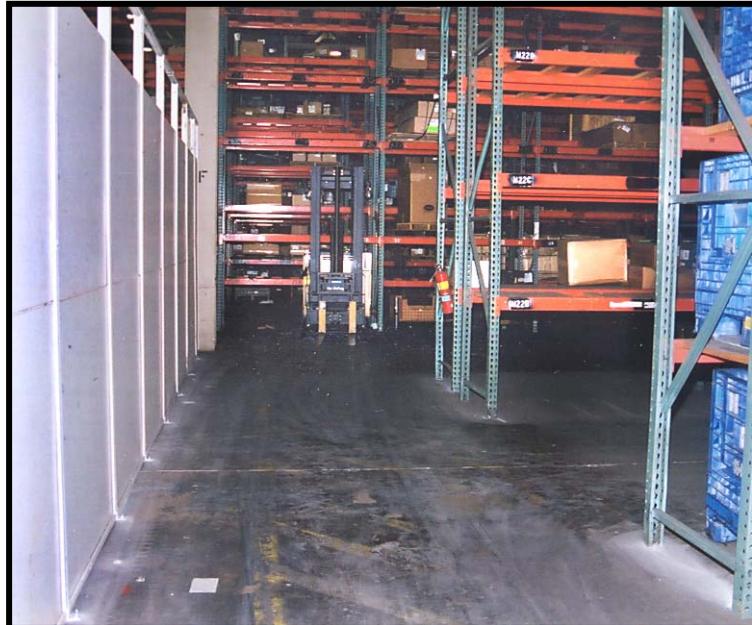
Photo 3 – View from the front of the forklift, showing the aisle ends and the wall to the side.

There were two forklift operators working on the night the incident occurred, the only two employees in the building. Employees were required to work in pairs for safety and logistical reasons, with each worker in opposite ends of the warehouse. The two forklift operators would occasionally overlap their work areas and had to be aware of the other operator's position. As *parts picker*, the victim assembled multiple packages from various pallet racks to be loaded the next morning into trucks. The victim had started his shift at 6:00 pm., and had no known reason to be in a hurry. He was in the middle of assembling an order, returning empty from the docking area. He was driving in reverse down an aisle which had aisle ends to the left of his machine and a white wall to the right side of the machine (see Photo 3).

The lights in the area of the crash were all working properly, and the floor was not littered, wet, or defective, but was smooth concrete (see Photo 3). Paint markings on the floor were very faint and worn, but the markings were for pedestrian traffic, and not for machine operators. There were numerous similar T-intersections in the warehouse area, and many intersections were equipped with convex mirrors. This forklift had a top speed of 7 mph (11 km/h), however, it is not known how fast the machine was traveling at the time of impact.

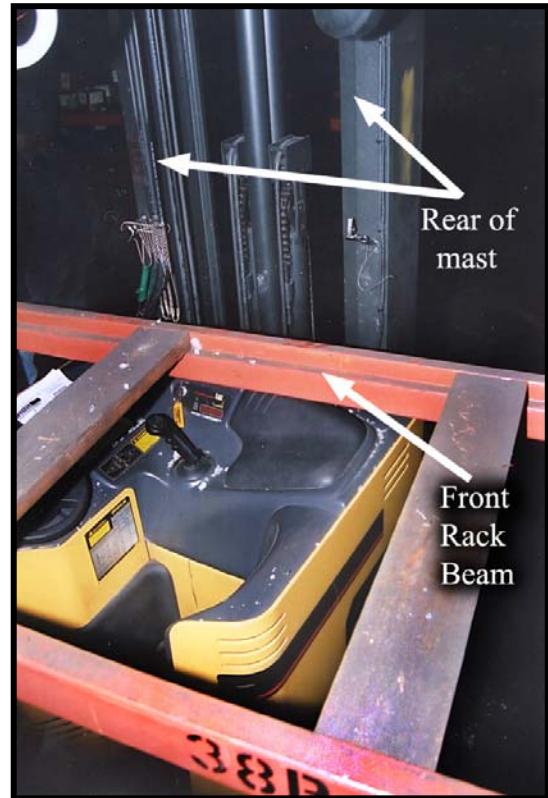
The stand-up reach forklifts were leased equipment and were battery-operated units containing electric and hydraulic motor components. The machine the victim was using had been at the company for only six months, and was in excellent condition. It was a Caterpillar, model NRR45, which had a lift capacity of 4,500 lbs. and a maximum elevated height of 300 inches. This 36-volt machine is classified as a Class II, Lift Code 3, standup reach powered industrial truck.⁽¹⁾ By convention, the front of this machine is the load-bearing end, and on this model, the operator stands facing the left side of the machine. (see Photo 4).

Photo 4 – View from behind the rack beam showing the operator's work area, machine controls on the console, and the unprotected rear corner of the machine.

Recommendation #3 *Manufacturers of standup reach forklifts should include vertical posts or framing at the rear corners of their machines, from the operator's console to the overhead guard, to protect the operator from horizontal components entering the operator's station.*
