**Case No. 3IA55**

**Report Date: 8-8-2004**

**SUBJECT: Construction Worker Electrocuted When Boom Forklift Contacted Power Lines**

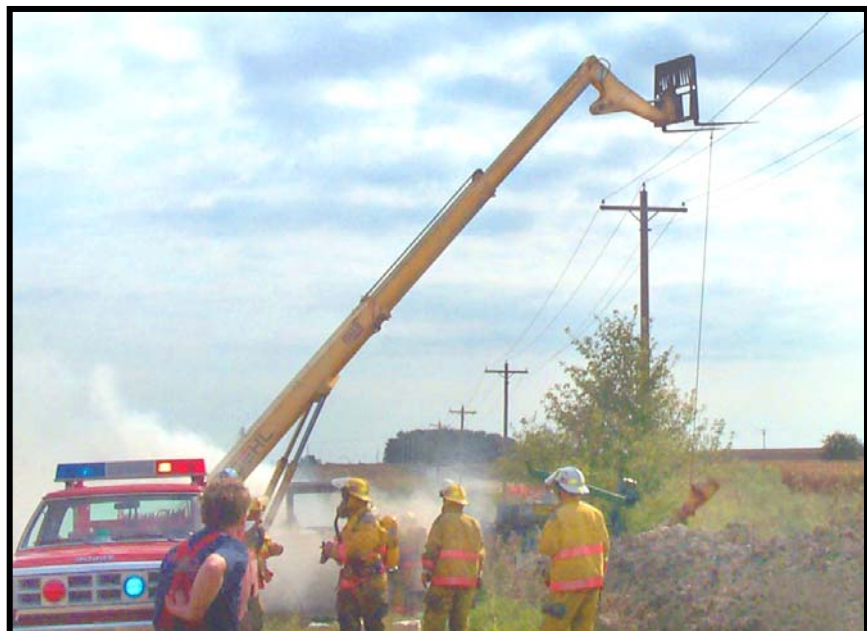
Photo 1 – View of firefighters at the scene, showing the forklift near the powerlines and the pump suspended by a wire rope cable.

pump during transportation. The forklift operator was talking to him through the front window of the forklift, and asked if he was clear of the electric lines, and the victim gave him the thumbs-up sign. Suddenly, while they were talking, the forks came in contact with the overhead power lines, and the victim was electrocuted. As he was standing on the ground, hanging onto the two hydraulic lines, the electric current passed through the steel cable, the pump, and the steel mesh lining of the hydraulic lines to reach the victim and the ground. The man was killed instantly, and the hydraulic lines began arcing into dry grass and started a fire. This fire spread to the forklift and a portable power unit for the pump. The forklift operator initially stayed in his machine, then jumped free from the forklift as instructed in prior training, and was uninjured. When firefighters arrived, the victim was lying on the ground in the middle of the fire with the forklift near, but not touching, the power lines (see Photo 1).

According to Photo 1, the boom on this forklift was raised approximately 45 degrees, while the maximum angle was 74 degrees. The photo also shows the boom in a fully extended position.

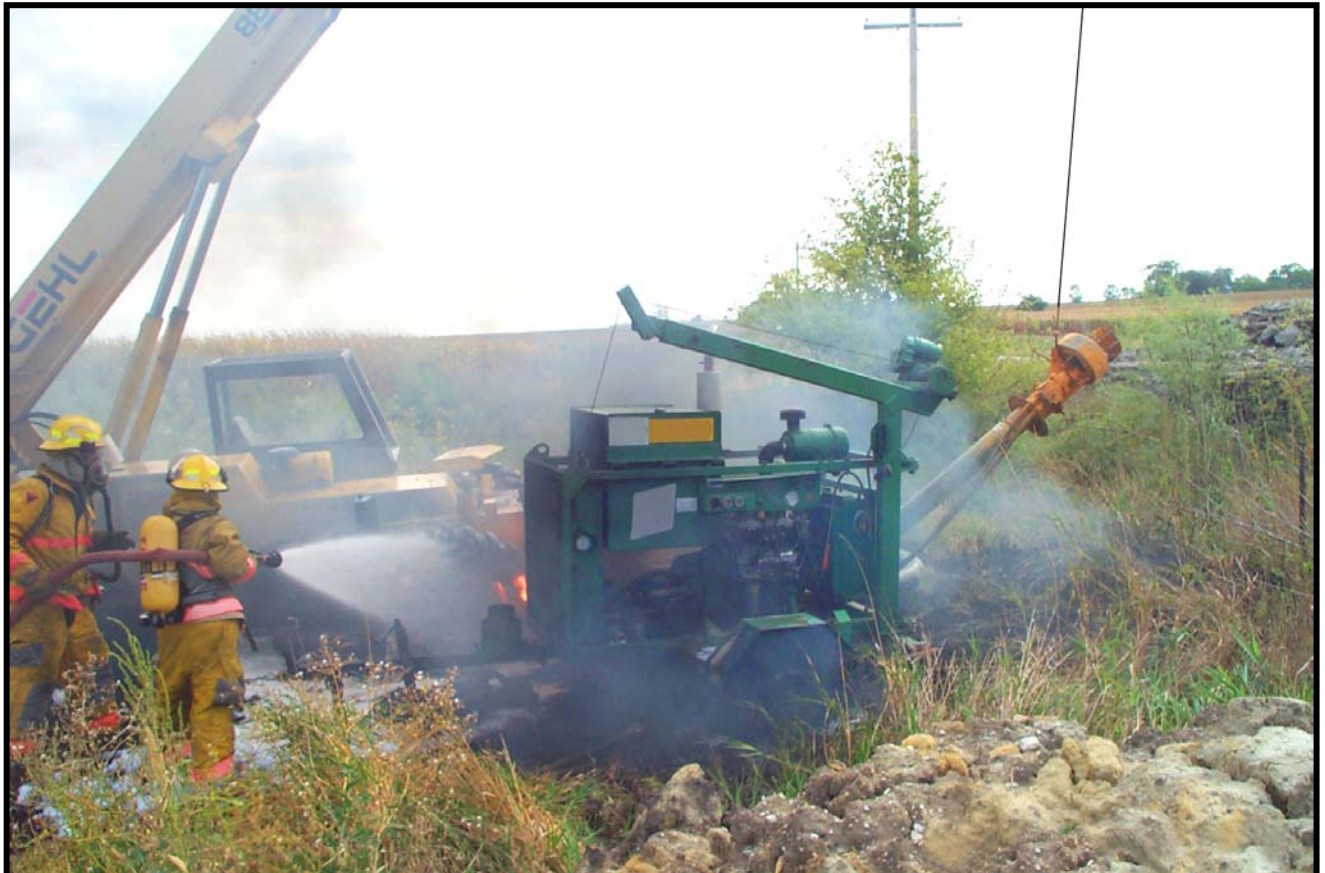
Photo 2 – Second view of firefighters at the scene, showing the portable hydraulic power unit and the suspended

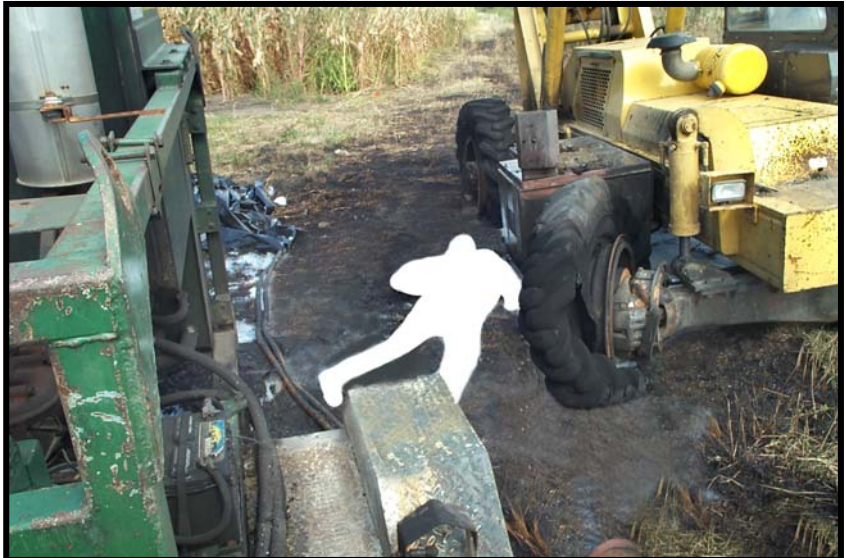
Photo 3 – View between the forklift and the hydraulic power unit, facing north, showing position of the victim after he fell to the ground.

At this time, the forklift operator was communicating with the victim, most likely through the open front window of the cab. He asked if he had sufficient clearance from the powerlines and the victim gave him the thumbs-up sign. Then suddenly the forklift came in contact with the northernmost powerline, and the victim, who was standing on the ground, was instantly electrocuted. The victim was hanging onto the hydraulic lines with his right arm, and standing next to the hydraulic power unit, facing the operator when he was electrocuted (see Photo 3).

Although covered with rubber, hydraulic lines contain a stainless steel wire mesh sleeve which makes the line an excellent conductor of electricity. Current traveled through the forks, the 18-ft. cable, and the hydraulic lines to reach the victim and the ground. The victim dropped the hydraulic lines and fell forward to the ground, and the hydraulic lines began arcing into dry grass in the area and started a fire. The fire quickly spread to involve the forklift and the portable hydraulic power unit.

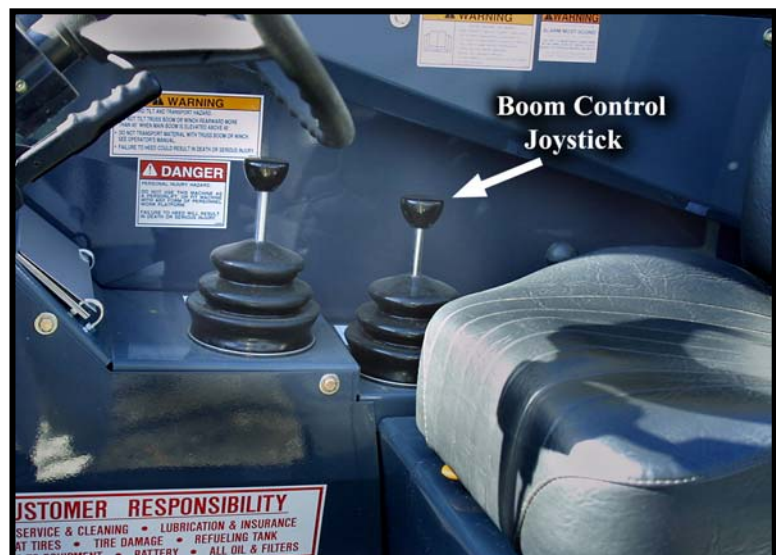
Photo 4 – View of cab area of a new identical forklift, showing position of the joystick which controls the boom.

Photo 4 shows the right side of the operator's area, which had three hydraulic controls: the front lever for the fork attachments, the middle 4-way lever for the boom itself, and the 2-way frame-leveling control to the rear. The middle control moved forward and backward to lower and raise the boom, and left and right to retract and extend the boom respectively.

If the operator was leaning far to his right, it might be possible to inadvertently push the middle lever to the right and extend the boom, but leaning to the right seems very unlikely due to the fixed window on the right side of the cab. This model of forklift had the front and left sides of the operator's area completely open, while the right side window and rear window were permanently sealed. The top of the operator's area was also open, with heavy cross members to protect from falling materials. The right window is always present and fixed as part of the safety requirements for this machine, protecting the operator from dangerous movements of the hydraulic components, which pass just a few inches from the window. Photographs confirm the presence of the right side window on this machine (see Photo 3), therefore, verbal communication between the workers had to be through other areas, most likely the front window area.

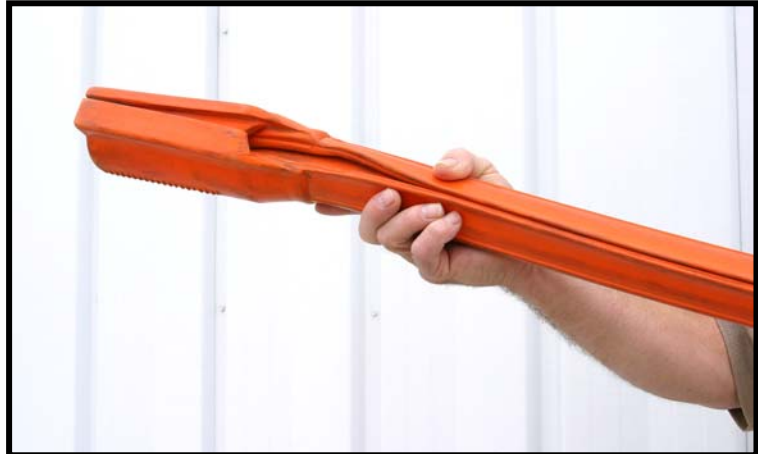
Photo 5 – Rubber sleeve (guts) used to insulate powerlines.

**Discussion:** Utility companies will apply insulators or cover-ups to powerlines if construction companies will ask. These are five-foot long orange rubber sleeves (commonly called guts) that are joined end-to-end over the wires, designed to prevent electrical contact with machinery or men (see Photo 5). Locally, this is a free service, and utilities are happy to do this to avoid possible outage or serious injury in case of contact. When contractors encounter transformers and other complex overhead electrical arrays, utilities can also use rubber blankets or other special means to insulate their equipment. It is the responsibility of every contractor to determine ownership of powerlines servicing and passing through areas where they are working. The use of insulating barriers is one listed requirement by OSHA, if equipment is expected to come within 10 feet of energized powerlines [CFR 1926.550(a)(15)(i)]
