**FROM: Iowa FACE Program**

**Case No. 3IA43**

**Report Date: 8-10-2004**

**SUBJECT: Worker Falls to His Death in a Telescoping Boom Forklift Overturn**

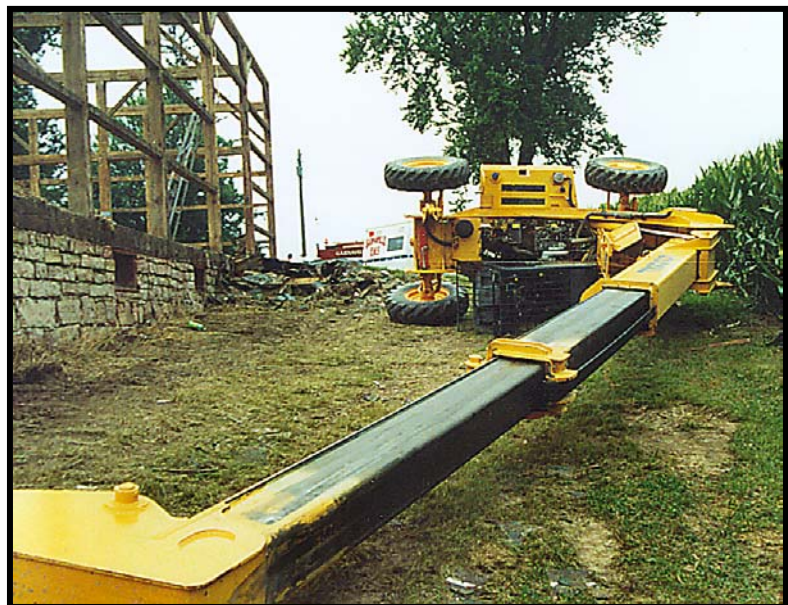
Photo 1 – View from the northwest of barn showing the overturned forklift adjacent to the barn driveway.

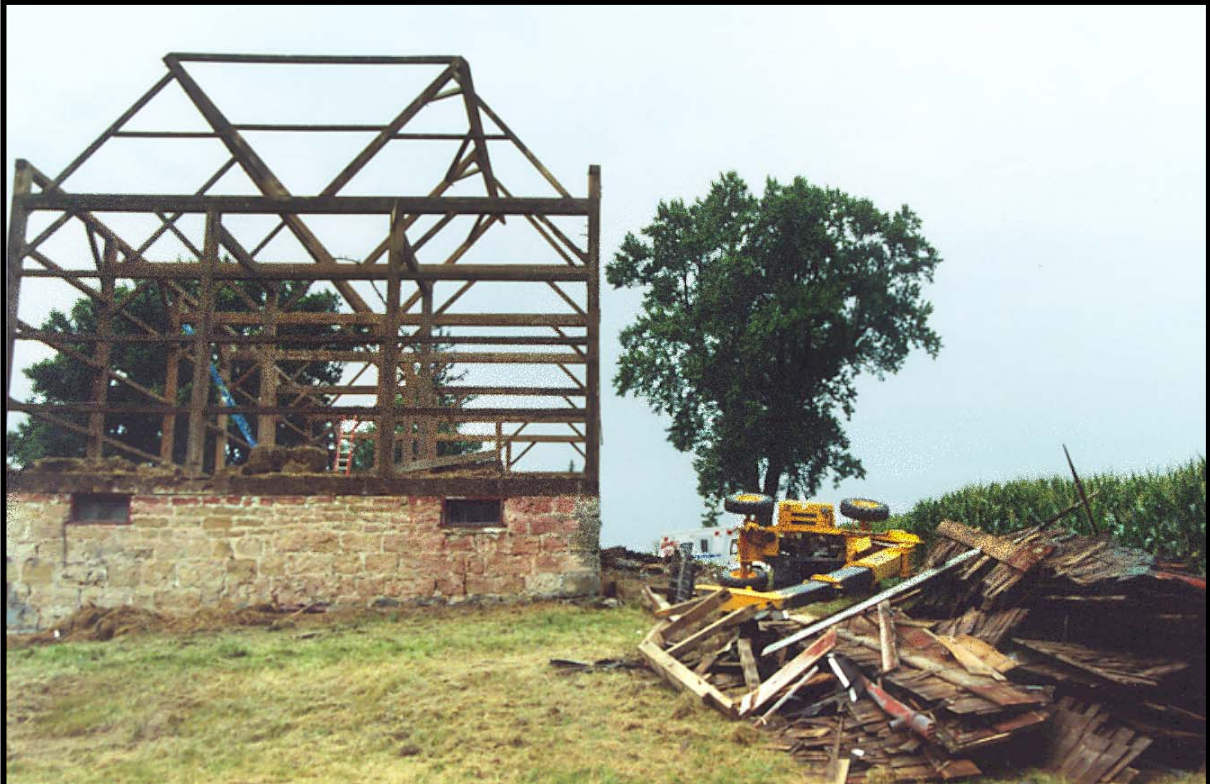
Photo 2 – View from the north side of the barn, showing the barn structure, the overturned forklift, and the broken rafter section lying next to the pile of discarded roofing.

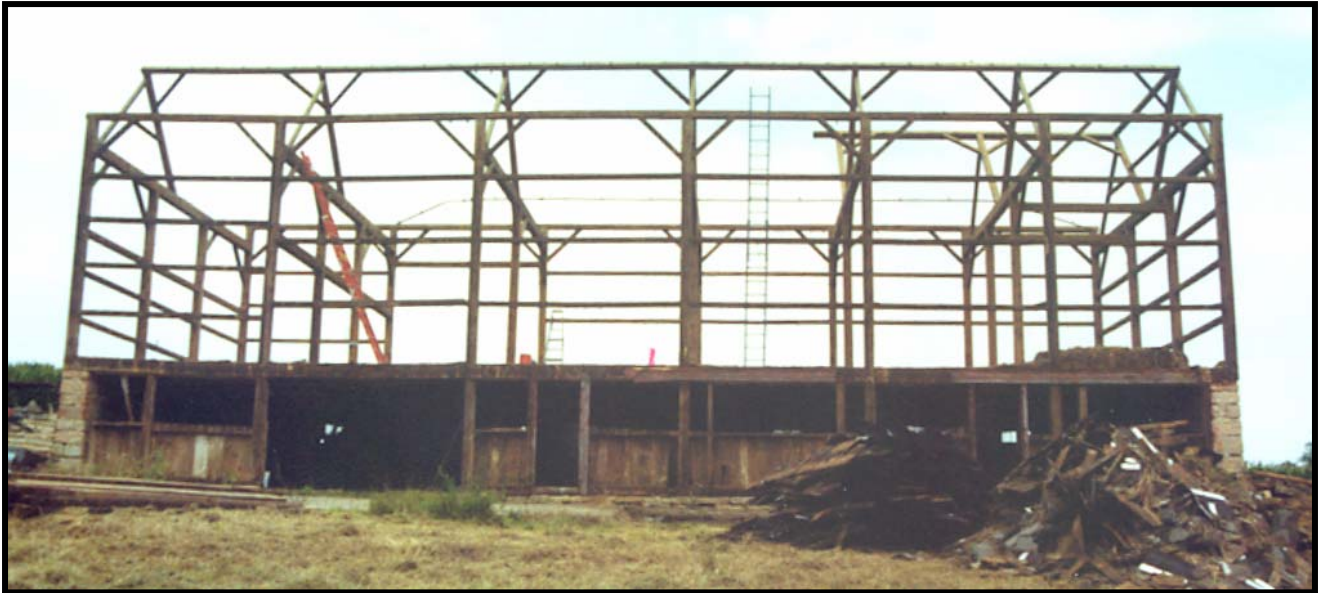
Photo 3 – View from the east of the barn showing the barn architecture and second pile of debris.

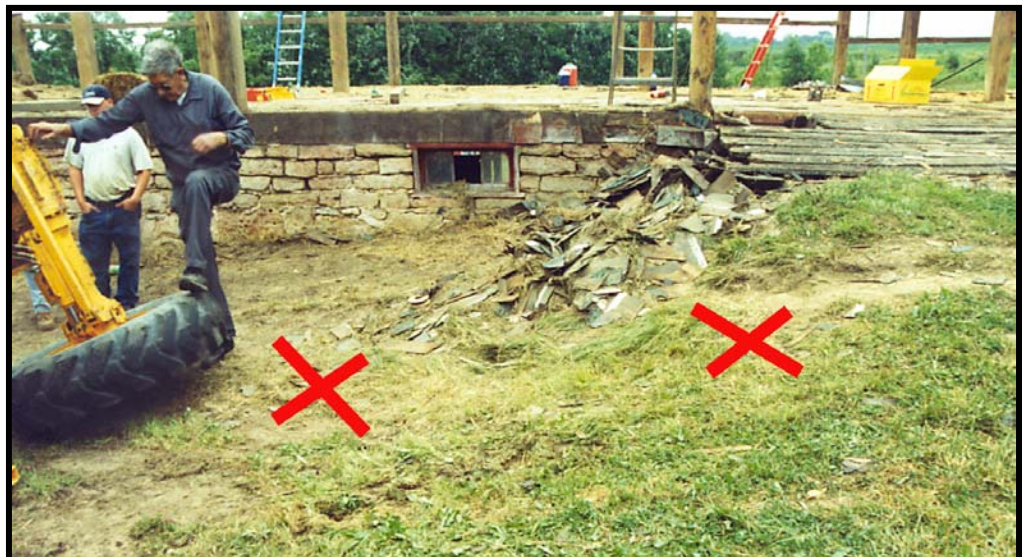
The men had already lowered one section of the rafters that morning. The forklift was re-positioned for the next section near the barn driveway / ramp on the west side of the barn. The operator positioned the forklift in the middle of the rafter section. This put the right wheels of the forklift in the driveway / ramp area, with the left wheels lower in grass to the side (see Photo 4). The frame

leveling control was used to compensate for the sloping ground, and it was in its maximum position. It was the crew's normal procedure for one man to ride up on the forklift to secure the beams to the forks, then, ride back down with the load. There was no personnel platform attached to this forklift, but the victim rode up on the forks of the machine. The forks were raised above the center portion of the rafter section and the section was secured with nylon slings to the forks. While the forklift provided support, other workers used pry bars and other tools to carefully remove pegs and loosen the joints. Once loose, the forklift would raise the section until it was free from the barn and then lower it to the ground in front of the forklift.

Photo 4 – View from the west of the barn, showing the approximate positions of the front wheels of the forklift, with the right wheel higher than the left due to the barn driveway.

**Discussion:** The frame-leveling system for this forklift was set at maximum tilt to compensate for the sloping ground. However, it appears that the incline was greater than the capacity of the leveling system. When a load is carried low, the machine is fairly stable. However, the weight and height of the load will work together to change the overall center of gravity of the machine. If the center of gravity at any time shifts beyond the tires of the machine, the machine will overturn. Factors that appear active during this incident are the ground sloping at / over the capacity of the

**Recommendation 1:** *A telescoping boom forklift should not be used on an incline which exceeds the limits of the frame leveling system.*
