FROM: Iowa FACE Program

Case No. 3IA36

Report Date: 8-02-2004

SUBJECT: Satellite TV Company Manager Dies While Preparing Pickup Truck for Transport

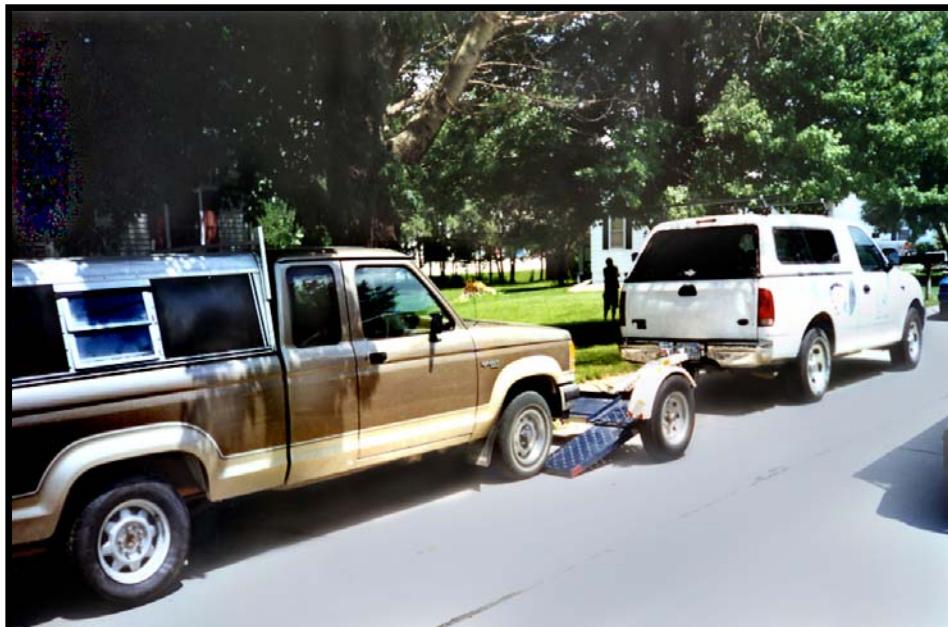
Photo 1 – Side view from the street showing both trucks and the 2-wheeled dolly.

The trucks were parked in front of the man's home on a residential street which was fairly level (see Photo 1). The sequence of events is not clear, but at the time of the incident, the victim was working under the truck-in-tow. The truck had its transmission in the park position, and the foot-operated parking brake was engaged. The straps securing the front wheels to the dolly were taken off the wheels (see Photos 2,3). The tilt locking pin which locks down the carrying pan of the dolly was not in place (see Photo 3). It is not clear whether the victim had already re-positioned the truck by driving it off and back onto the dolly. The other man arrived from the house with his tools, and the victim quit working with the front wheels and crawled underneath the passenger side of the truck-in-tow with tools in hand to disconnect the driveshaft from the differential. Besides engaging the parking brake and setting the transmission in park, the victim did not use other means to secure the truck from rolling before crawling underneath. He was lying on his right side facing the rear of the vehicle.

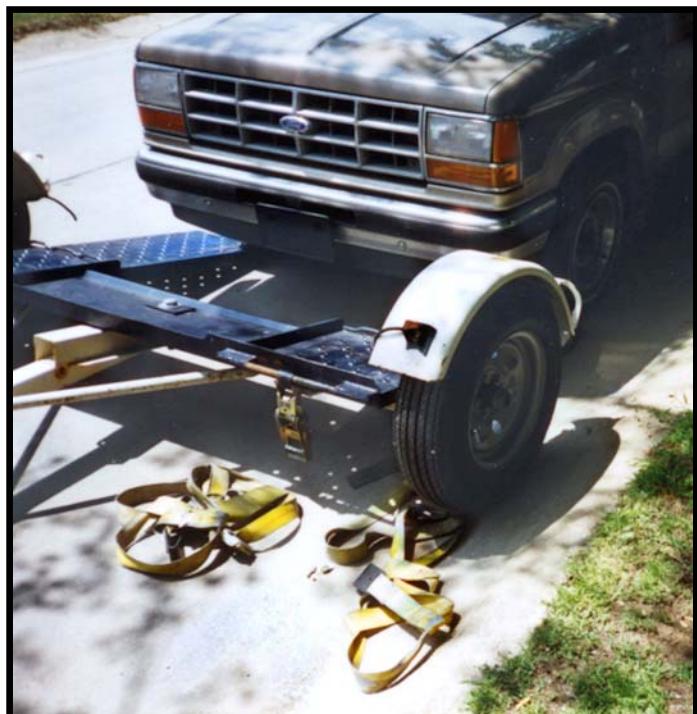
Photo 2 – Closer view of the dolly showing hold-down straps on the ground and position of the vehicle-in-tow.

It is unclear whether the victim had already repositioned the truck or was preparing to do so. In either case, he had removed the wheel straps and the tilt locking pin. He proceeded to remove the driveshaft before securing the truck to the dolly. It is unclear whether he was aware of the proper safe loading procedures, or whether he may have been distracted in some way. In this situation, the wheel straps, tilt locking pin, parking brake, and transmission park position, all failed to keep the vehicle from rolling off the dolly.

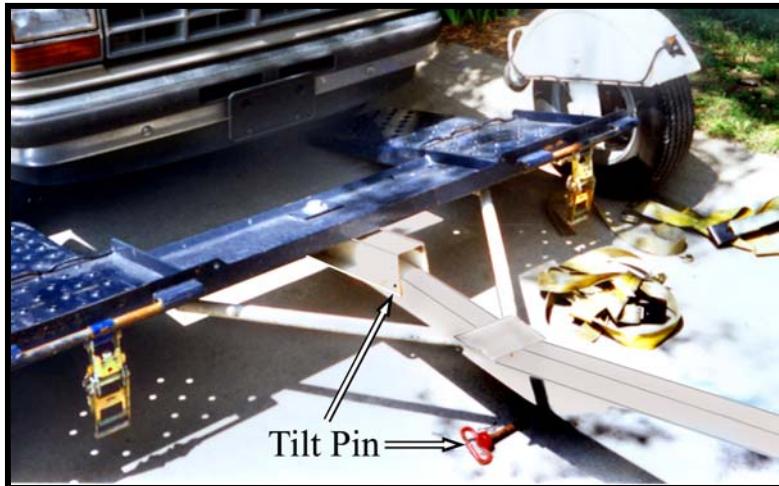
began to roll. Because the tilt locking pin had been removed, the ramp for the dolly tilted downward, and the truck rolled down the ramp and crushed the victim against the pavement, causing asphyxiation. The other man tried to push the truck back up the ramp, but was unable to do so. He then ran to get a jack from his garage while his wife called 911. He was unable to raise the truck off the man with his jack, and had to wait for emergency rescue, which arrived in five minutes. Using the Jaws of Life and cribbing, fire crews pulled the man from under the truck, but he was declared dead when seen by medical personnel. The disconnected back end of the driveshaft was on the ground and did not contribute to the man's injuries (see Photo 4).

Photo 3 – Front view of tow dolly showing tilt pin removed and ramp tilted downward. (Photo enhanced for clarity)

This type of two-wheeled dolly is used frequently for transporting passenger cars behind RVs and other vehicles. The manufacturer of this model states in the operator's manual that the dolly is not designed for commercial applications, and that the warranty would be void in such case. The dolly is designed so that when the front wheels of the vehicle-in-tow are driven up the ramp, the ramp and the carrying pan will tilt forward to a horizontal position. A heavy tilt locking pin is then inserted through the tongue to lock the carrying pan in position. Then the front wheels are secured to the dolly using heavy-duty straps. At the time of the injury, the tilt locking pin was removed and the dolly's carrying pan and ramps were free to tilt back. The wheel straps were removed, and there were no chocks, wheel stops or other means in place to keep the truck from rolling. The dolly itself did not appear to be defective or to malfunction, and the terrain appeared level. The towing truck in front was a newer half-ton truck with the hitch ball on its bumper. It did not have a frame-mounted trailer hitch where the ball is usually lower. The truck's higher bumper hitch ball position may have set the dolly slightly upward, which could have allowed the truck-in-tow to roll backwards more easily.

Discussion: The tow dolly in this case did not appear to malfunction, and the operator's manual did have instructions which would have prevented this injury. However, some improvements could be considered. It might be possible to develop a *tilt-locking mechanism*, which would be automatically locked at all times, except when specifically actuated for tilting the wheel pan and ramps for loading and unloading. The pin used in this case could provide additional protection. Having two mechanisms for securing the tilt might be beneficial also to avoid pin failures and potential unintentional rolling events. The operator's manuals should clearly warn about securing the vehicle with wheel straps and tilt locking mechanisms before working under the vehicle, or disconnecting the driveshaft. While the parking brake may help, it is not reliable. The transmission park position does not provide any protection when the driveshaft is disconnected. Another contributing factor in this incident was the high ball position, which tilted the dolly slightly downward. The operator's manual in this case does address the height of the ball, but it might be important to stress the issue and set clear requirements for the height of the ball.

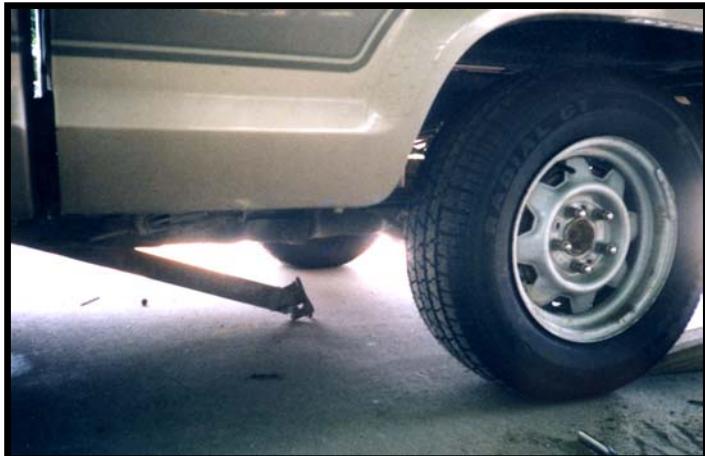
The truck-in-tow had a typical foot-actuated parking brake. The pedal was connected to a single cable, which splits into two going to both rear drum brakes. An officer at the scene examined the parking brake and found it to be defective. The pedal pushed down only halfway, as compared to normal parking brakes, and there was no audible ratchet sound when the pedal moved. The pedal did return when released, but the brake was apparently not working sufficiently to stop the truck from rolling down the ramp. Since this mechanical brake was defective, the truck was held in position on the ramps only because the transmission was in the park position, and the driveshaft alone was holding the truck on the ramp. With the driveshaft removed, there was nothing to stop the truck from rolling.

Photo 4 – View from driver's side of the vehicle-in-tow showing the driveshaft disconnected from the differential.

The cause of death, as taken from the medical examiner's report was, "mechanical asphyxiation due to vehicle on decedent's chest". An autopsy was conducted. The victim was not injured by the driveshaft seen in Photo 4.

The victim had the parking brake and the transmission park engaged. However, parking brakes on older vehicles are often unreliable. The park position of an automatic transmission will hold the vehicle in place in normal parking situations. However, it requires that the power train is intact. Disconnecting the driveshaft, raising a driving wheel from the ground, or other reasons can make the transmission park ineffective. In this case, removal of the driveshaft removed the only braking for the vehicle, and allowed it to roll down the dolly ramp. It is not clear whether the victim had already finished his task re-positioning the truck, preparing to do it, or leaving the truck as is. In any case, the front wheels should have been secured to the dolly by the straps, and the tilt locking pin should have been inserted before he proceeded to disconnect the driveshaft.
