**TO: Director, National Institute for Occupational Safety and Health**

**FROM: Iowa FACE Program      Case No. 3IA20      Report Date: October 10, 2003**

**SUBJECT: Teenager Dies in Tractor Overturn When Home-Made Rollbar Fails**

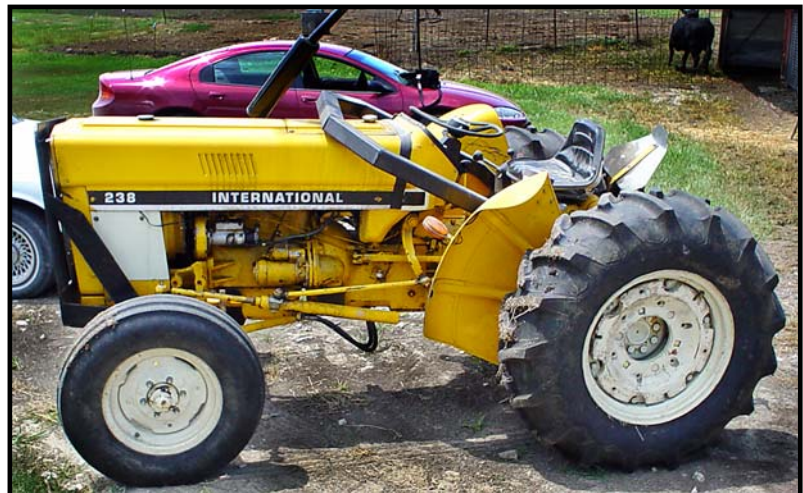
Photo 1 – Side view of tractor showing rollbar collapsed forward.

tractor forward, the post did not budge, but the tractor's front end immediately jumped upward. The grandfather yelled for him to push in the clutch pedal, but there was no time to react or stop the overturn. The front end continued to rise and the tractor rolled over backwards, slamming to the ground and instantly killing the boy. The rollbar collapsed and failed to provide protection. It did not bend or break, but the cast iron axle housings on both sides broke, leaving large pieces of the

**Recommendation 3:** *Self-made rollbars are not recommended as they may not provide adequate structural strength in an overturn.*

**Discussion:** ROPS appear simple and relatively easy to make, but they must have appropriate structural strength to absorb the energy and provide protection in the specified envelope in case of an overturn. Manufacturers design and test ROPS according to the ASAE 383.1 standard<sup>1</sup>, but it is not feasible for individuals to do so. The rollbar on this tractor appeared to be built very well by a qualified welder. The rollbar itself did not suffer significant damage in the overturn. However, the mounting of the rollbar was insufficient and the forces from the overturn broke the axle housings. It is not known if this self-made rollbar would have stayed intact if mounted according to the manufacturer's specifications (see Diagram). Self-made rollbars are often thought to be better than nothing for overturn protection. However, without testing, the adequacy of a self-made rollbar is questionable. Given the complexities in design and testing, it is recommended that ROPS be built only by manufacturers who can ensure that the ASAE standard requirements are met.

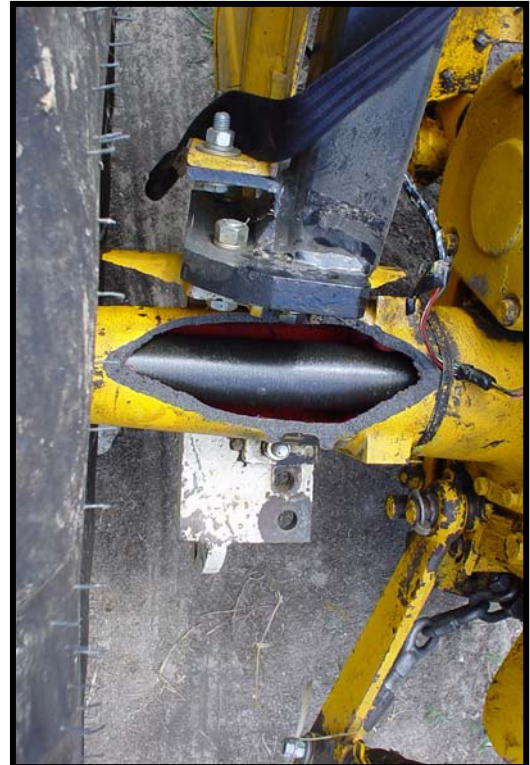
Photo 2 – Close-up view of left rear axle, looking down from the top.

bracket. The mounting brackets had approximately 2x2 inch (50x50 mm) and 2 inch (50 mm) high stubs of steel remaining from the original ROPS. The new rollbar was made to slip over these stubs from the original ROPS, welded to the mounting brackets, then painted with black paint (see Photos 2+3).

By visual observation, the rollbar was built very well with precise cuts, consistent welding, and detailed finish. The seatbelt was bolted onto the sides of the rollbar. The short bolts connecting the brackets to the mounting bases were different grades (SAE Grade 5 and 8). The missing long bolts connecting the top and bottom brackets were not replaced. The bottom mounting brackets had bolt holes and wear marks which could give an impression that the brackets were used for some purpose other than being part of the ROPS mounting system.

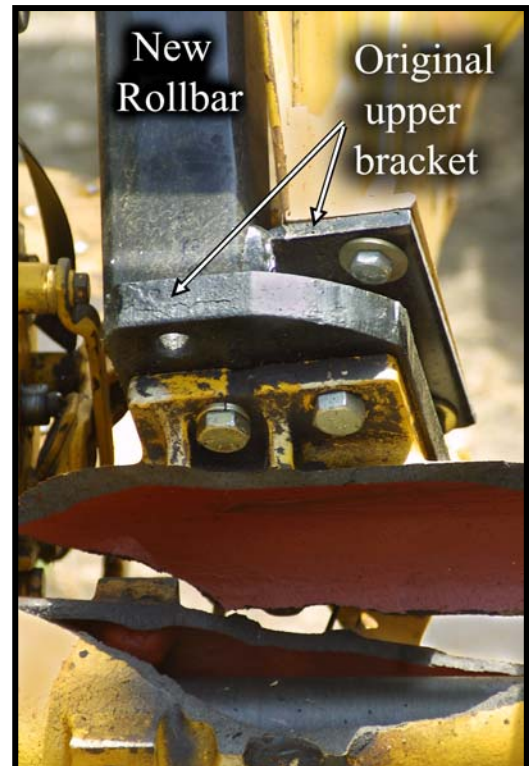
Photo 3 – Close-up view of right axle showing construction of rollbar and its attachment to the axle housing with short bolts. This also shows the original ROPS upper bracket with fender attachment, repainted to look new (refer to Diagram).

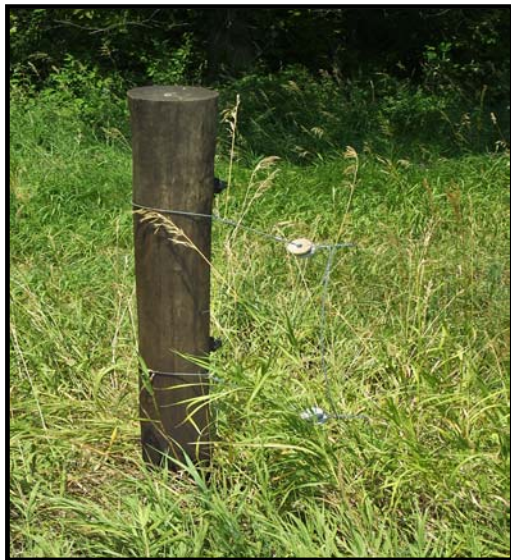
Photo 4 –Wooden fence post, similar to the one in the incident.

The victim and his grandfather were removing an electric fence line surrounding the old pasture (see Photo 5). The fence was made of 6-inch (15 cm) diameter creosote wooden posts (see Photo 4) and small fiberglass posts between the wood posts. The posts appeared relatively new, and were in good condition. They were eight feet (2.4 m) long and set approximately 4 feet (1.2 m) deep in the ground. The fiberglass posts were easily removed by hand, but the wood posts required significant force. Initially, the grandfather attempted to pull this post using the 3-point hitch lift arms of the tractor. This was unsuccessful, for the hydraulics did not have enough power. Their alternate method was to use the rear wheel and a chain, which had worked successfully prior to this incident. They backed the tractor in position with the right rear wheel adjacent to the post. A chain was attached to the base of the post, and the other end looped through the rim and around the rear tire. On other occasions, when the rear wheel turned, it would yank the post up and forward out of the ground, making it a quick and easy method to remove posts, something the grandfather had learned from his father long ago.

**Recommendation 4:** *The rear wheel of a tractor should not be used to pull posts from the ground.*

**Discussion:** Tractors have sufficient power and torque to cause an overturn under a variety of conditions. Many rear overturns occur when pulling heavy objects, where the chain is attached higher than the centerline of the rear axle, such as the three-point hitch upper linkage. When the rear wheel is attached to a strong deeply-embedded fence post, there is a great risk that the tractor will overturn, or that the chain will break. This method has been used, especially in the past, when three point hitches and front-end loaders were not common on tractors. In this case, the chain was attached to the back side of the wheel, and the tractor was driven forward to lift the post. A safer alternative

would be to attach the chain to the front side of the wheel, and back up. In that case, the torque from the wheel will push the front down rather than up. However, even this method is not recommended, as there are great risks for breaking equipment and causing injuries. Safer methods include using the three-point hitch, special jacks designed to pull fence posts, or a front end loader and large enough tractor for pulling posts from the ground.

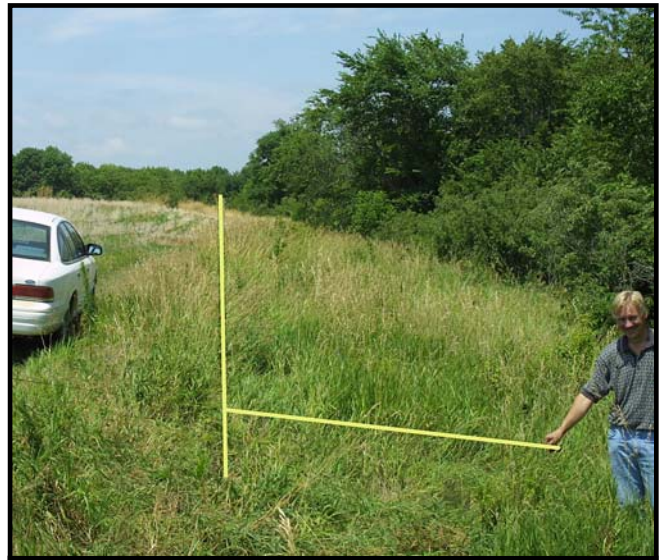
Photo 5 – Site of the overturn showing the location of the post and the downward ground slope of 8 degrees.

The ground was sloping (about 8 degrees) near the post, and the tractor was facing uphill. This may have contributed to the overturn and the rollbar failure. It took a few degrees less rotation and time for the tractor to reach the point of no return, leaving less time to react and stop the overturn. Secondly, the downhill behind the tractor allowed more rotation and momentum before the rollbar crashed into the ground, increasing the forces on the rollbar. After the incident, the post had loosened so that it could be removed by hand by those who arrived at the scene. The boy was dead at the scene when emergency crews arrived.

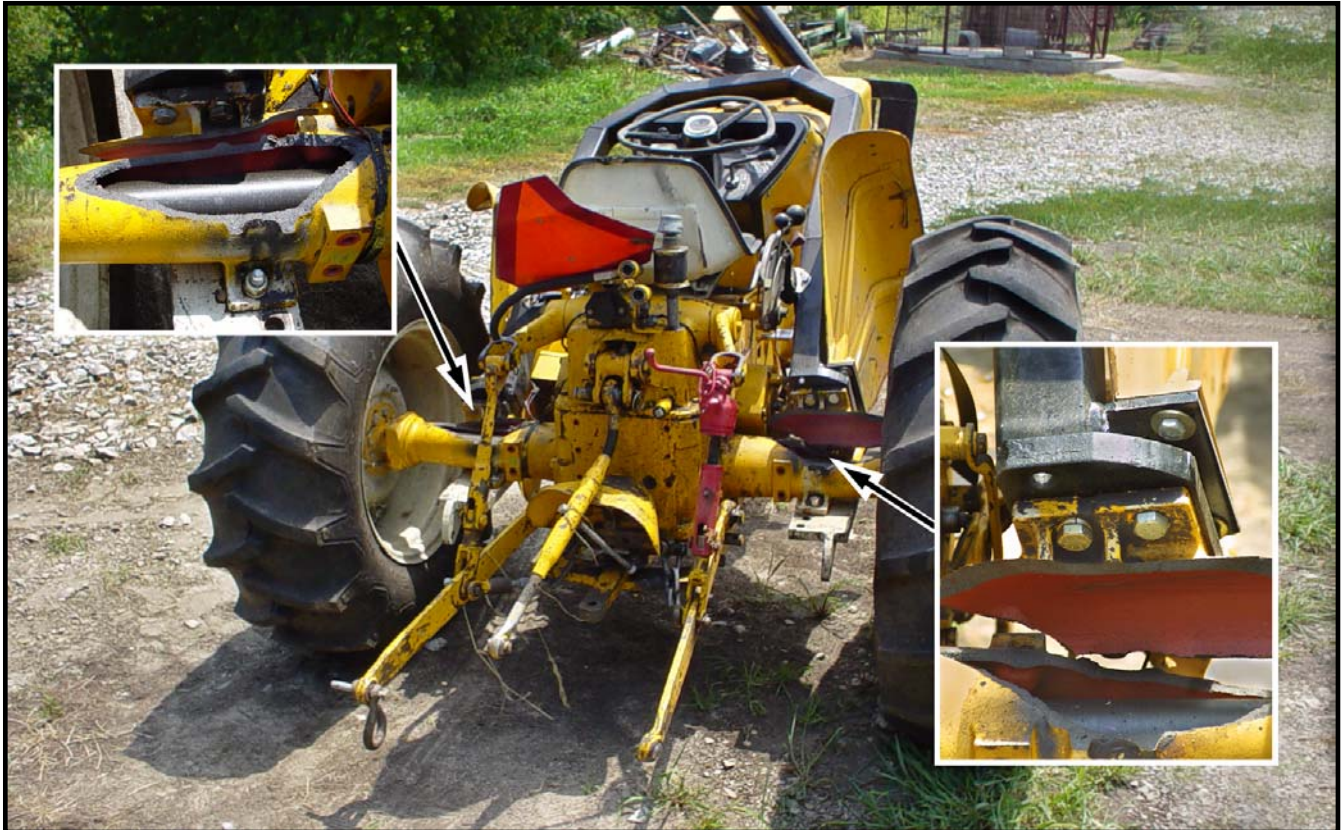
Photo 6 – Rear view of tractor with inserted photo enlargement of left and right broken axle housings.

housing still bolted to the rollbar brackets. (see Photos 2, 3, 6).

By visual inspection, the 3/8 (9.5 mm) cast iron housing material did not have obvious pre-existing damage. The cast iron material appeared consistent in all areas on both sides where pieces were torn from the top of the housings.

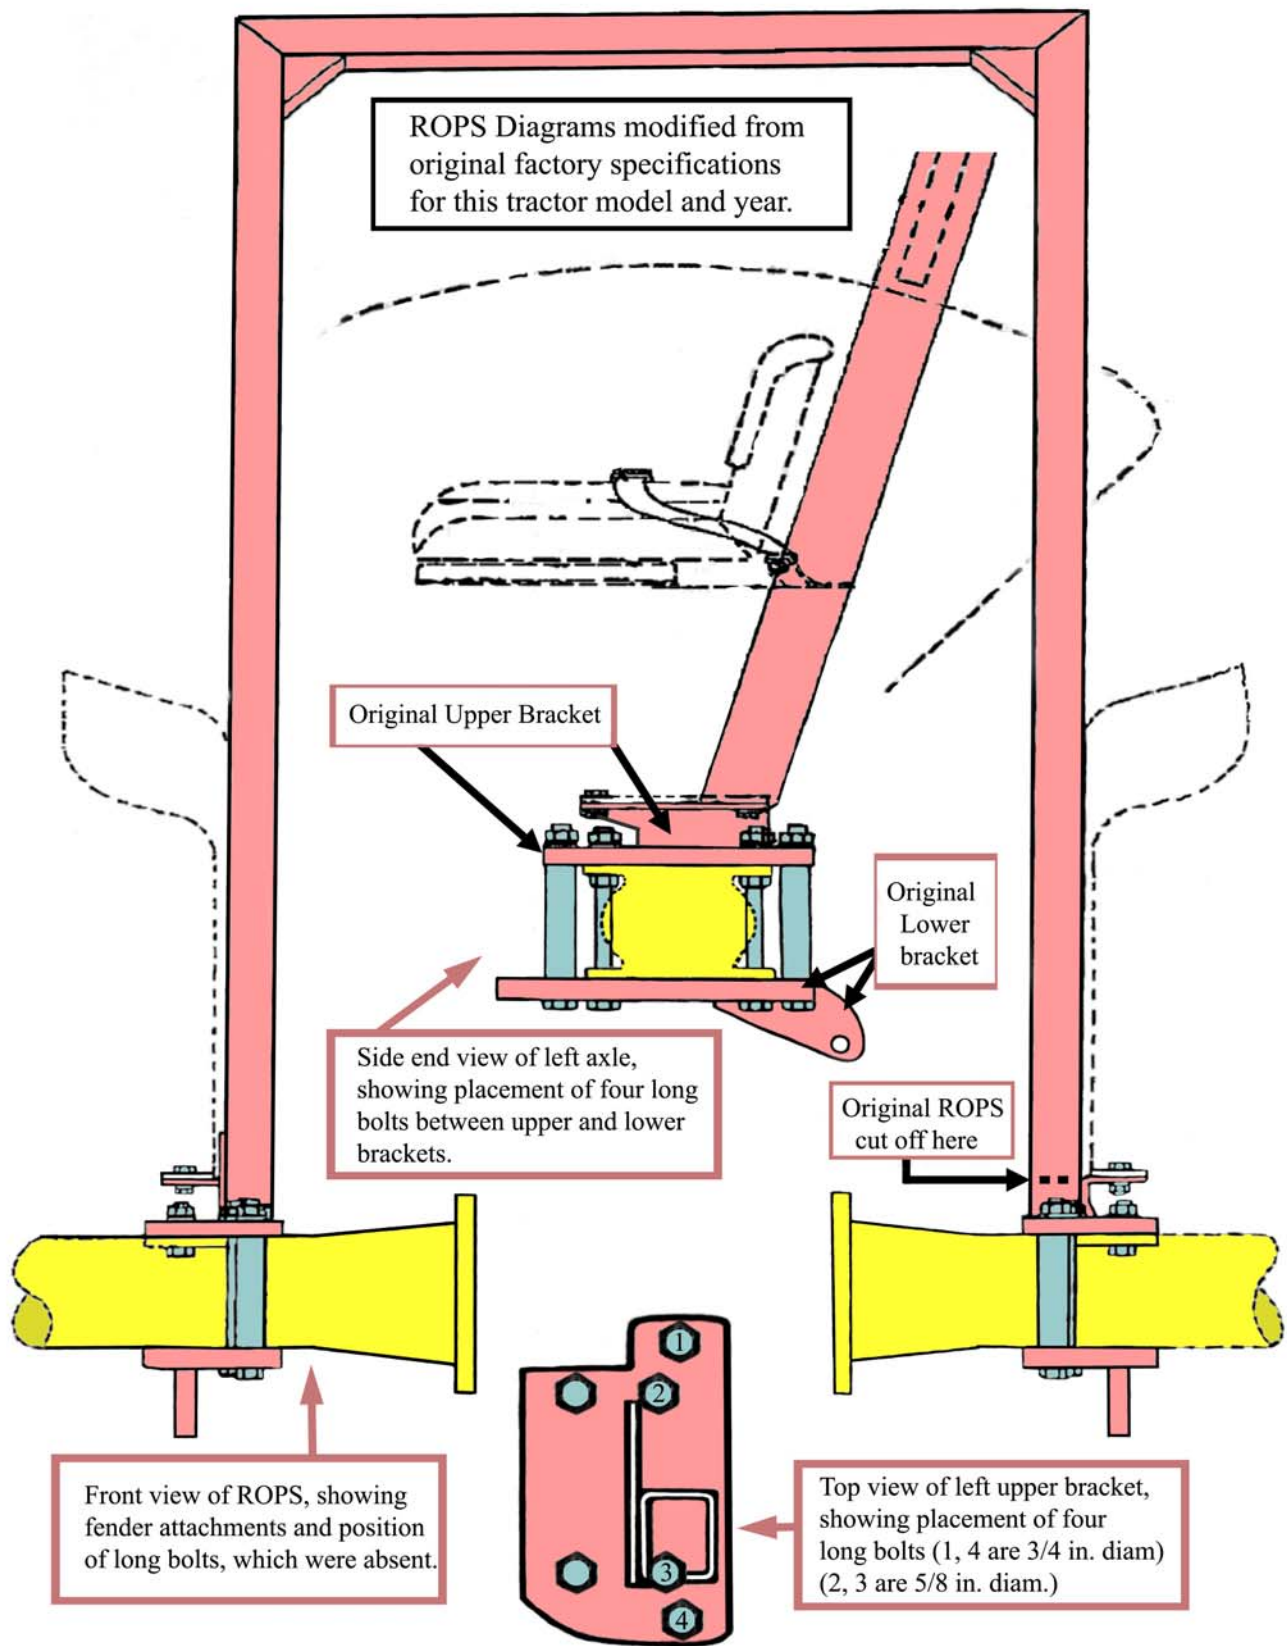
Both the top and bottom mounting brackets for the original ROPS were intact and in place (please see Diagram), however, the four 9-inch long (23 cm) bolts between the top and bottom brackets were missing. These bolts were an integral part of the ROPS design specifications and provided significant strength as they distributed mechanical stress to the entire axle housing in the event of an overturn. The bottom bracket was bolted only to the bottom mounting base of the axle, and the top bracket, with fender and new rollbar, was attached with short bolts to the top mounting base of the axle housing. The original bolt configuration is shown in the specification sheet (see Diagram).
