**TO: Director, National Institute for Occupational Safety and Health**

**FROM: Iowa FACE Program      Case No. 21A56      Report Date: 7/22/2003**

**SUBJECT: Farmer Killed When Tricycle Tractor With Front-End Loader Overturns**

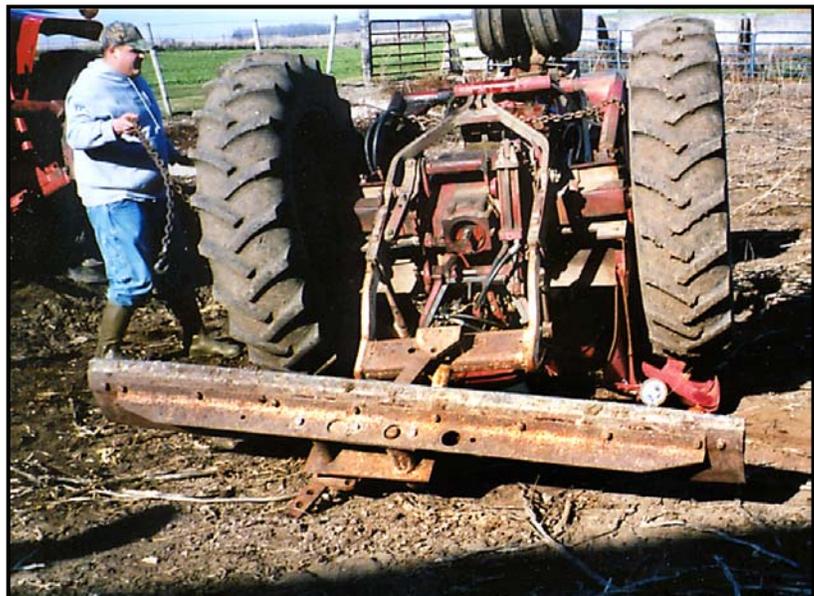
Photo 1 -- Shot of the rear of the overturned tractor, facing north.

The right rear wheel on the tractor was unclamped after the rollover (see Photo 1). There was no damage evident on the rim, and this was not thought to be a factor in this accident. The hydraulic lever to dump the bucket was pushed forward. It is possible that the victim had just activated the lever when the overturn occurred. However, the load of dirt appeared to be still in the bucket during the overturn, and most of the dirt landed under that overturned bucket.

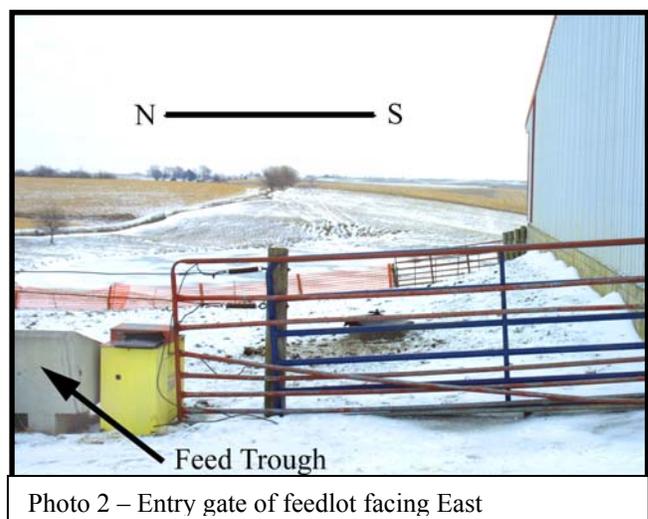
The feedlot was near the farmyard on the north side of the machine shed. It had a long concrete feed trough on its western edge (see Photos 2, 3). Several bucket loads of dirt had already been dumped and spread near the machine shed, and the farmer was dumping and leveling the remainder of the dirt next to the feed trough. Entry into the feedlot was from a gate between the south end of the feed trough and the machine shed (see Photo 2). The farmer had entered the feedlot and turned left towards the feed trough. He was adjacent and parallel to the feed trough at the time of the overturn.

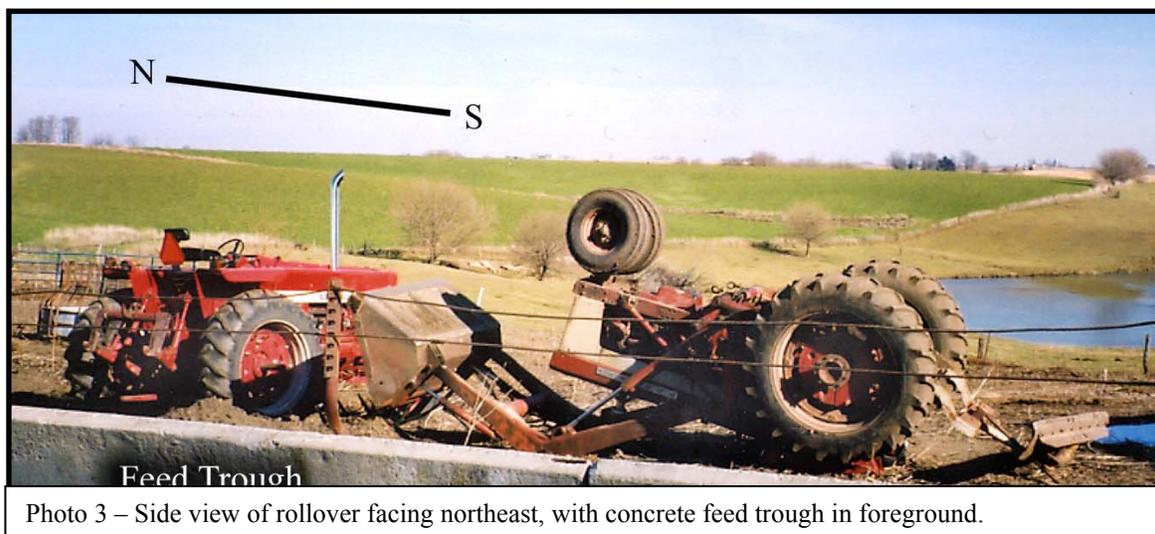
The terrain in the feedlot was soft dirt, and it sloped slightly to the Northeast (see Photo 2). The slope was only a few degrees, and would typically not raise concern about tractor overturn. A relative stated the tractor had routinely been operated in much steeper terrain, and he cannot imagine how the tractor could overturn at this location. He mentioned that if the tractor front end goes over a bump, the hydraulics might “pop or the loader may bang down hard”, but he could not see how this could contribute to this rollover.
