**Case No. 2IA24**

**Report Date: 10/14/2002**

**SUBJECT: Tanker Truck Driver Killed by Unshielded PTO Shaft**

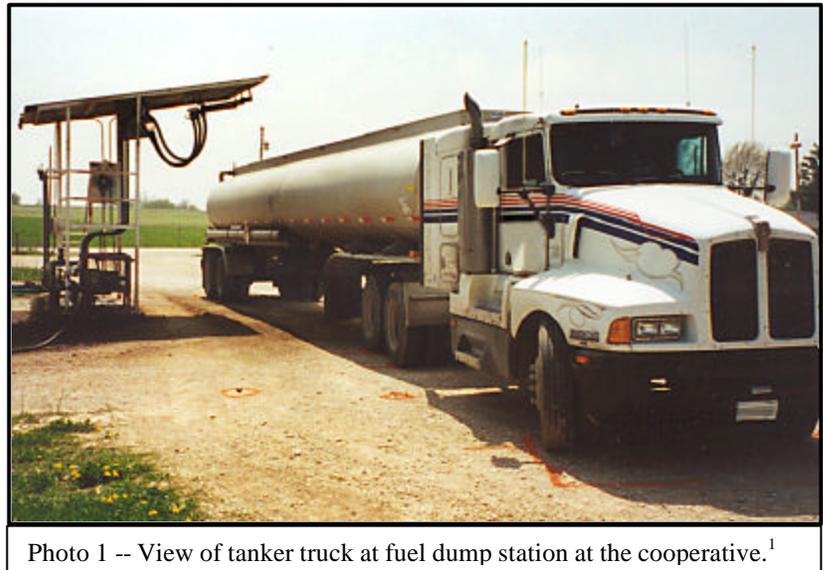
Photo 1 -- View of tanker truck at fuel dump station at the cooperative.<sup>1</sup>

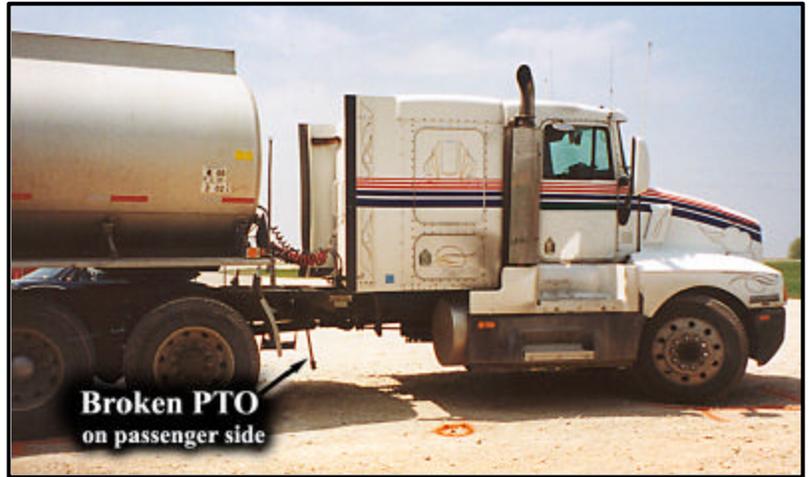
Photo 2 -- Passenger side of truck showing broken PTO shaft.<sup>1</sup>

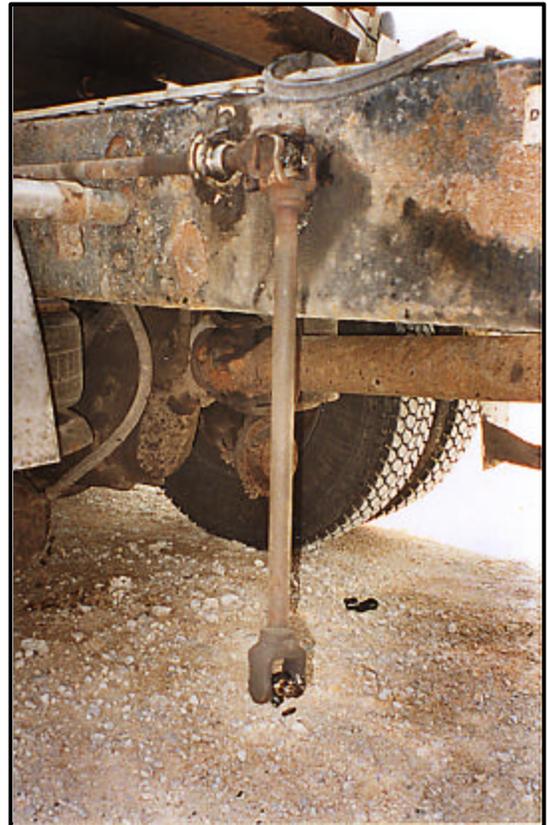
inspected, but had since been removed. At the time of the incident, the shaft was completely exposed. No employees or company supervisors could locate the missing shield, nor had information why, or when, it was removed. It is not evident (from Photo 3) how the shield was attached to the truck. The paint, wear, dirt, and grease marks on the frame indicate the shield may have been missing for some time.

Photo 3 -- Close-up of broken PTO shaft.<sup>1</sup>

**Recommendation #1:** *Employers and workers should ensure that PTO drivelines and other exposed drive-train components are shielded from contact with workers.*

**Discussion:** PTO drivelines are a well-known hazard. PTO's are commonly used in vehicles and machinery to transfer power from the engine to operating parts of the machine. In vehicles, the PTO drivelines to the wheels/axles/differentials are typically not shielded, but they are in locations where they aren't accessible during normal operation. All drivelines that are accessible must be shielded. The PTO shaft powering the fuel pumps in this truck tractor was located in a place where it was accessible in the space between the cab and the trailer. This type of driveline should be guarded. As reported by the company employees, it was guarded when the vehicle was last inspected, but at the time of the incident, the guard was missing. The employers should ensure that adequate vehicle maintenance programs exist and guards are kept in place. It appeared that the shield had been missing for some time. Workers should notify employers about missing shields and other safety hazards, and have them corrected without delay.
