**THE UNIVERSITY OF IOWA**  
Iowa City, Iowa 52242

**Case No. 2IA3**

**Report Date: July 2002**

**SUBJECT: Construction Worker Killed When Cement Forms Fell From Crane**

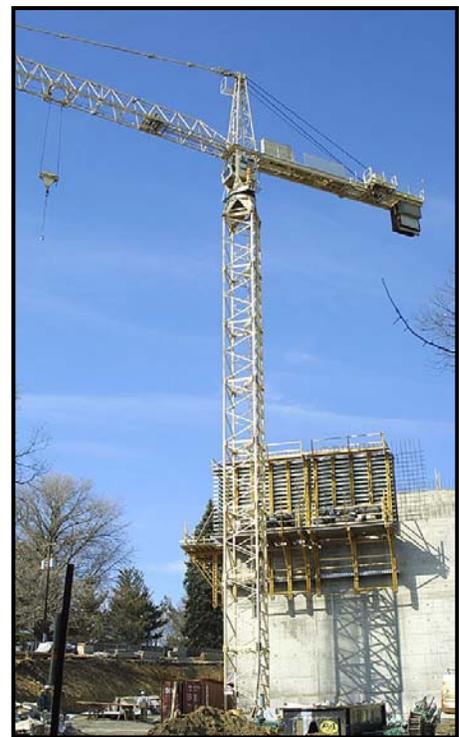
Photo 1 -- Hammerhead crane at site.

The electric powered hammerhead crane was erected near the southwest corner of the building, and provided full access to all areas under construction. This crane was 120 feet tall (36 m), with a reach of 180 feet (55 m), and a capacity of six tons (5.5 metric tons) at full extension. On a busy day, the crane was in constant use, making a lift about every 10 minutes, transporting all types of building materials -- brick, mortar, lumber, re-bar, steel, etc. On the day of our visit, the

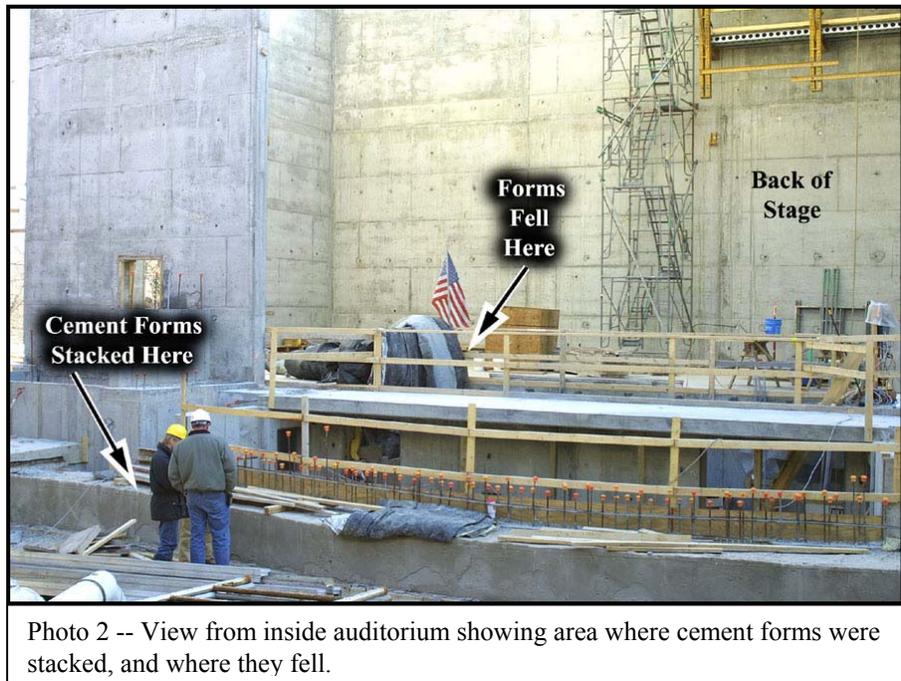
The construction crew was building a new auditorium for a private college, and had been pouring multiple concrete foundations and walls. The victim was working that day as the ground man, supplying other co-workers on a platform in the stage area of the auditorium (see Photo 2). There was no special reason he had to be in the area where the load fell, and exactly what he was doing at that time is unknown.

Photo 2 -- View from inside auditorium showing area where cement forms were stacked, and where they fell.

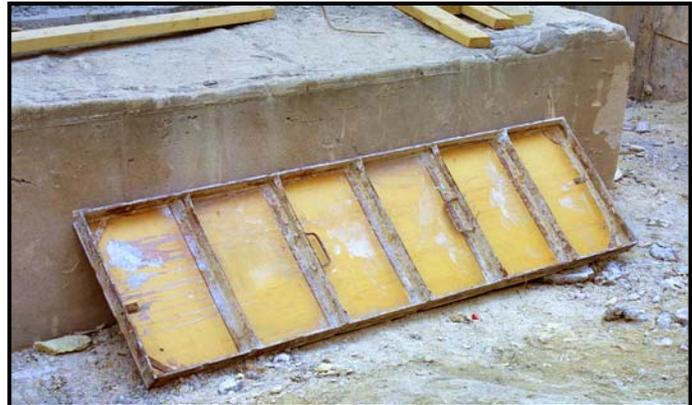
The cement forms were of various sizes, and consisted of plywood sheets attached to a steel frame (see Photo 3). Most of them were 24 inches (60 cm) wide, and four, six, or eight feet (1.2, 1.8 or 2.4 m) long. These forms were used for interior walls, and not for exterior load-bearing walls. They were stacked inside the auditorium, out-of-sight from the crane operator's station, due to an auditorium wall, which had previously been built (see Photo 6). The forms were stacked flat, with the two nylon slings arranged at appropriate locations to ensure a balanced load. On end view, the stack of forms was approximately 24 inches (60 cm) wide and 33 inches (84 cm) tall. The heavy-duty two-ply slings were four inches (10 cm) wide and 16 feet (4.8 m) long, with a choker capacity of 8,600 lbs. (3,900 kg) each. The slings were fairly new, being in service only a few weeks.

Photo 3 -- Typical plywood and steel cement form.

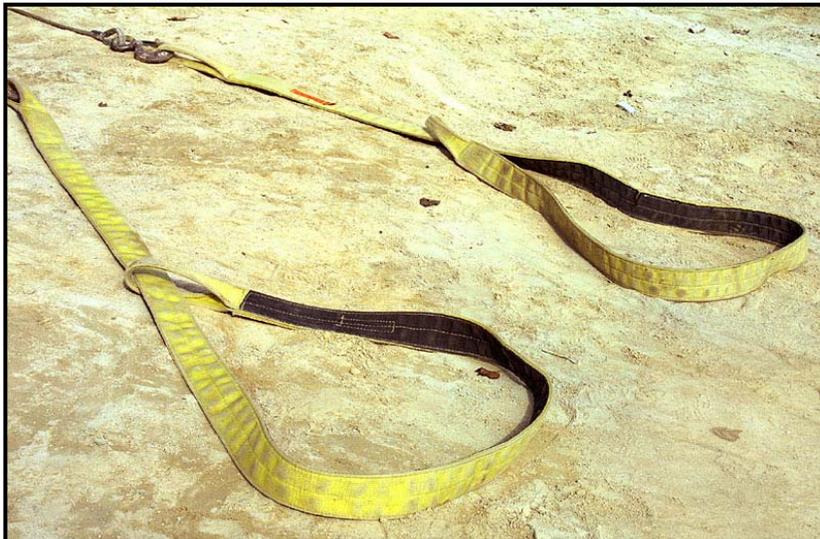
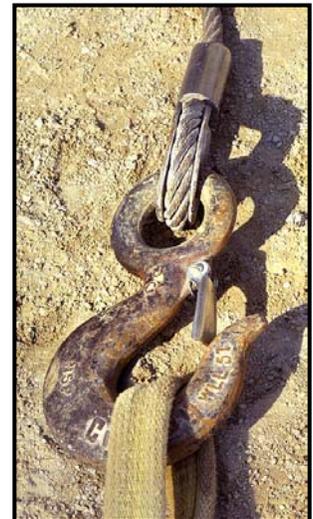
Photo 4 -- View of two nylon slings in typical choker position.

Photo 5 -- Close-up of hook and sling end.

Rigging consisted of a 1½-inch (3.8 cm) master link attached to a two-leg wire rope bridle, which was made of two, ¾-inch (19 mm) wire ropes, 10 feet long (3 m), attached to 10-inch (25 mm) eye hooks (see Photos 4,5). Each eye hook had a five-ton capacity and a safety latch, which was functional on both hooks. The nylon web slings had eyes at both ends, and were configured in a choker hitch around the load of forms, with the free end slipped over each hook. Two workers rigged the slings, hooked the sling ends on the hooks, and one worker radioed for the operator to begin his lift. The load was level, and nothing unusual was noticed at this time, but apparently one of the sling ends was not fully seated within the hook.

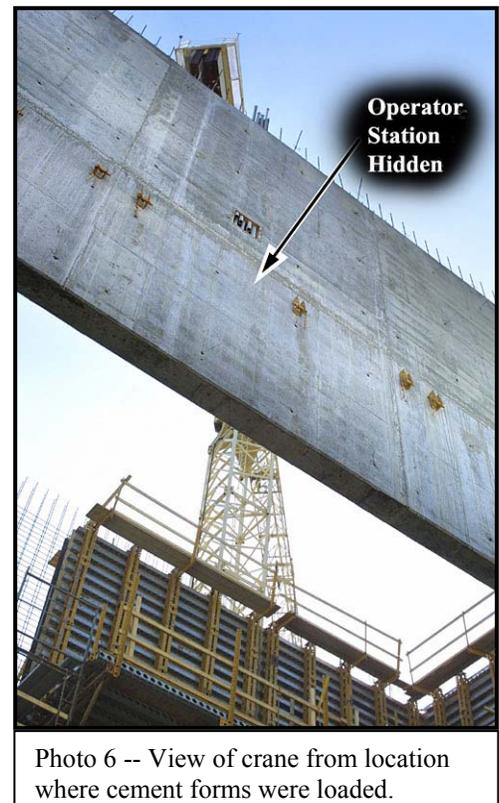
Communication between the crane operator, the person rigging the load, and others at the jobsite must be effective. Crane operators must be aware of all work locations, and likewise, workers should be alerted to stay clear of areas where loads will be moving overhead. The concrete wall (in Picture 6) blocked the crane operator's view to the location where the load was rigged. Even though they had radio contact, lack of visual contact may have compromised communication between the crane operator and the person rigging the load.

Photo 6 -- View of crane from location where cement forms were loaded.

Depending on the situation, multiple people at a worksite may need to be involved in communicating where crane traffic will be, and how best to protect workers from the hazards of suspended loads. Effective radio and visual communication between foremen, crane operators, rigging persons, and possibly others at the jobsite, may be needed to avoid hazardous situations. Applicable ANSI hand signals should be used, and illustrations should be posted at the job site (29 CFR 1926.550(4)).

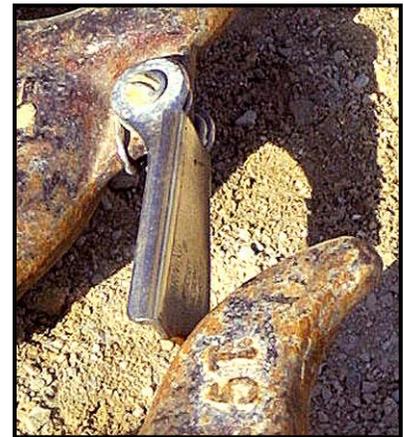
**Discussion:** In this case, the load fell after one of the slings came off the hook, but it is unclear how this occurred. Construction company representatives said it appeared to be a correctly attached and balanced load, however, for failure to occur, the sling had to come out of the hook. It is possible the nylon sling partially rolled or twisted out of the hook before the lift was begun, without the rigger noticing it. The sling may not have been fully seated within the hook, the latch may have been partially open, or the latch may have been bent sufficient to be nonfunctional.

It is critical that a lifting hook has a functioning safety latch. Hooks without latches, or ones with damaged latches are sometimes called "killer hooks" for obvious reasons. Simple hook latches (see Photo 7) are easily damaged during normal use, and may bend to one side or the other compromising their function. Over the years, many new types of hooks have been invented, some with integral self-locking latches. These hooks offer significant protection from latch failure, and would be an excellent option for use in areas of high crane traffic (see appendix). During our investigation we were not able to inspect the actual hook used at the time of the fatal accident.

Photo 7 -- Close-up of a typical spring-loaded latch on a hook.

**Recommendation #3 *Construction workers rigging loads for cranes should carefully check every load prior to signaling crane operators to lift the load, giving special attention to the condition of the safety latch on the hook.***
