FROM: Iowa FACE Program Case No. 1IA021 Report Date: 7/24/03

SUBJECT: Two Railroad Repair Workers Asphyxiated in Damaged Tank Car.

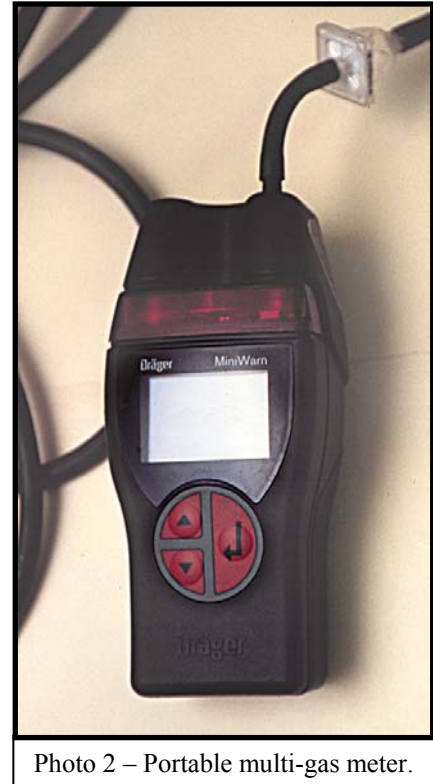
According to the company's confined space protocol, the more experienced foreman operated the portable multi-gas meter to conduct air quality testing, while the lesser-trained attendant remained at his station near the top hatch to confirm meter readings and provide assistance. There were three foremen at this company facility, and all were trained to operate the portable meter. The first victim was the employee with the most experience using this meter, and had used it 150 times in the past. This portable multi-gas meter was only used to test tank cars at this facility. It was equipped with four (4) different electro-chemical sensors: [oxygen (%), combustible gases (% Lower Explosive Limit), hydrogen sulfide (ppm), and carbon monoxide (ppm)]. The meter also featured a digital readout, built-in (automatic) data logger, and an audible alarm to warn users when measurements outside pre-set limits were detected.
