FROM: Iowa FACE Program Case No. 01IA02001 Report Date: Jan. 2002

SUBJECT: City Street Worker Was Struck and Killed by a Speeding Car

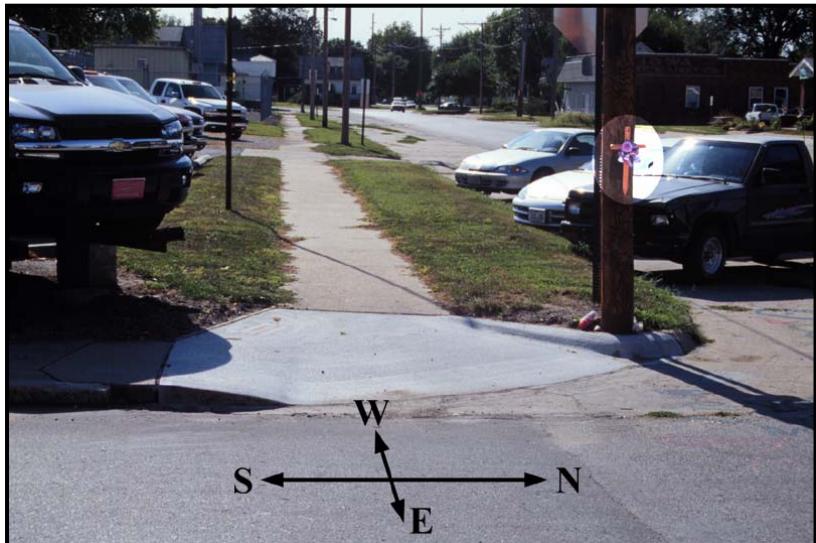
Photo 1 -- View of corner facing west, showing new concrete sidewalk, angled parking, and replaced utility pole.

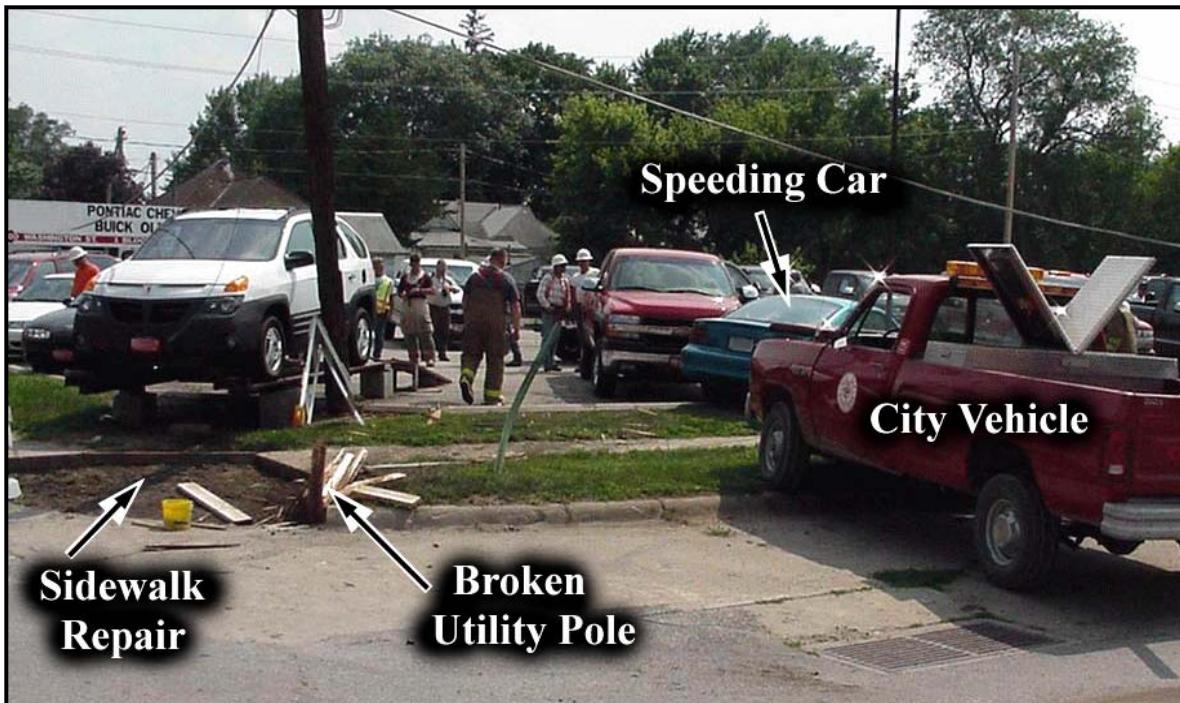
Photo 2 -- Police photograph facing southwest, showing sidewalk repair, path of vehicle and auto dealership where it stopped.

The men were working on the southwest corner sidewalk, and did not need to work very far into the street. Two folding barricades were set up in the street, adjacent to the corner, and the remainder of the intersection was open and fully operational from all four directions. A city truck was parked in angle parking northwest of this location, to protect workers from traffic approaching from the west (see Photo 2). The men were wearing safety vests and hard hats. The victim was working in a crouched position with his back toward the traffic.

A car approached from the east, driven by a female teenager. She stopped at the intersection in a normal fashion, planning to turn left. During this time a 17-year-old male teenager approached the corner also from the east, driving his car at high speed, trying to chase the girl. He could not stop and proceeded to pass her on the left side, but she had initiated her left turn, and he struck her car on the driver's side. His vehicle bounced into the work zone striking the victim, a utility, pole, the city truck, and several parked cars in an auto dealership. The victim was run over by the speeding car and killed instantly. The teenage boy, who was not injured, was later arrested and charged with vehicular homicide. He had a past record for speeding and reckless driving.

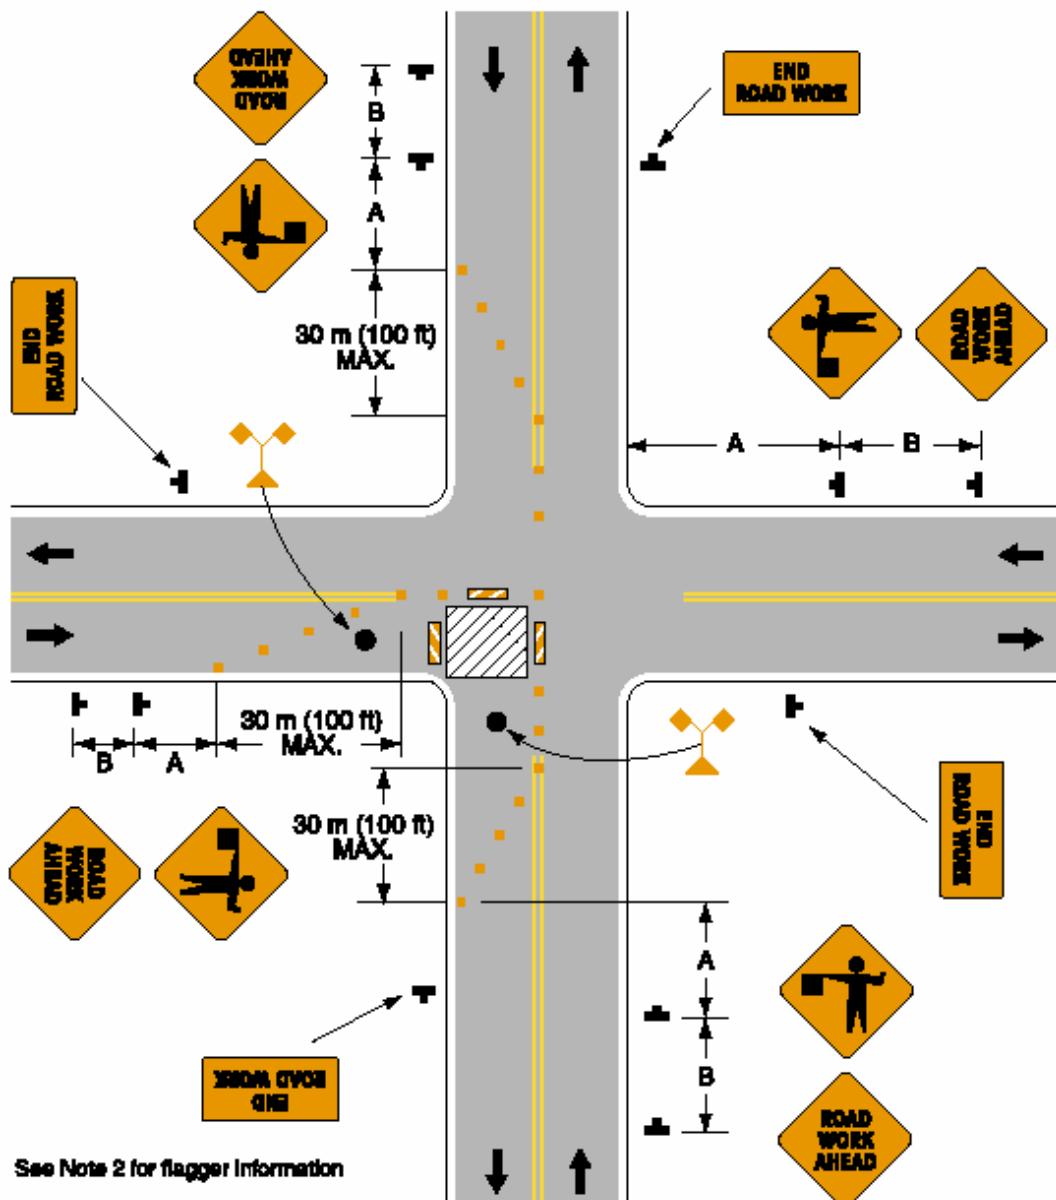
Figure 6H-27. Closure at Side of Intersection (TA-27)

According to the MUTCD (Manual on Uniform Traffic Control Devices), work on the side of an intersection requires a flagger, specific signage, and channelizing devices (see Diagram). In the diagram, the intersection is blocked, forcing one-lane traffic on three approaches to the intersection. This degree of traffic control is required when the intersection is partially closed or blocked, however, in our case, since work was actually on the sidewalk, and not the street, the intersection was completely open, and all lanes were operating as usual, yet with caution.

Recommendation #1 *MUTCD guidelines (Manual on Uniform Traffic Control Devices), for closure at side of intersection may apply to this situation, and should be considered as a safety measure.*

1. The situation depicted can be simplified by closing one or more of the intersection approaches. If this cannot be done, and/or when capacity is a problem, through motor vehicle traffic should be directed to other roads or streets.

2. Depending on road user conditions, flagger(s) or uniformed law enforcement officer(s) should be used to direct road users within the intersection.
