THE UNIVERSITY OF IOWA
Iowa City, Iowa 52242

FROM: Iowa FACE Program Case No. 00IA08201 Report Date: March 2002

SUBJECT: Farmer Fatally Injured by Rotary Mower When Tractor Seat Falls Off

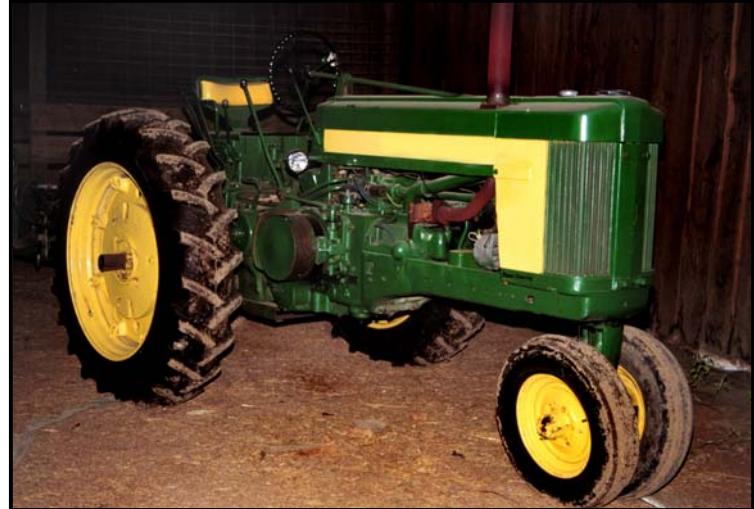
Photo 1 -- Side view of identical tractor model.

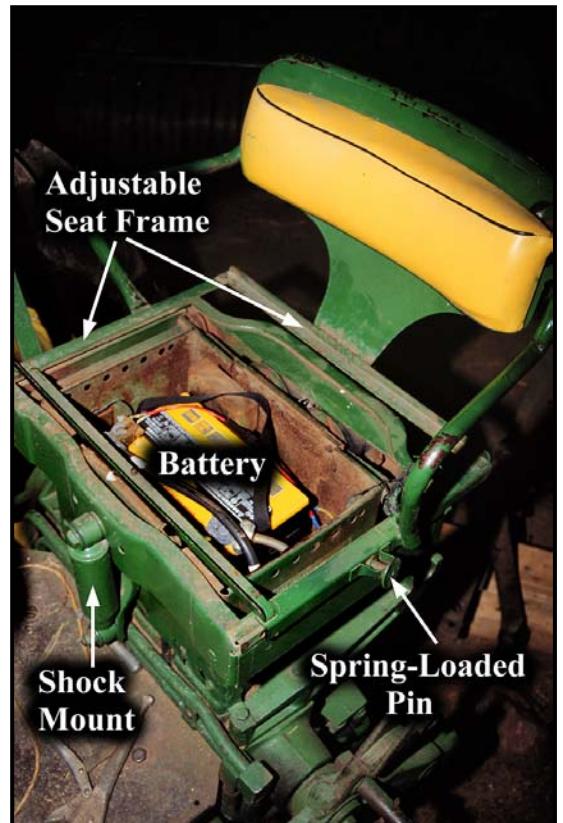
The battery housing forms the base of the seat on this tractor (see Photo 2). A shock-absorbing main seat frame is built around the battery housing. The seat cushion, backrest, and armrests are attached to the top part of the frame, which is adjustable and slides on tracks at the edges of the main frame. A spring-loaded pin on the left side of the seat locks the seat in place (see Photo 3).

Photo 2 -- Top view of seat showing seat frame, battery housing, and adjustable pin. (cushion removed)

In the photo, the pin is operational, but according to the victim's relatives, it was damaged, and the tractor was in overall poor condition. We were not able to observe the tractor, so the extent of the damage is not clear, but considering the age of the tractor, many forms of wear and tear could damage the pin.

Recommendation #1 *Owners/operators of tractors should ensure that the tractor seat is in good condition and firmly attached to the base.*

Discussion: Machines should be kept in good repair, including the seat. The seat on this tractor was in poor condition. The attachment was worn and when driving unexpectedly into a sinkhole in the field the jolt separated the seat from the frame and threw the operator off the tractor. This tractor was used because the regular tractor was in the shop, and this older tractor was adequate for operating the small mower. Older tractors like this are often used for mowing.

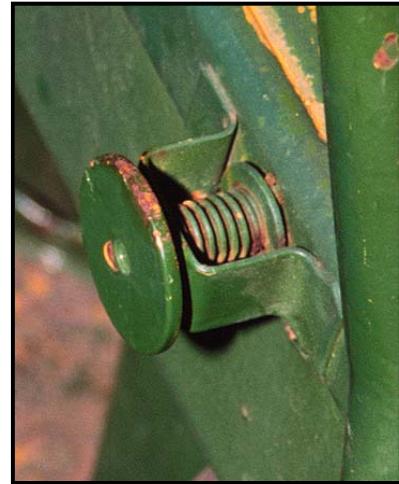
Photo 3 -- Close-up of spring-loaded pin on left side

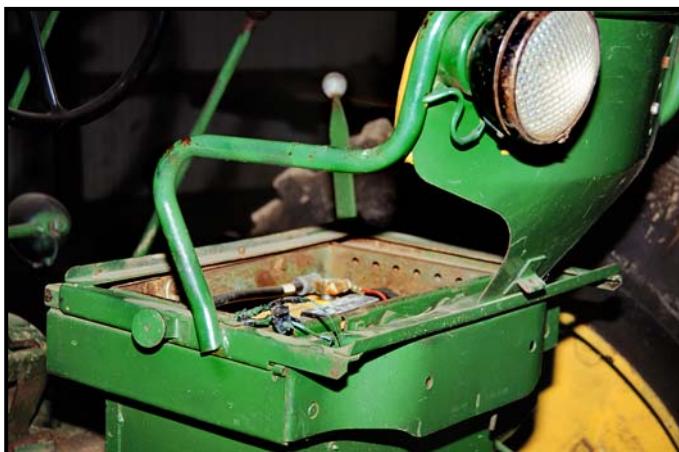
The adjustable top part of the seat frame moves forward and backward on the tracks/grooves. Bent metal tabs at the end of the tracks are designed to keep the seat in the adjustable range. The back and armrests are welded directly onto the sliding top part of the frame (see Photo 4). Over time this seat attachment may become loose, especially if the spring-loaded pin is not keeping the seat in place. The tabs may wear, and the top frame may bend or wear and be more prone for sliding out of the tracks.

Photo 4 -- View of left side of seat, showing sliding track and armrests welded to the seat edge.

Discussion: The seat frame in this tractor was separated from its base during a strong jolt. It appears the seat slid back and the tabs at the end of the tracks were not able to stop it. It's also possible that the adjustable top part of the frame was bent and loose enough that it pulled the seat up and out of the tracks during the jolt. In either case, the seat adjustment mechanism was not secure enough to hold the seat in place. The challenges in manufacturing a tractor seat are significant and include adjustability for various size operators, shock absorption, vibration damping, weather and corrosion resistance, durability, and comfort. Some recent seat models allow the seat to rotate to the right to reduce bending of the back when observing implements behind the tractor. Furthermore, some seats tilt to remain vertical when driving on sloping ground. Regardless of the features of the seat, the construction of the seat frame and its support structure should be able to withstand use in demanding conditions.

Recommendation #3 *Equipment manufacturers should design the seat support structure to withstand use in demanding conditions for the lifetime of the tractor.*
