Case No. 00IA06401

Date: August 2001

SUBJECT: Tree trimmer falls to his death as boom truck lift arm collapses.

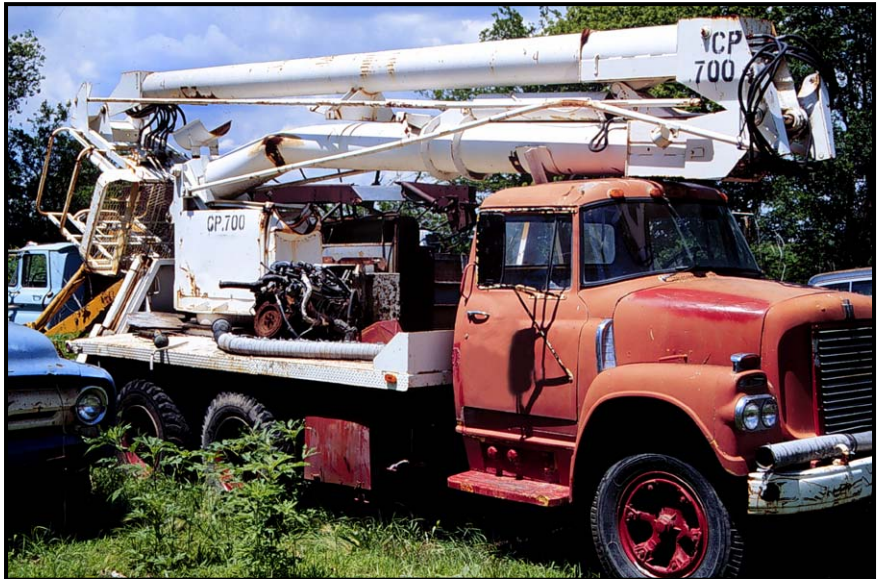
Photo 1 -- View of boom truck as it sits in a junkyard. The bend in the lift arm occurred when the machine fell to the ground.

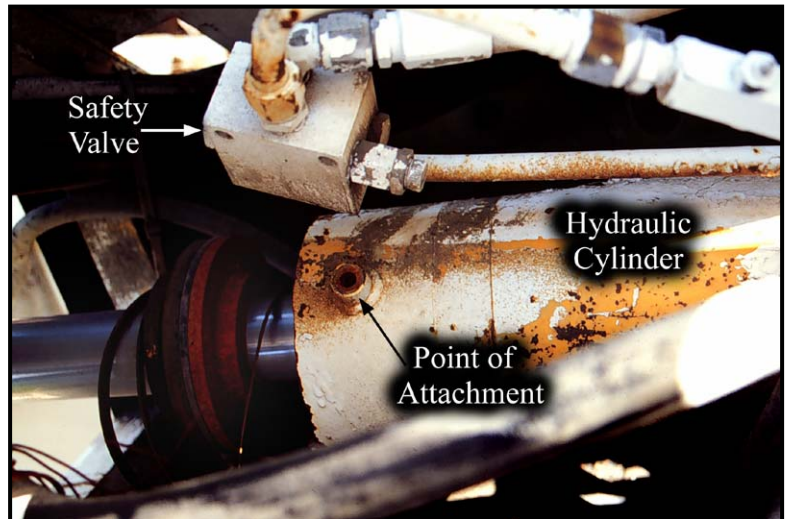
A single heavy hydraulic cylinder provided lift for each of the two lift arms. The lower, and heavier, hydraulic cylinder had a safety valve (see Photo 2) attached to the upper end of it, designed to prevent movement of any hydraulic fluid if the vehicle suddenly lost power or hydraulic pressure. This hydraulic cylinder was power-up and power-down, and was in a retracted position when the lower boom was fully raised. In Photo-1 the main hydraulic cylinder is not seen, being enclosed within the rectangular white box, which pivots on the main truck bed.

The victim was working off the back of the truck at a height of ~11 m (35 feet). They had been on the job for about 30 minutes doing routine work, tying off and cutting branches. The victim was re-positioning the boom when the safety valve suddenly snapped off where it enters the cylinder, hydraulic fluid shot out, and the elevated boom immediately fell to the ground. The victim was not handling a heavy branch or putting unusual stress on the boom at that time. A police officer at the scene, who was directing traffic, stated that he heard two pops, like something was breaking, then noticed the boom move back and forth a few times before it crashed to the ground. There was no apparent incident that could have put unusual stress on the safety valve, rather it appeared to break due to long term wear and fatigue.

Photo--2 Lower main hydraulic cylinder showing safety valve broken off at its attachment point.

Discussion: This boom truck appeared to be in excellent working condition prior to the incident. There was no warning that the safety valve might break and cause the lower lift arm to fall. The exact location of the break is significant. This area, flush to the attachment point on the cylinder, implies that significant lateral stress on the safety valve was present. This type of break could occur due to metal fatigue from vibration or constant stress applied on the safety valve at this point. Considering the relative weight of the safety valve, and that the threaded nipple was its only connection to the hydraulic cylinder, it is likely that vibration over time caused metal fatigue where the nipple enters the cylinder. Anticipating such breakage through maintenance would be very difficult. There was no testing conducted on the broken metal parts, however fatigue appears the primary reason for the failure. Considering the constant stress and vibration from hydraulic fluid, as well as possible bumps from objects, it appears that the size and weight of the valve was excessive to be supported only by the 13 mm (1/2 in) pipefitting nipple. This size hydraulic element would likely require a fixed installation with solid brackets or other means to eliminate the vibration stress.

Recommendation #1 Hydraulic fittings should be designed to withstand the stress and fatigue encountered in normal use.

Recommendation #2 Engineering interventions should be developed to prevent boom lift fall in case of hydraulic failure.

Discussion: In this case, designers attached a safety valve to the cylinder, to prevent accidental lowering of the boom in case of hydraulic failure. However, there was no protection if the safety valve itself should fail. Other engineering means could be developed, such as a dual hydraulic system where one system could still work if the other system fails. Mechanical support systems may be possible as well. Relying entirely on the proper function of one hydraulic system appears to create an excessive risk in a machine such as this lift.

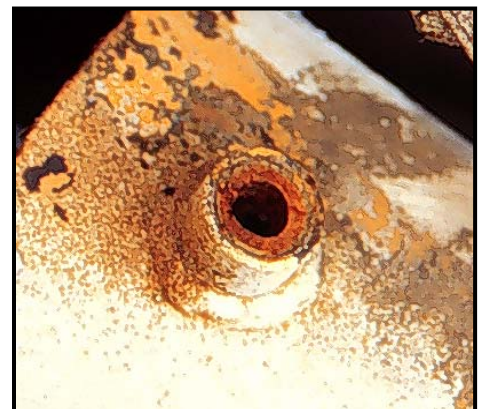
On inspection the nipple was cracked off flush with the edge of a short sleeve, welded to the side of the hydraulic cylinder (see Photo 3). The valve was hanging in position, still connected to its metal hydraulic lines (see Photo 2). The owner of the truck inspected the break after the incident, and said it was a clean break, without evidence of prior cracking or rusting. He had no explanation whatsoever for what may have caused the

Photo 3 -- Hydraulic line input showing broken edge of nipple. Photo taken several months later shows significant additional rusting.

nipple to snap, for to his knowledge, it had never been damaged prior to the accident. At the time of our inspection, the broken metal nipple was quite rusted, as it had been sitting in a junkyard for several months.
