FROM: Iowa FACE Program Case No: 00IA03101 Report Date: January 2001

SUBJECT: Worker Dies When Tower Crane and Water Tower Crash to the Ground

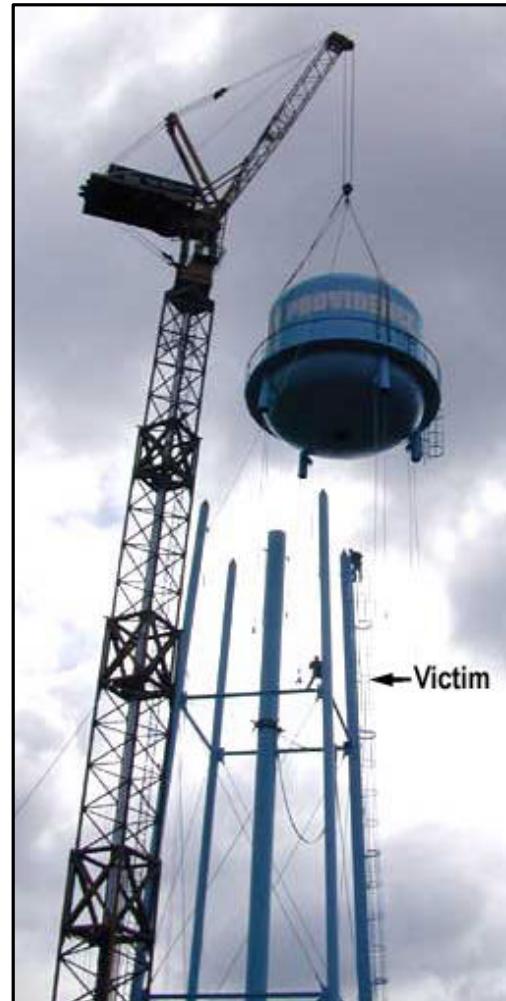
Photo 1 -- Picture of water tower taken a few minutes before the incident.

onto the water tower legs. The other man, the victim, was on a horizontal strut, preparing to position and tighten the X-bracing immediately after the tank was lowered onto the water tower (See Photo 1). The owner of the tank company was standing on the ground giving directions to the other two men.

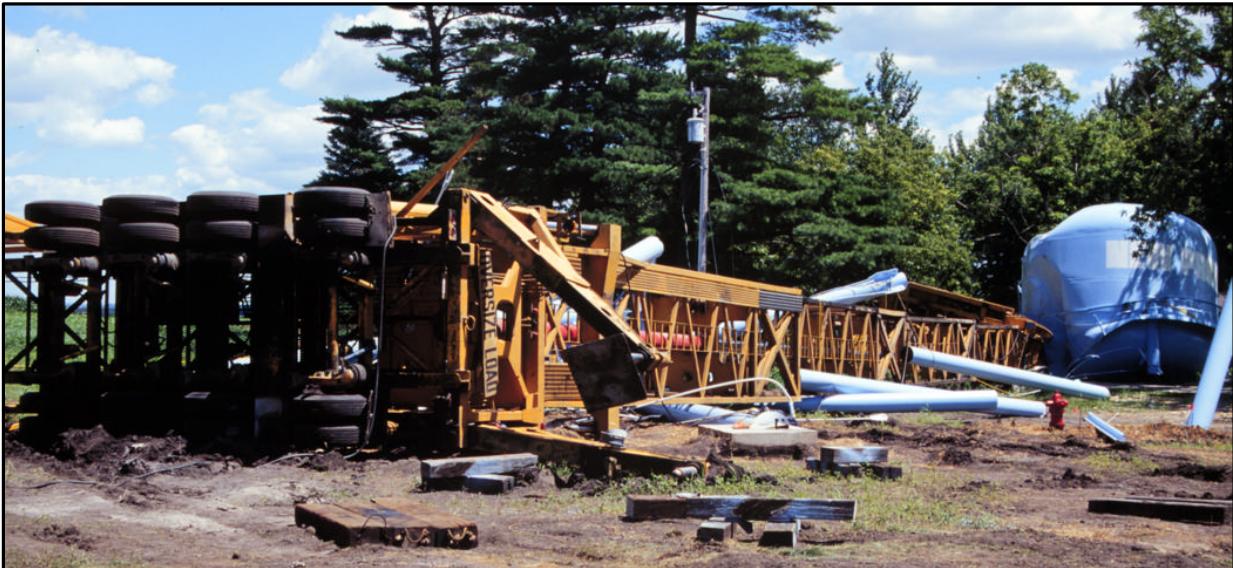
Photo 2 -- View of the crash scene taken during investigation -- photo shot from the rear of the crane trailer.

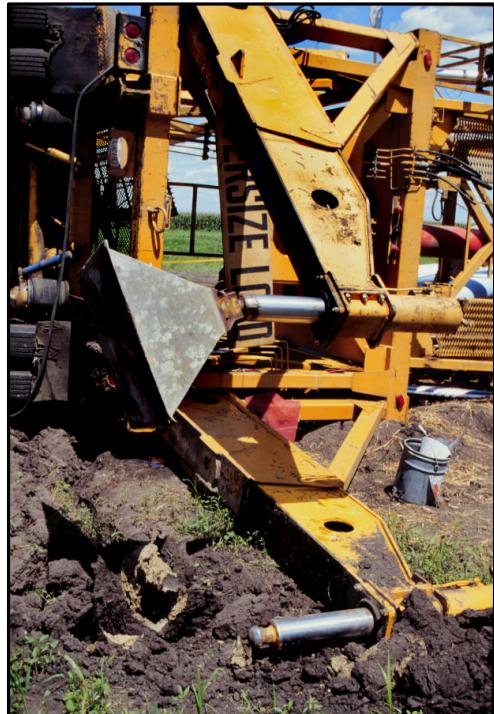
Each front outrigger was set on two timbers, which were set directly on the ground. The timber dimensions were 85 inches long, 12 to 13 inches wide, and 7 inches tall. Each rear outrigger was set on three of these timbers, which also were set on the bare ground. There was no evidence of an attempt to move the 6-12 inches of topsoil in the area; all outriggers were set directly on this black dirt. The right rear outrigger was set inside the perimeter of the new water tower, approximately 11 feet from the well opening. No plywood or steel plates were used under the timbers to distribute the load, nor were any bolts or other rigging used to secure the timbers together.

Photo 3 -- Close-up of rear outriggers.

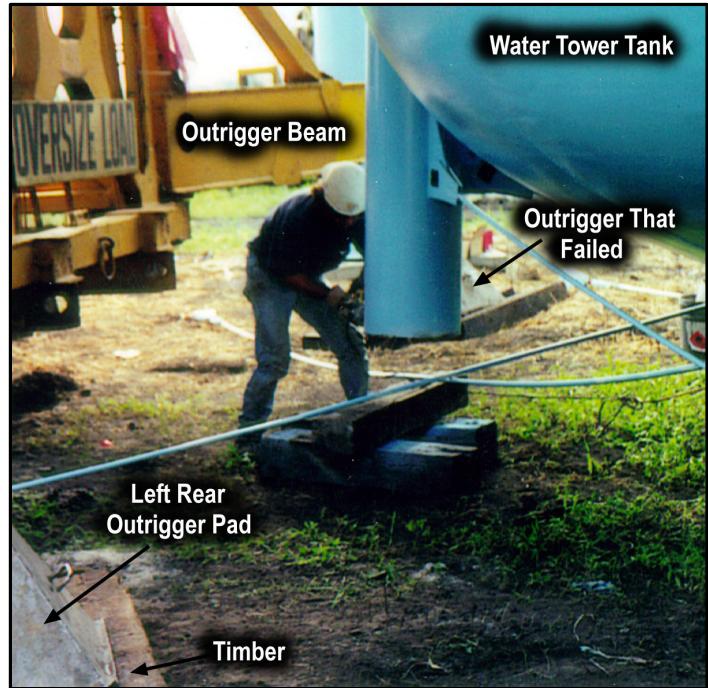
Shortly before the final lift, the water tank was raised a few feet off the ground to clean up the bottoms of the support legs (Photo 4). This photograph shows a glimpse of the outrigger and cribbing timbers that completely failed 20 minutes later. On a closer look at the photo (Photo 5), some details are noteworthy: (1) the ground is not level under the timbers, (2) the cribbing timber to the right has already begun to roll out from under the pad, and (3) there is a space between the right and middle timbers. The appearance of the timbers in this photo is consistent with the final position of them after the accident, as seen in Photo 6.

Photo 4 -- Tank worker preparing leg of the water tank.

Discussion: Evaluation of the incident circumstances indicates that the ground under the right rear outrigger had begun to fail early in the lift. As evidenced by Photo 4, the ground under the outrigger was already failing, yet the hoisted load was less than waist high above the ground. Had the ground condition under the outrigger been detected and correctly assessed at this point, there would have been time to lower the load and change the outrigger set up to one that was more stable. During the lift there were several workers on the ground, including the owner of the tank company and the foreman of the crane crew. Once the lift was begun, it lasted about 11 minutes, during which the ground under the outrigger continued to fail to the point that the lean of the crane caused it to become unstable and it fell over. It seems likely that the attention of ground observers would be focused on the lifted load and the workers on the water tower. However, as a crane lifts and then swings its load into position, the outrigger loading changes, increasing as the load is swung over them. To detect potentially unstable conditions, the entire crane setup should be observed during a lift.

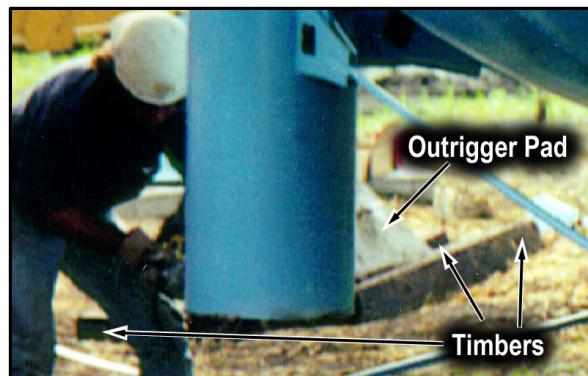
Photo 5 -- Close-up of timbers under the right outrigger that failed 20 minutes later.

Contributing to the occurrence of the incident was the manner in which the timbers were placed under the outriggers. As can be seen in Photos 4, 5, and 6, just prior to the incident, the cribbing timbers were rolling out from under the outrigger pads and spreading away from each other. Some crane companies we consulted always use plywood or steel plates under outrigger timbers to minimize shifting of the soil and/or cribbing rollout, even if they are setting up on highway concrete. In addition, some operators use long bolts through timbers to create a solid base, to prevent cribbing rollout (See Figure).

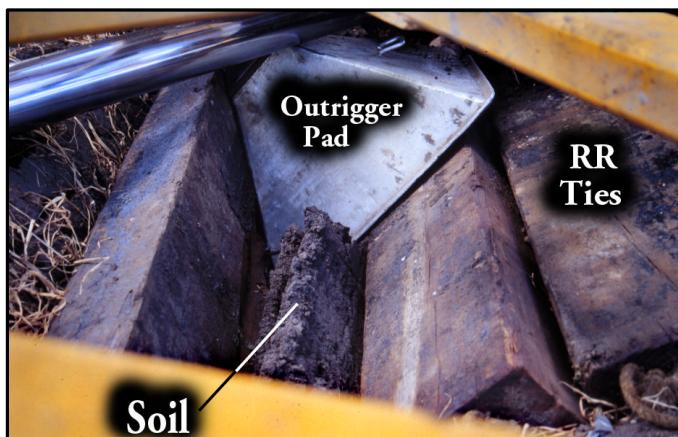
Photo 6 -- Failed outrigger pad and cribbing timbers.

vertically within 3 to 4 feet of the water tower legs when the right rear outrigger on the tower crane suddenly shifted and sank down between the timbers, causing the tower to fall towards the water tower structure (See Photo 6). The soft soil was pushed upwards, the stabilizer arm on the right outrigger snapped, and the outrigger arm swung to the rear of the trailer as the crane began falling. Witnesses report it took several seconds for the crane and tower to fall to the ground, taking nearby powerlines with it.

The investigation concluded that the tower crane fell directly in line with, and on top of, the right rear outrigger, complete failure of the ground under the right rear outrigger occurring soon after the full load was upon it. Although the top of the ground in the area was dry, deeper soil under the three timbers was wet and soft. The weight of the load squeezed this soil upward between the timbers (See Photo 6). There was a depression approximately 18 inches deep in the ground made from the right rear dual tires of the trailer (See Photo 7). This depression was evidently made when the outrigger failed and the complete weight of the hoisted load and the crane was momentarily transferred to the trailer before the tower fell flat to the ground.

In this case, it is apparent that the rear outriggers were setup improperly. The ground was not leveled under the outrigger, and cribbing timbers were not placed close together, nor were other means taken to prevent cribbing rollout. It appears that much of the hoisted load was transferred to the middle timber, which was certainly not adequate to support the load. More significantly, adequate bearing area to reduce the outrigger loading below 2000 psf.. may have prevented this incident.

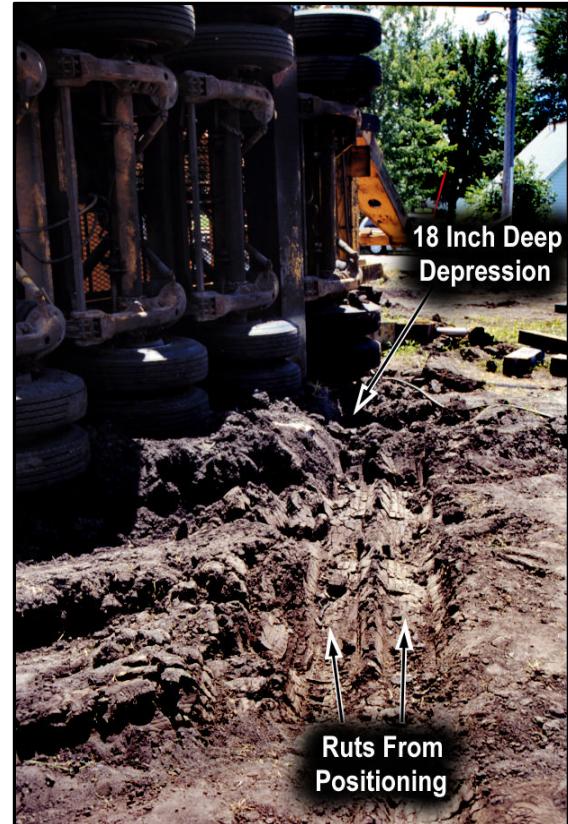
As mentioned, it was difficult for the semi-tractor to move the crane trailer into position because of the soft topsoil. Photographs show deep wheel tracks from the four sets of dual tires under the heavy trailer (See

Photo 7). A local farmer with 30 years of farming experience described the soil as "*hard as pavement on top, yet pure gumbo underneath*". He said the soil was very difficult to work; it drained poorly, and retained moisture more than other soils. This jobsite was flat; the ground surface was dry; the temperature was in the 90s, and there was essentially no wind that day.

Photo 7 -- Soft topsoil in construction area.

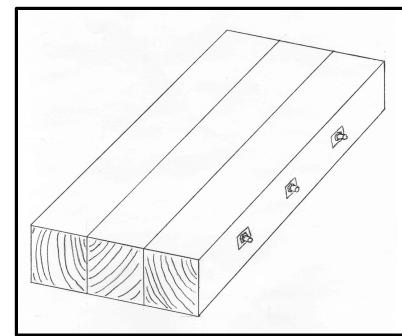
Figure -- Bolted Cribbing Timbers to prevent rollout.
