## Construction worker crushed between falling dump box and truck frame

### SUMMARY

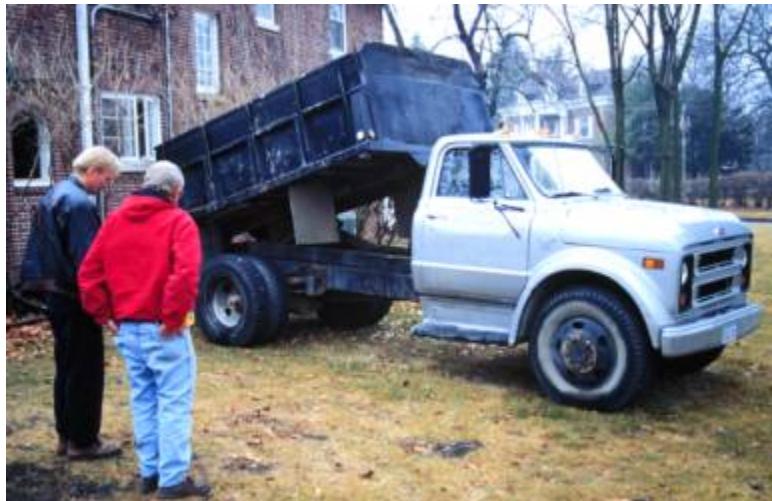
**Photo 1**

During the fall of 1999, a 53-year-old construction worker was killed after he unloaded sand from a dump truck. He partially raised the box of his truck to dump out a portion of wet sand at a work location, then leaned under the box to manually trip the hydraulic linkage to bring the box down. The hydraulic linkage was located at the hydraulic pump, behind the cab between the main frames of the truck. This action was

apparently a habit to save some time from walking around the truck to push the dump lever inside the truck cab. However, this time, because of the heavy load of sand, and because the box was only partially raised, the truck box came down immediately pinning the man between the box and the frame of the dump truck. The man suffered massive head injuries and was dead at the scene. The deceased truck driver had several years of experience with machinery and was the lead man for the small construction company.

- *Workers should use proper machine controls rather than actuating machine functions at hazardous locations.*

- *Employers should train and supervise workers adequately to ensure that safe procedures are followed.*
- *Manufacturers of dump trucks should consider options to discourage unsafe use of dump box hydraulics, such as placement or shielding of controls*

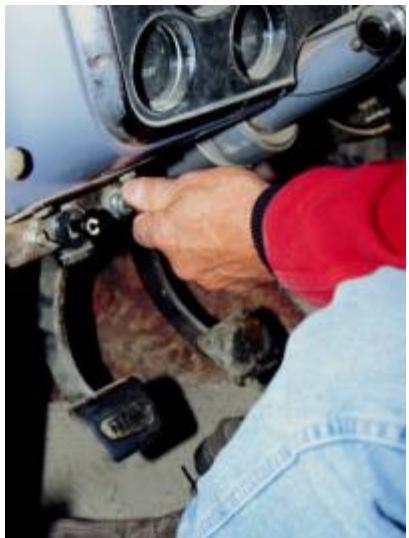
**Photo 2.**

The dump truck was a 1968 model with a payload of seven tons. It was maintained by the victim and was in normal operating condition. The hydraulically-controlled dump box was actuated by a hand-operated knob inside the cab of the truck (see Photo 2), and controlled by the clutch pedal. A cable ran from the knob to a hydraulic valve located

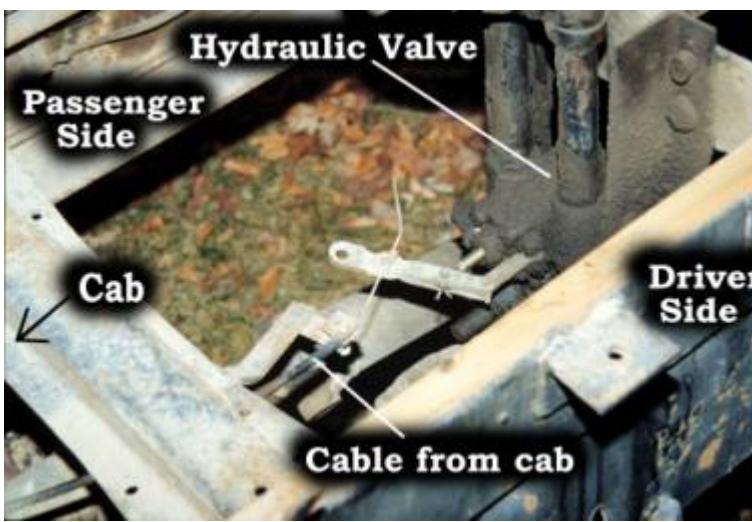
**Photo 3.**

between the main frames of the truck (see Photo 3). When the box was raised, this cable end and actuator lever at the hydraulic pump housing were visible and within easy reach.

**Discussion:** The hydraulic linkage in this older dump truck was easily accessible from the sides of the truck when the box was raised. While this is an unexpected hazardous behavior, it might be possible to prevent such behaviors by placing the linkage where it cannot be easily reached or enclosing the linkage so that it could not be easily misused.

**Recommendation #3:** *Manufacturers of dump trucks should consider options to discourage unsafe use of dump box hydraulics, such as placement or shielding of controls.*
