**FROM: Iowa FACE Program**

**Date: August 2000**

**SUBJECT: Farmer crushed to death under broken corn planter.**

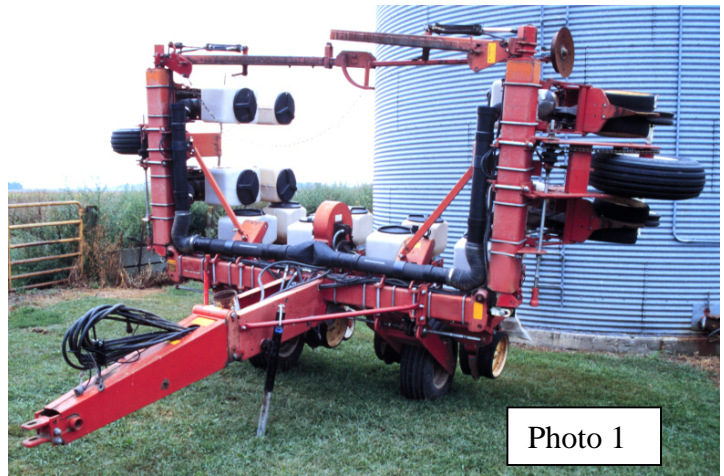
The victim and his father were working together on their first day of corn planting in the spring of 1999. The 8-row planter they were using was 10 years old and had been purchased four years earlier. The planter had a single axle and four wheels situated behind the toolbar (see Photo 1).

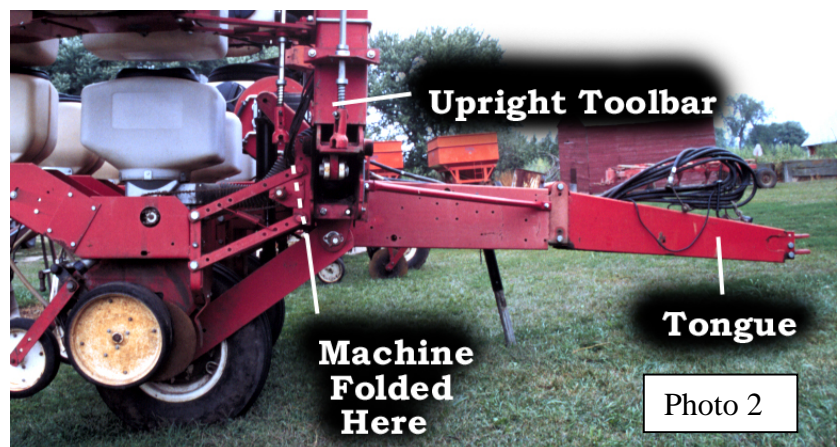
then suddenly without warning, the planter tongue folded in the region where it was attached to the toolbar (see Photo 2). What the victim was doing immediately prior to this is unknown. The toolbar with all its attachments, including the filled seed hoppers fell to the ground, crushing the farmer underneath. Rescue was called immediately, as the driveway was adjacent to the farmhouse, and the man was air-lifted to a regional hospital, however, his injuries were severe and he died shortly after arrival.

**Discussion:** Several identical planters from this manufacturer failed in the same fashion as this one, at the critical union of the tongue and toolbar. This design put too much stress on the bolts leading to bolt failure and breakage. Newer planters from this manufacturer have re-designed the union of tongue and toolbar, with welded seams that virtually eliminate a similar type of accident. If companies are aware of weaknesses in machinery design, they should warn current customers of potential problems while they are making design improvements.

**Recommendation #2** *Manufacturers of farm equipment / implements should routinely review service calls for their machines and consider recalls or modifications as needed.*

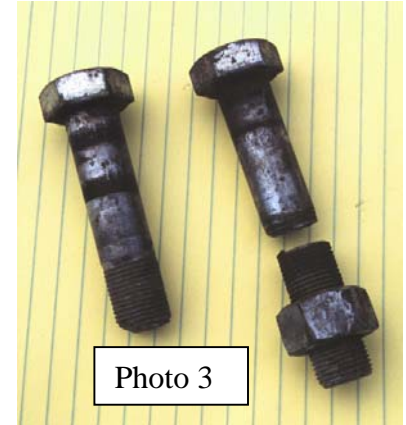
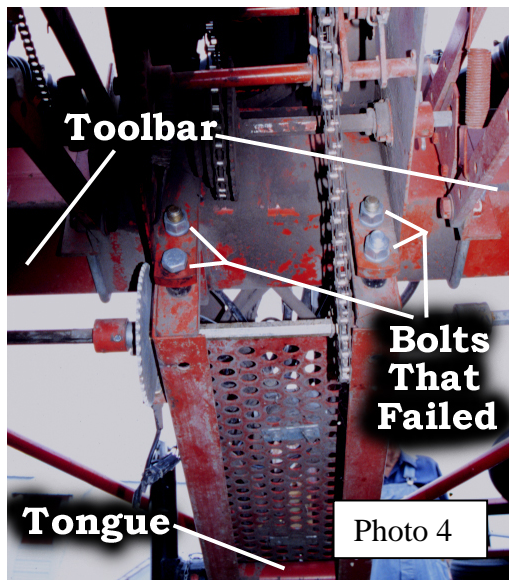
The tongue of this planter was bolted around the toolbar with six bolts, two ~ 250mm (10-inch) long bolts on top, and four 125 mm (5-inch) long bolts on the bottom, all of them being 19 mm (¾ inch) in diameter. It was the 125 mm (5-inch) bolts underneath the toolbar, which were broken. Portions of two of these bolts were retrieved from the field where the planter broke down, and we photographed these bolts during our investigation (see Photo 3). It appeared the bolts had been sheared off due to extreme forces acting on them during planting. One bolt had an obvious tear near its head, which was partially torn off.

We visited the local implement dealer who sold the used planter to the victim. Workers were aware of this fatality and stated that four similar planters had failed in the same manner that spring. They mentioned that it had been an unusually wet spring, and therefore the soil was hard and difficult to plant. They had repaired four similar planters, three with a missing or broken bolt, and another which had folded / collapsed in an identical fashion and hit the ground. We were told that the original specifications for the machine calls for 16 mm (5/8-inch) diameter bolts, but that they were recently upgraded to 19 mm (¾-inch) diameter, and that newer planters have a different design.

Mechanics at this implement dealership could see no reason why the planter needed to be bolted, rather than welded together at this stressful area under the toolbar. The section behind the toolbar rarely needed maintenance or repair and the components would be easily accessible even if the unit had been welded together.
