**FROM: Iowa FACE Program**

**Date of Report 11/15/1999**

**SUBJECT: Operator of three-wheeled agricultural sprayer was killed when machine overturned.**

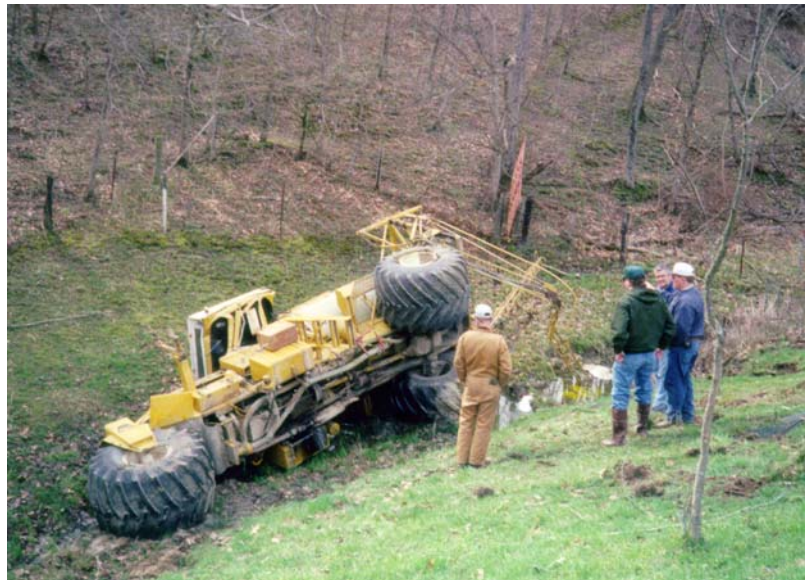
During the spring of 1999, a 26-year-old operator of a three-wheeled agricultural boom sprayer was killed when the sprayer drove through a barbed wire fence and careened down a steep ravine, rolling over at the bottom. The victim had just finished spraying a small 5-7 acre field with bean herbicide and was folding in the hydraulically-controlled spraying booms when the machine apparently moved forward too far and rolled through a barbed wire fence.

There were no apparent skid marks from braking. The ravine on the other side of the fence was quite steep and it would have been difficult to stop the machine once the front wheel broke through the fence. While running down the slope, the left rear tire of the sprayer hit a small tree, causing the machine to swing to the left, then crash on its side and top in the gully. The cab was not designed as a Roll Over Protective Structure (ROPS), nor were seat belts installed in this machine. Therefore there was little protection for the driver when the machine overturned. The operator was thrown through the front window and fatally crushed as the cab crumbled under the weight of the sprayer. The machine was 20 years old and appeared to be in good working order. There was some indication that the parking brake was not operational. We requested a test to determine whether the brakes were in working order, however the machine shop where the machine was taken after the crash was not able to have this testing done. The victim was an experienced sprayer operator. The injury occurred about 5:30 p.m. towards the end of the workday and fatigue may be a contributing factor. The death was not discovered until an hour later when the victim failed to show up at another work location. He was found dead at the scene.

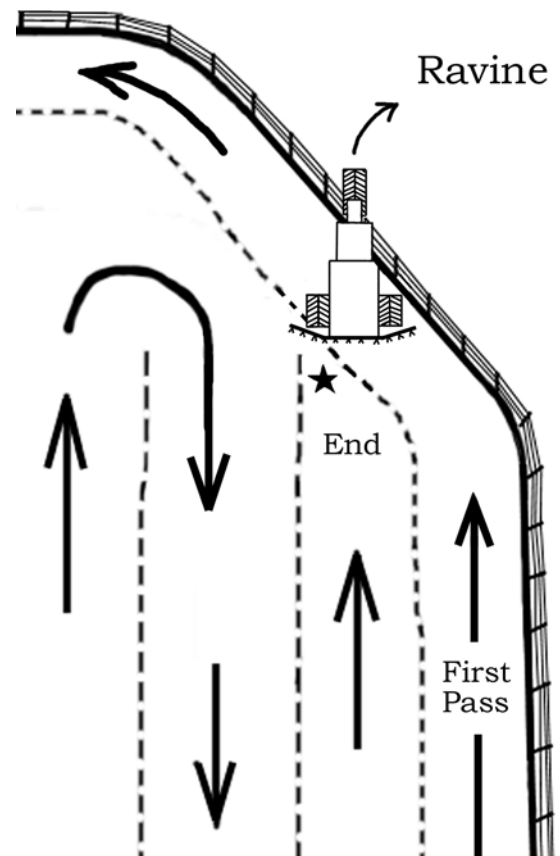
After spraying around the perimeter once and completing the back and forth spraying in east-west direction, the victim came to the southeast corner of the field, pointing towards the east. The last piece of ground to be sprayed was the pointed area marked with a star on the diagram. He had started to move the sprayer booms to transport position at this point. It is not clear whether he stopped or moved the booms while the machine was still in motion. The booms are at the back of the machine and pivot to the sides for transport. The width of the booms was 15.5 meters (51 feet) according to our measurement. It was apparent that the spray booms were partially folded in when the rollover occurred.

The end of the field was diagonal to the straight south edge of the field (see diagram). As illustrated in the diagram, to spray the entire area, the operator would have to drive forward into the perimeter strip that was sprayed, bringing the front of the machine very close to the fence. While coming to the end of the field and preparing to bring in the sprayer booms, it is possible that the operator could come too close to the edge of the field without noticing it in time.

**Discussion:** The field in this case was irregularly-shaped and the operator came to the corner of the field where the field edge turned about 45 degrees to the left. The operator had circled the field once at the perimeter and then had completed driving back and forth the rest of the field. As presented in diagram 1, to cover the area near the end of the diagonally edged field, the operator must drive very close to the edge of the field. If the operator makes two passes around the field before back and forth spraying, there would be more room at the end of the field to make turns and the stop at the end. This method may be safer in most cases when the field is irregular. Pesticide applicator certification training, as well as a company specific training should address this method.

**Recommendation #2** *Agricultural chemical applicator training should include specific instructions regarding spraying irregularly-shaped fields.*
