# THE UNIVERSITY OF IOWA

**FROM: Iowa FACE Program**

**SUBJECT: Tractor operator was killed in an overturn while moving a sandblasting trailer.**

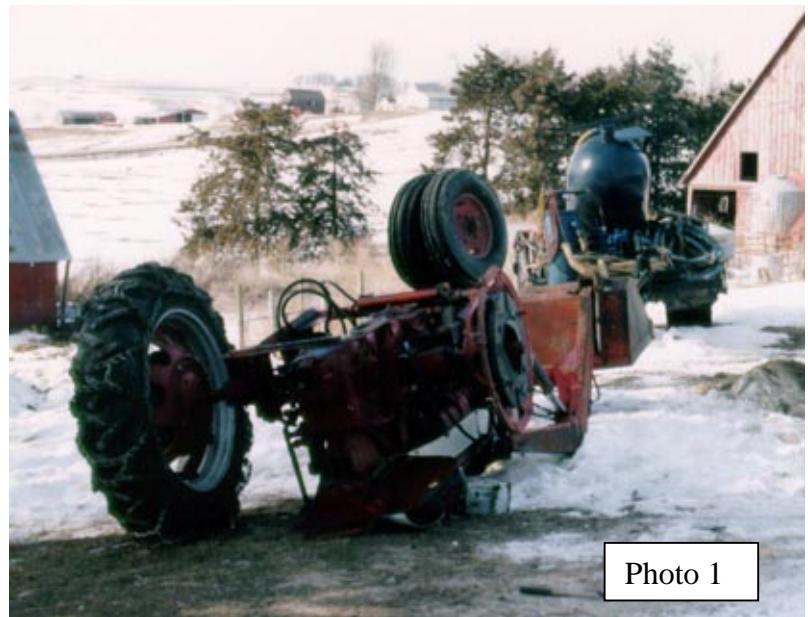
Photo 1

During the winter of 1999 a man was killed while operating a narrow-front tractor at a rural business location in Iowa. The man was the owner of a sand blasting company and was in the process of moving a sandblasting trailer on his acreage. This homemade sandblasting trailer had previously been filled with sand by an employee who then parked the trailer in an undesirable location, slightly

downhill from the main driveway. The trailer for the sandblaster had a high-mounted tongue, and the support jack for this trailer was in an extended position, therefore it was impossible to hook the trailer directly to the tractor draw bar. The man attached a chain from the trailer tongue to the front-end loader bucket. He lifted the tongue off the ground, then tried to back uphill with the tractor. The sand blasting trailer was full of sand and very heavy. It had snowed recently, and the victim was having difficulty getting sufficient traction while backing uphill in this position. Realizing he needed more pulling power, he attached a 50-foot chain from the tractor draw bar to the rear of a compressor truck used in the business. The man's wife drove the truck, following hand signals from her husband. The truck was positioned on the entrance road to the acreage, slightly at an angle from the tractor and the sandblasting trailer. As they began to pull and move ahead, the truck turned slightly to its right down the driveway. This created a situation where the chains were pulling the tractor at an angle creating sideways forces at both attachment points. These forces caused the tractor to overturn to its left side, killing the operator underneath. The tractor did not have a Roll Over Protective Structure (ROPS).

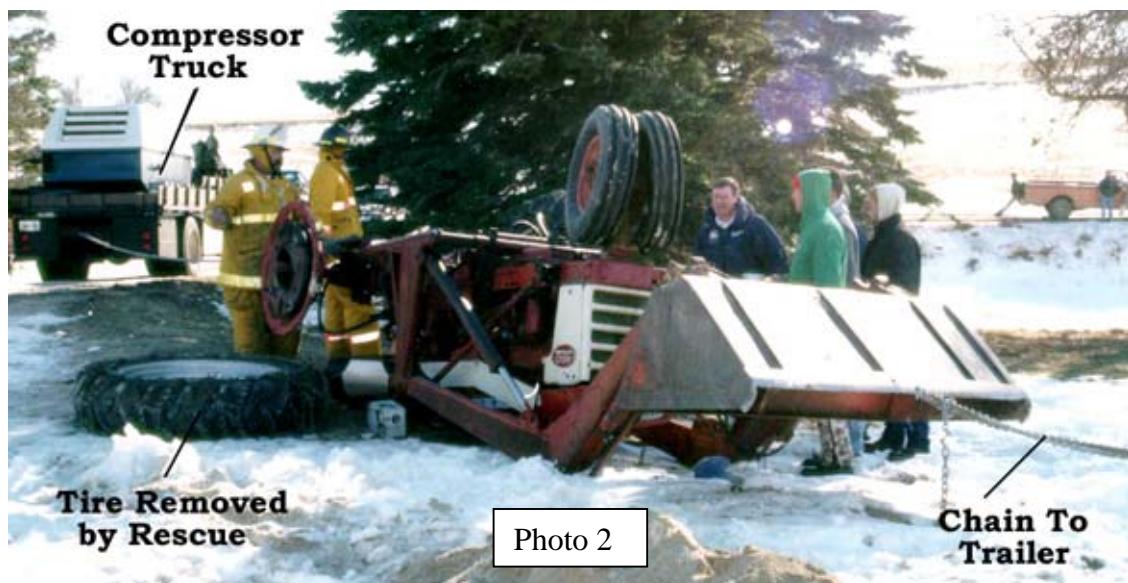
**Discussion:** Towing or pulling heavy equipment can become hazardous if the powered vehicle is pulling at an angle or if attachment points are high off the ground, thus increasing the risk of overturn. In this case the tractor front attachment point was the edge of the front-end loader (see Photo 2), which was approximately 1.2 m (4') off the ground. Supporting the heavy trailer with the loader shifted some weight from the back wheels to the front wheels, which reduced the tractor's pulling power and compromised stability due to the narrow front design. Initially the tractor and the sandblasting trailer were aligned, but after the truck started to pull and move down the driveway at an angle, significant sideways forces to the front and rear of the tractor were created. The combination of this changed angle, the tractor weight shifted to the front, the high front attachment point, narrow front wheels, and the sloping ground to the side of the tractor were accumulative factors sufficient to overturn the tractor to its left side. Even if visual communication between the two drivers was maintained, there would likely not have been sufficient time to react and prevent the sudden overturn. Pulling machinery at an angle should be avoided, and attachment points should be kept low, below or near axle level.

**Recommendation #1** *To avoid overturns, operators of heavy equipment should pay special attention to the attachment points and direction of pull while towing other equipment.*

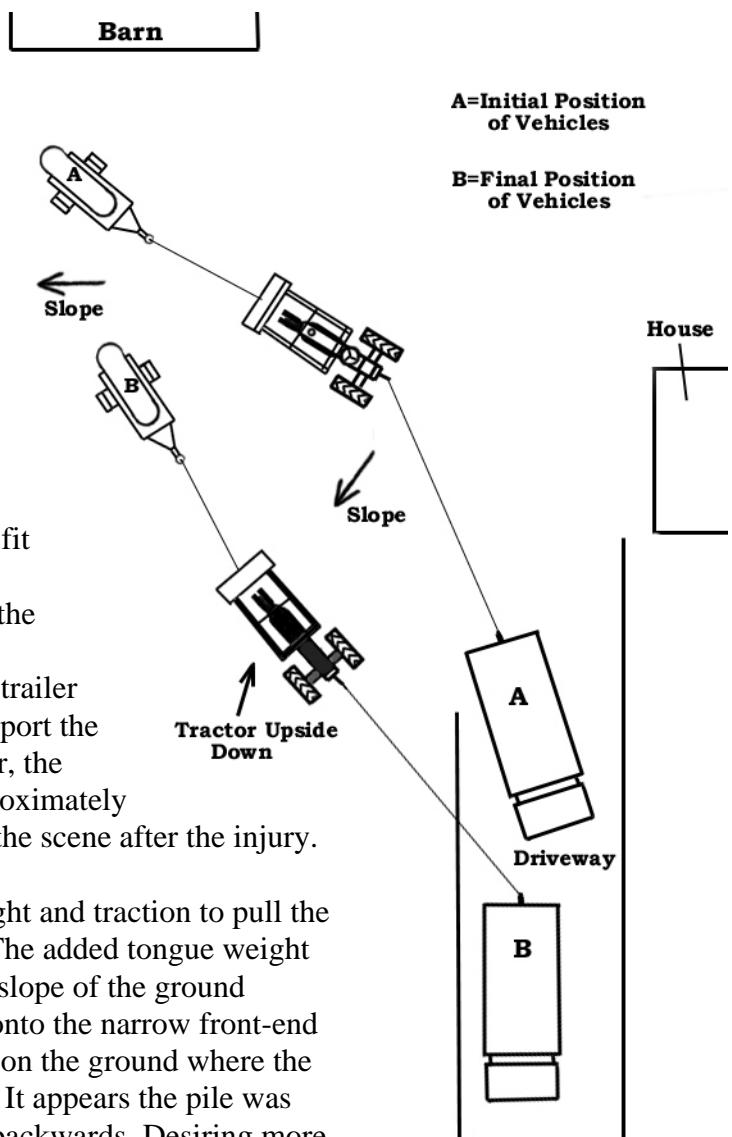
The tractor did not have sufficient weight and traction to pull the trailer up the slope on snowy ground. The added tongue weight to the front bucket, combined with the slope of the ground transferred weight off the rear wheels onto the narrow front-end of the tractor. There was a pile of sand on the ground where the tractor was sitting prior to the rollover. It appears the pile was formed from the rear wheels spinning backwards. Desiring more pull, the victim attached a 50-foot chain from the draw bar of the tractor to the rear of the compressor truck, which was positioned near the driveway heading towards the road. The tractor was an older tricycle-type model and did not have a ROPS to protect the operator.
