FROM: Iowa Fatality Assessment and Control Evaluation (FACE) Program

SUBJECT: Youth farm worker is killed when he becomes entangled in PTO driveline of an old grinder-mixer.

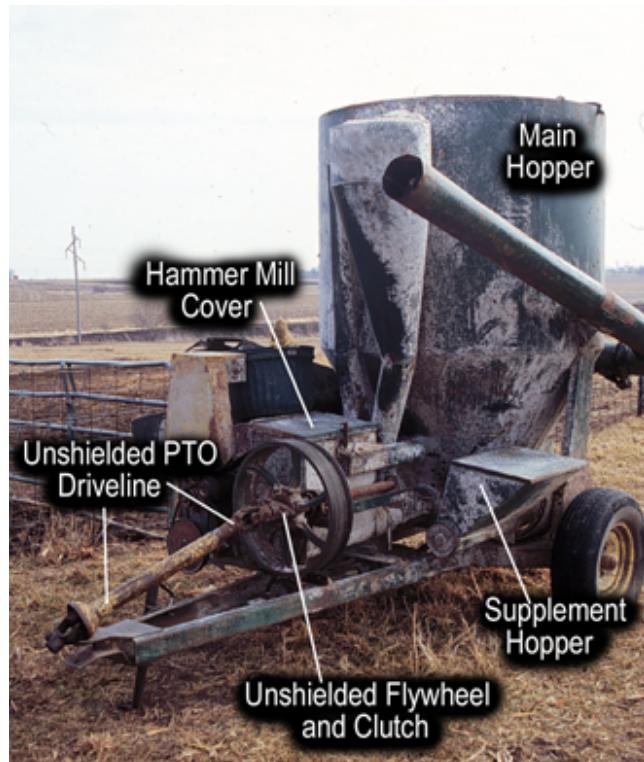
Picture 1 – PTO-Driven Grinder-Mixer

In January 1999, a 17-year-old high school student working part-time for a dairy farmer was killed when his clothing was caught by the unshielded power take-off (PTO) driveline of a grinder-mixer (see Picture 1). He had been helping the farmer add sacks of feed supplement to ground corn in the mixer. The task was almost complete and the farmer was closing the hammer mill cover while the youth stood near the PTO driveline in front of the flywheel. Although the flywheel was disengaged, the PTO driveline and unshielded flywheel clutch were rotating at about 200 revolutions per minute (RPM). The farmer heard a thump, then noticed that the boy had been caught and entangled around the driveline at the flywheel clutch. He died instantly from severe head injuries.

Recommendation #1: Employers should ensure that PTO drivelines and other drive-train components are completely shielded to prevent worker contact with rotating machine parts.

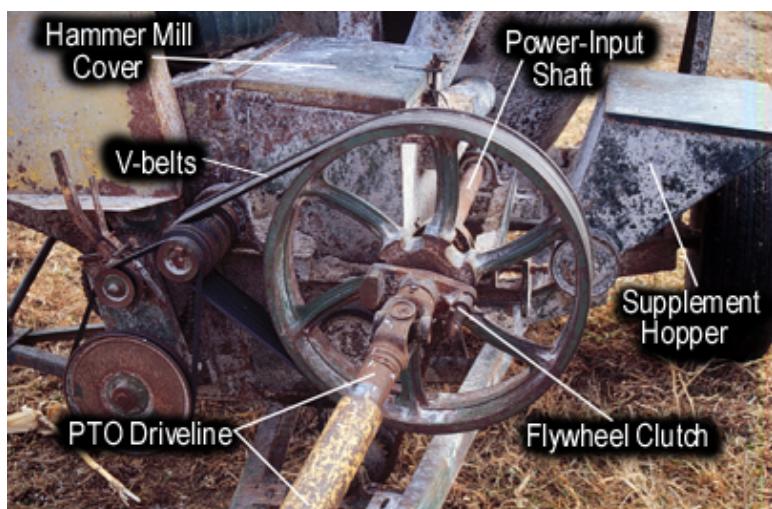
Picture 2 – Hammer Mill Drive Train

At the time of the injury, the farmer and the youth were mixing feed using the PTO-driven grinder-mixer to combine soybean-based protein supplement with ground corn. The grinder-mixer, a 1970's model, had been bought used in 1988. It was operated by a PTO driveline, which was permanently bolted to the grinder-mixer's power-input shaft (see Pictures 2 and 3).

To use the grinding system, one would engage the flywheel using the spring-loaded drive-pin of the flywheel clutch mounted on the power-input shaft (see Picture 2 and 3). The flywheel would then drive the hammer mill through a set of 12 V-belts. When disengaged, the flywheel floated (remained stationary) on the power-input shaft, while the clutch mechanism, including the spring-loaded drive-pin, rotated with the shaft. With the PTO engaged, the mixing system

operated at all times. A feed supplement hopper (see Picture 2) was normally used for adding smaller quantities of feed supplements to the mix, however, the discharge auger for this hopper

had not worked properly since the farmer had purchased the machine, despite efforts to repair it.

Recommendation #3: Employers should ensure that damaged machine components and systems are maintained in proper working order.

Discussion: The discharge auger for the feed supplement hopper of the grinder-mixer had not been operable for 10 years. While the alternate method of loading feed supplement into the hammer mill hopper provided a means to mix the feed, loading at this location placed workers closer to the rotating machine parts than loading at the supplement hopper. Also, the PTO driveline was not the only unshielded rotating component on the machine. Although the hammer mill was not being used at the time of the incident, and the flywheel remained stationary, the power-input shaft mounted on the left side of the hammer mill housing was rotating. This unshielded shaft was just below waist-level and within a few inches of a worker loading material into the hammer mill. Loading the material from this location, near the flywheel, may also have decreased the victim's awareness of the need to remain clear of the rotating driveline. Using the supplement hopper as designed would not have eliminated the hazard from unshielded rotating machine parts, however it may have decreased worker exposure by increasing the distance of the work area from the hazard.

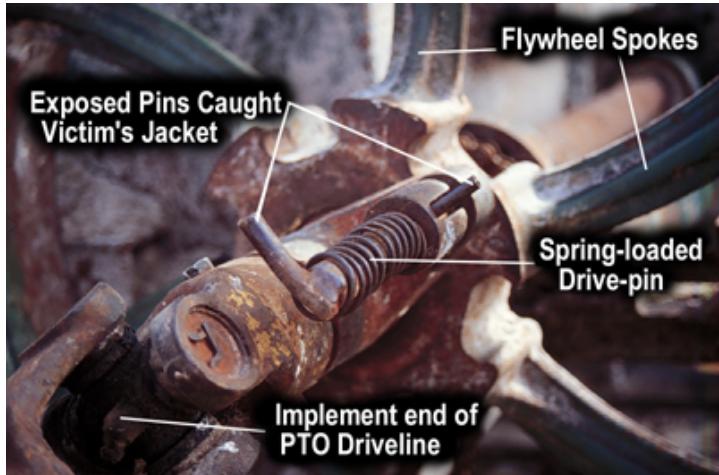
Picture 3 – Flywheel Clutch

housing was used to move the supplement to the main hopper where it was mixed with grain. The implement-end half of the driveline shield, as well as the shield covering the flywheel, had been damaged and removed by the farmer 10 years prior to the incident.

Since the grinding system was not being used, the flywheel was disengaged, however the unguarded clutch mechanism with exposed drive-pin was rotating. After the farmer and the youth had loaded about 25 sacks of supplement into the hammer mill housing, the farmer put the sizing screen back into a slot inside the hammer mill, then closed the hammer mill cover. The youth was standing on the farmer's left side (see Picture 4), facing the flywheel with his left side close to the spinning driveline. According to the farmer, while he was closing the cover, he suddenly heard a thump, the tractor engine stalled, and he realized that the boy had been caught and wrapped

around the driveline. Evidence indicated that the unguarded drive-pin caught the youth's jacket just below the left pocket and he was instantly entangled.

As previously stated, evidence indicates that the youth was standing near the rotating flywheel clutch facing the farmer when his clothing was caught by the exposed clutch mechanism, most likely the spring-loaded drive-pin. He was killed instantly when he became entangled in the PTO.

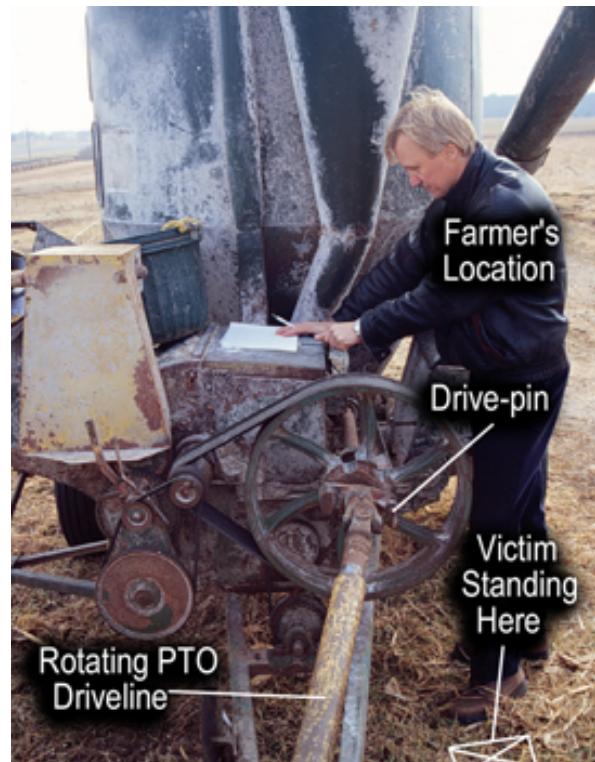
Picture 4 – Position of Farmer and Victim

The grinder-mixer was parked inside a corncrib building with its driveline connected to the PTO of a 66 kW (90 hp.) tractor. The tractor was idling, and at idle speed the PTO driveline rotates at about 200 RPM. The farmer and the boy worked in the seven-foot wide space between the machine and the corncrib wall, lifting sacks of soybean-based protein supplement from the floor and carrying and emptying them into the hammer mill housing.

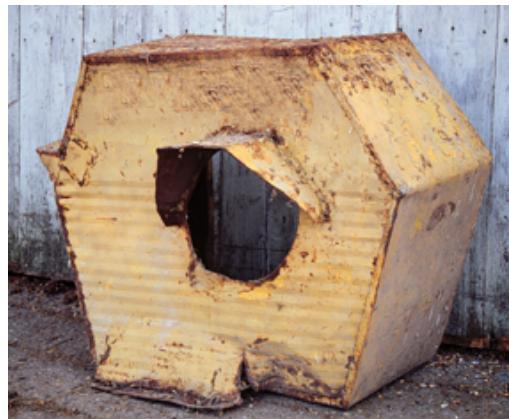
Picture 5 – Flywheel Shield, Front

Discussion: The implement end of the PTO driveline, the flywheel clutch, and the flywheel on the machine in this incident were unshielded. The shield covering the implement end of the PTO driveline had been damaged and removed 10 years prior to the incident. The flywheel and the drive-train components at the front of the machine had originally been guarded with a sheet steel shield (see Picture 5). This shield had also been damaged and removed about 10 years prior to the incident.

A total shielding system for a PTO driveline includes a tractor master shield, the PTO driveline shield(s) and an implement shield¹. Additional shields may be necessary to protect workers from exposure to other moving machine components such as flywheels, clutches, drive belts, and pulleys. For example, the power-input shaft was mounted on the left side of the hammer mill housing. Workers using the hammer mill for loading would be within only a few inches of this rotating shaft. Standards for drive train shields are contained in standards ASAE S318.13 and ASAE S522.
