THE UNIVERSITY OF IOWA
Iowa City, Iowa 52242

FROM: Iowa FACE Program

SUBJECT: Farmer Slips Off Tractor Step Into Path of a Grain Semi Truck

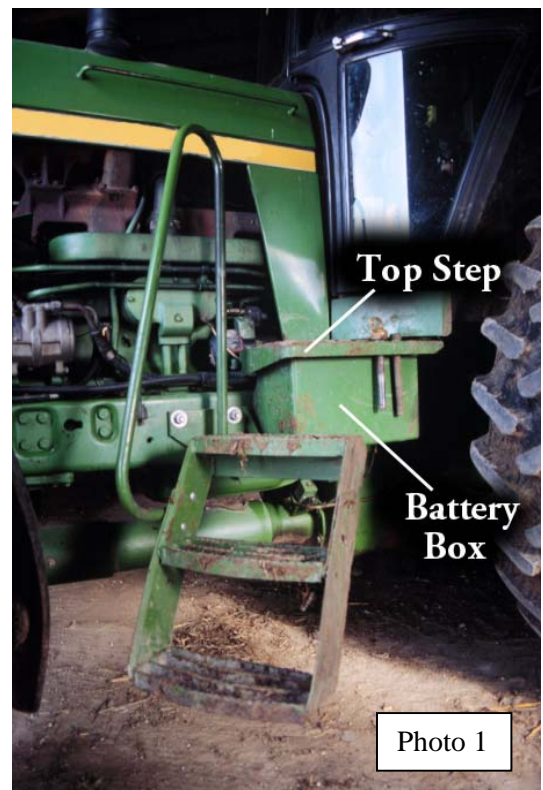
The farmer was driving a newer tractor that belonged to a neighbor. It had a cab and had been modified with an after-market set of steps on its left side, designed to make the tractor safer to enter and exit. The set consisted of three serrated steel non-skid steps and a left handrail (Photo 1). These steps were designed for this model line of tractors to improve the access to the tractor. They were 15 inches wide, 5-6 inches deep, with 9 inches between steps.

#1 *Tractor manufacturers should give more attention to the safe design of steps and handrails to further increase operator safety.*

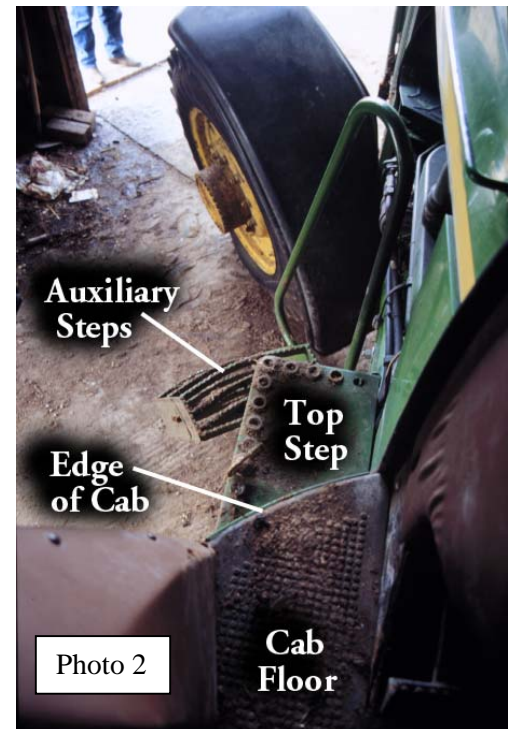
Photo 2 was shot from the cab looking down, and shows how the steps are aligned to be parallel to the entrance of the cab. The top step is the rectangular cover for the battery case. It has several holes punched in its edge to improve traction. On the day of our visit, two hitch pins had been placed in these holes as a convenient storage location, but it is not known whether they were present on the day of the fatal fall.

The glob of mud from the victim's workboot was found on the outside edge of this step, and it is apparent that this is where the man slipped and fell. While climbing the steps it is possible that he slightly missed the step or slipped and lost footing, and did not have a good grip of the handrails at the time when preparing to step into the cab.

It is commendable that after-market steps and handrails have been developed. It would be important to further develop the ergonomic design of these steps and handrails. In this case, it might be possible that the top of the battery case be changed so that its edge will align with the steps or the entrance of the cab.
