THE UNIVERSITY OF IOWA
Iowa City, Iowa 52242

SUBJECT: Two mechanics crushed to death when tow truck falls from jack stand.

SUMMARY

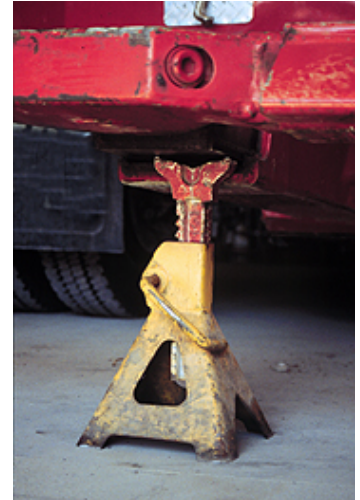
The two mechanics were repairing the differential gears on the truck rear axle. The truck was in their shop and was raised using the hydraulic wheel lift. This wheel lift or “stinger” is used for securing the wheels of the towed vehicle and supporting it during towing. There are two types of stingers: 4-way stinger which moves hydraulically up-down, and in-out, as well as 6-way stinger which also includes tilt-up and tilt-down as shown in Picture 1. The truck involved in the injury had a newer tilting 6-way stinger.

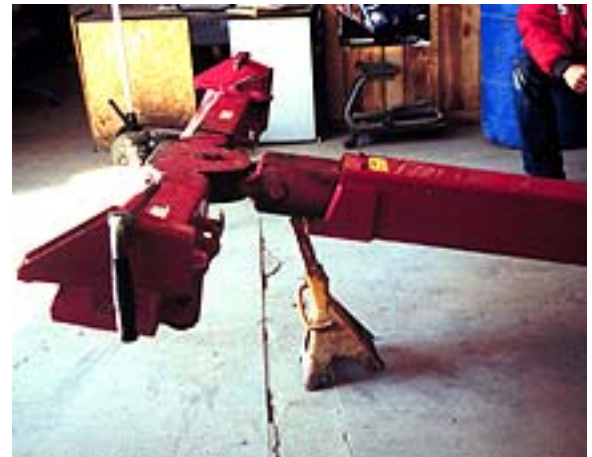
While working on the rear axles the tow truck suddenly rolled forward slightly, slipped off the floor jack stand and fell, immediately crushing the two men working underneath. From police photos one can see the stinger in a tilted position, rear end raised, with the jack stand knocked over to the rear. The rear feet of the jack stand became bent as it tipped over, but the jack stand did not fail or collapse as was first suspected by police. It appears the arm of the tilted stinger simply slipped off the jack stand. There were no additional supports or blocking under the vehicle, therefore the rear end of the tow truck fell flat to the ground crushing the men underneath.

considerably tilted, as shown in Picture 2, which was taken during the demonstration.

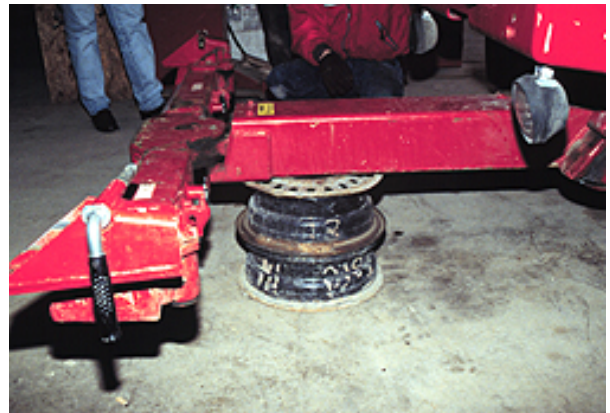
Discussion: The rear end of the tow truck in this case was supported only by a single floor jack stand, placed in the middle under the hydraulic wheel lift arm. The base of a jack stand is relatively narrow, and is not designed to accommodate any sideways movement of the vehicle without tipping. Apparently the workers were unaware of the hazard they created by removing both rear wheels and not using other supports. The parking brakes were ineffective because the wheels were removed, nor had the front wheels been chocked. Demonstrations using a similar jack stand and similar stinger position showed that very little force or forward movement is required for the stinger to slip off the jack stand. Substantial supports, designed and rated for the type of vehicle, should be used when working under raised vehicles.

The tow truck owner demonstrated an inexpensive alternative support where two heavy tire rims were stacked and welded together. This support appeared very solid and much less prone to tipping compared to a jack stand. Even with considerable movement of the stinger bar, the vehicle remained safely supported on the welded rims. Yet, even if the vehicle is supported in this fashion, it is still essential that the front wheels are chocked and additional supports used before working under the vehicle.

Recommendation #1: *Vehicles must be properly supported when working under them.*
