FROM: Iowa FACE Program

SUBJECT: Farmwife was killed as a gravity flow wagon filled with beans tipped over on her.

SUMMARY

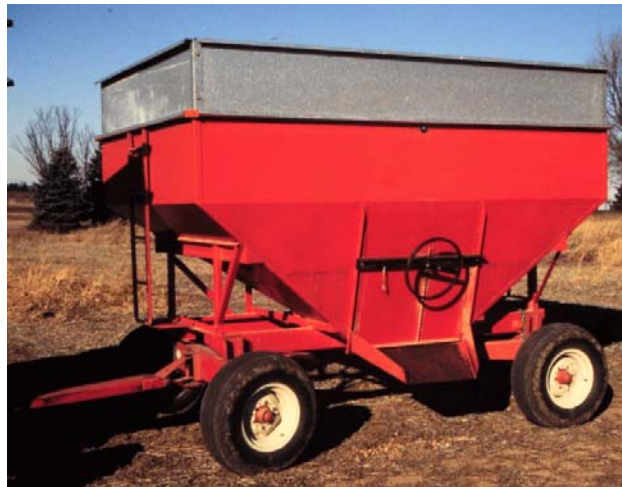
The wagon was four years old and had a capacity of 8.81 m³ (250 bushels); a full load of soybeans weighs 6,800 kg (15,000 lb)². The wagon had factory-made side wall extensions which increased its capacity to the dimensions above. The farmer had two identical wagons of this type and several older wagons. The grain was on the left side, direction of travel (See Picture 1).

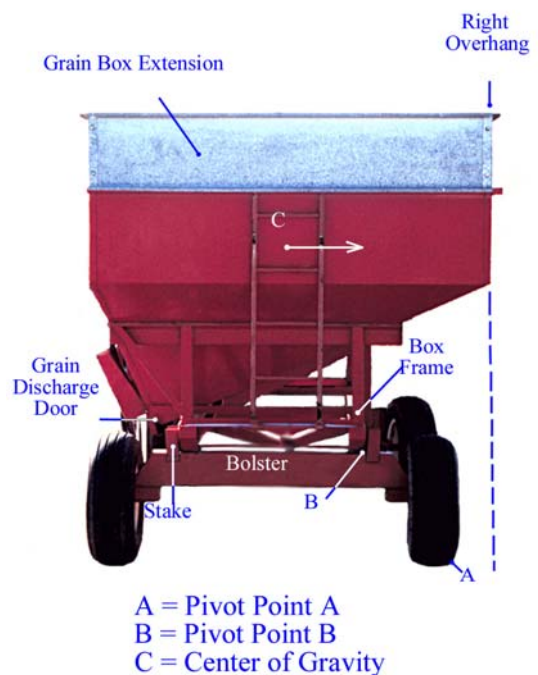
The bottom of the box is asymmetric, slanted towards the side door. The top of the box is offset to the right side and overextends the right wheels (See Picture 2). According to the manufacturer, the wagon is designed so that the center of gravity is at the center line of the running gear with full load when side wall extensions are used. In this case the box was filled to the top with soybeans.

Before they began unloading the wagon, it was leaning a few degrees to the right. While they were removing grain from the left side door, the center of gravity gradually shifted to the right. Since the box was not attached at all corners, the support base was narrow. The front point of support (pivot point) was the wheel's ground contact point but the rear pivot point was the bolster - box frame contact point (pivot point B). These two points formed the tipping axis.

The box frame stakes are 1,067 mm (42") apart, and the back pivot point therefore is only 533 mm (21") from the centerline of the running gear. This is narrow considering the height 2,616 mm (8'7") and width 2,235 mm (7'4") of the wagon. While unloading, the center of gravity shifted beyond the tipping axis and gravity pulled the grain box over. If the box had been attached at all four corners, the pivot point at the back would have been the wheel's ground contact point (pivot point A). This would have given the wagon

a wider support base. The wagon may still have tipped, but probably much later, and there may have been some visible or audible warning. These pivot points are illustrated in Picture 2.

Discussion: In this case the grain box was attached to the running gear with two chains at two opposite corners. The result of this attachment was that the pivot point at the back was the box frame corner – running gear bolster contact point, which is only 533 mm (21”) from the running gear center line. This makes the support base of the wagon very narrow. The grain box tipped around this pivot point as the rear wheels stayed flat on the ground. Attaching the box from all corners would likely have prevented this fatal injury. Further engineering research may be needed to determine whether four corner attachment is feasible instead of currently typical two corner attachment. Based on this case, four corner attachment appears beneficial to prevent similar overturns and injuries. One technical solution can be as simple as attaching each corner with a chain.
