**FACE 98IA048**

**Subject: Farmer falls to his death from a combine during maintenance**

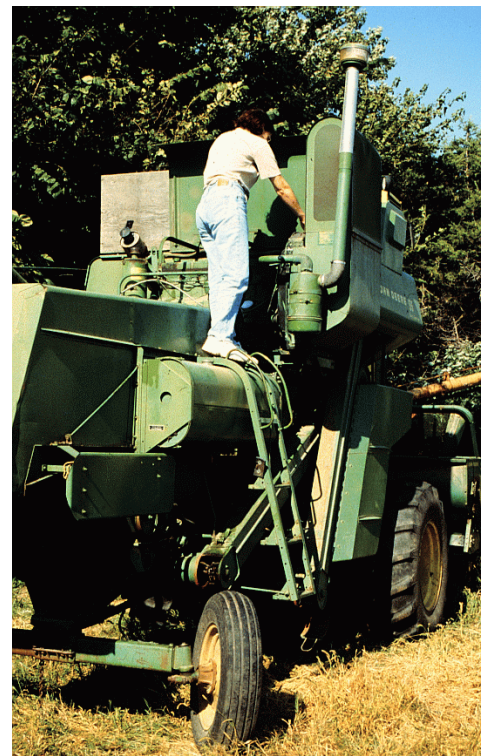
The combine was a three-row, self-propelled combine, 1969 model, designed for corn harvesting. It had evidence of wear and tear typical for a combine of this age, however, it appeared to be in fair working order. The engine, radiator, and batteries on this machine were on top, behind the grain tank, which is typical for most combines. A service ladder was located on the right side of the combine and lead to the back of the engine area. To access the radiator cap, the operator must climb on top of the combine and stand either on the last steps which curve towards the center of

the machine or on top of the combine chassis which forms a service platform. The ladder helps getting up on top, however, was not up to the best current standards, such as ASAE S318.13, Section 8. The height of the first step was approximately 710 mm. (28 in.), the usable width of the steps was 280 mm. (11 in.), and the height of the top of the ladder and the service platform was approximately 2,130 mm. (86 in.). The steps were made of smooth metal which was not slip-resistant. There were no guardrails on top of the combine around the service area. To pour antifreeze into the radiator, the worker must stand near the edge of the combine without adequate fall protection. It appears difficult to find solid footing to have adequate support to maintain good balance while pouring antifreeze, considering that both hands may be needed to hold the antifreeze container.

**Discussion:** The service ladder in this machine had a fairly high first step, approximately 710 mm (28 in.). According to ASAE standard S318.13, 8.5.1. “The height of the first step should not exceed 686 mm (27 in.), preferably 550 mm (21.6 in.)”. The handholds at the top of the machine were not adequate to maintain good balance while moving from the ladder to the service platform, especially when carrying tools or fluid containers. Handholds should extend above the top of the ladder. The steps were made of smooth iron. A more slip resistant surface would be preferred.

**Discussion:** The service platform area on top of the combine did not provide adequate fall protection. According to ASAE S318.13, 8.4 “*Handholds, handrails, guard rails, or barrier type safeguards shall be provided, if necessary, to minimize falling during normal operation or servicing, unless similar protection is provided by other parts of the equipment*”. Furthermore, S318.13, 8.4.1 states: “*Guardrails when provided shall have a top rail 1000 to 1100 mm (39.4 to 43.3 in.) above the working walkway or platform with a rail approximately midway between the platform and the top rail*”. The engine compartment provided adequate fall protection to the front, however there was a considerable risk of falling to the sides of the combine during daily maintenance such as checking the oil and coolant levels. The height of the service platform was approximately 2,180 mm (7’2”), and the possibility of falling from this elevation makes fall protection necessary. While the evidence is not clear whether the service ladder or the service platform characteristics contributed to the fall, following these principles is necessary to avoid falls from large machinery overall.

**Recommendation 1.** *Machinery manufacturers should provide safe service ladders with handholds for access to elevated service areas.*

**Recommendation 2.** *Machinery manufacturers should provide adequate fall protection at elevated service platforms.*
