Nebraska FACE Investigation NE 2004-40

Hispanic Laborer Run Over and Killed by Backing Dump Truck in Roadway Construction Zone

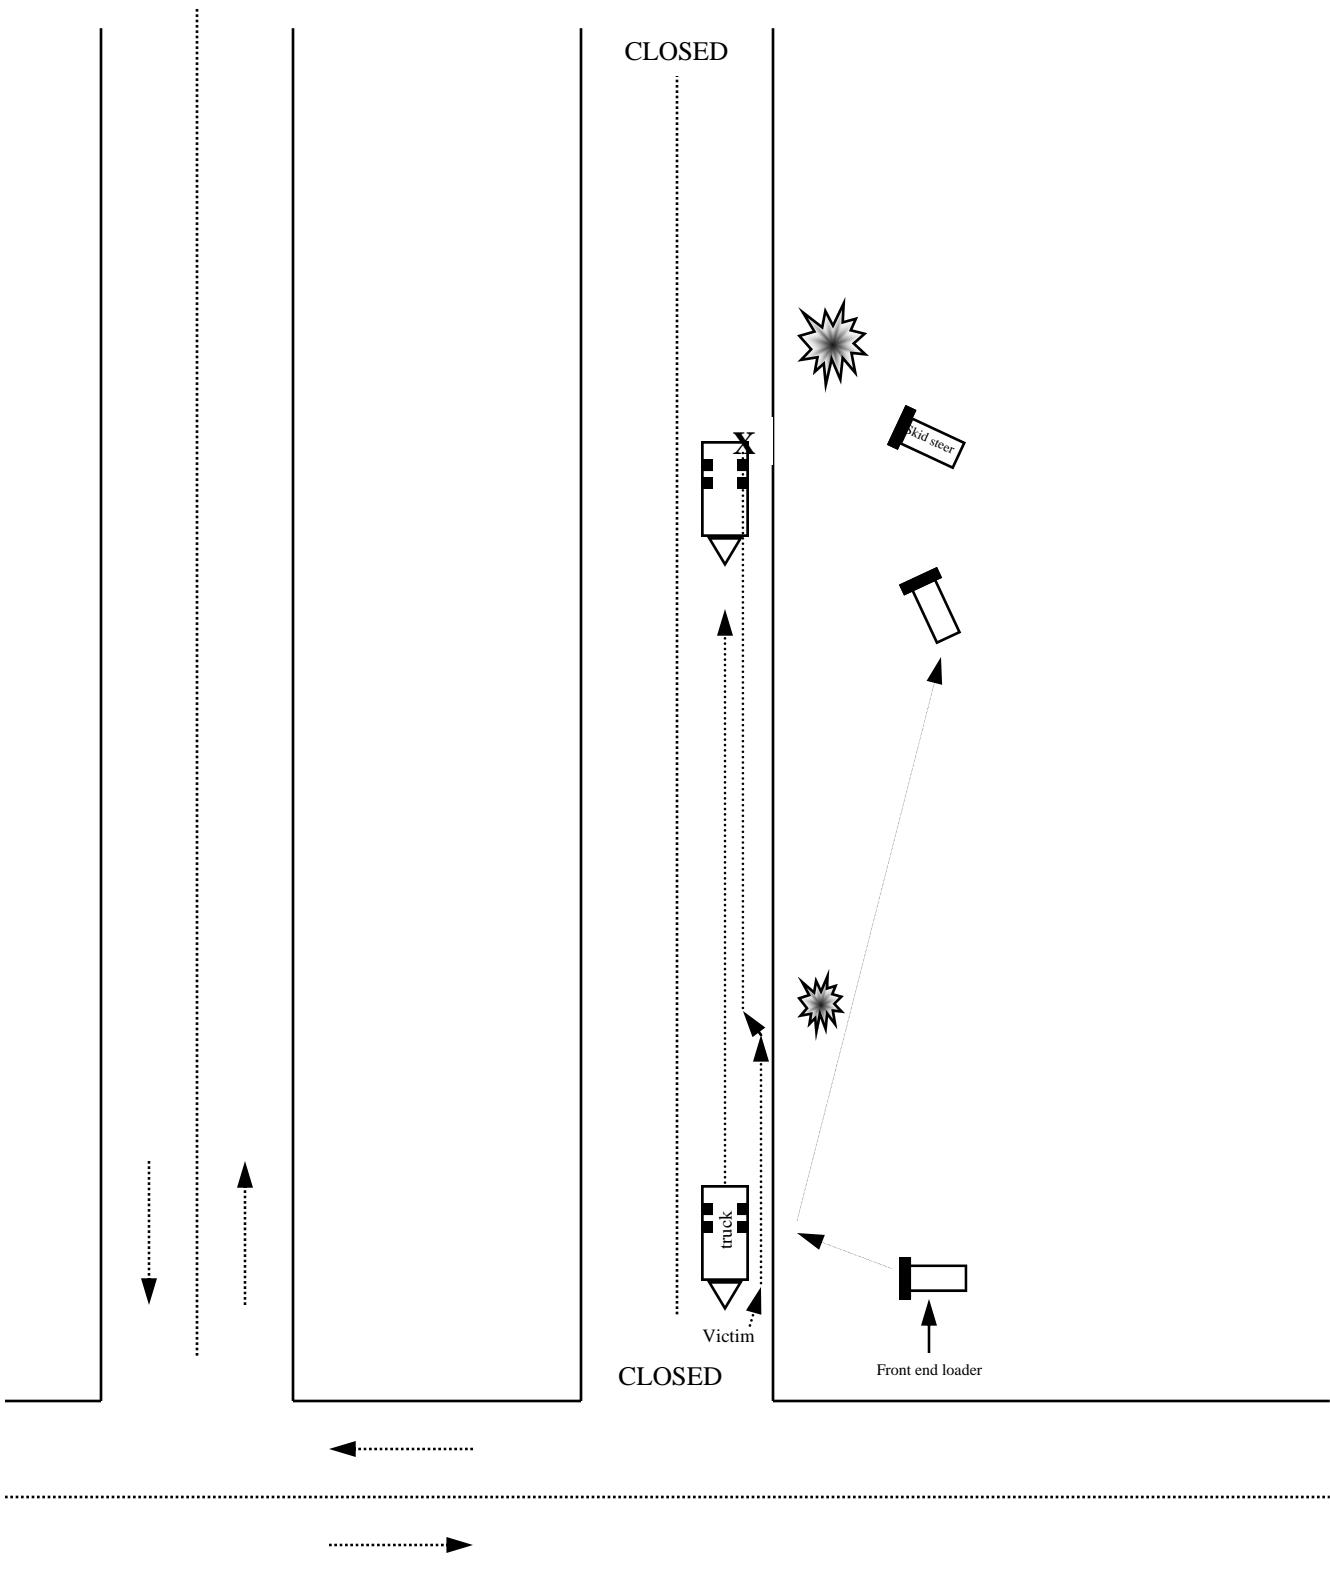
Attachment #1—Site Diagram (Not to scale)

At approximately 4:45 p.m. the victim and all of the workers all met in front of the dump truck to get their instructions from Worker #1, the job foreman. The dump truck was idling in PARK, facing south. They were told that there were two piles of debris north of their location, behind the dump truck. They were told to leave the first pile and start up with the second, larger pile by shoveling and manually placing the concrete materials in a skid steer bucket, which would load it into the dump truck. After that they were quitting for the day.

Worker #5 got into the passenger side of the dump truck to warm up, while the victim made a comment to the truck operator that he was cold also, and started to walk north along the driver's side of the truck. Worker #4 went to a nearby front end loader that was already full of concrete debris, and drove it towards the dump truck. As he approached, the victim stopped to allow Worker #4 to dump his load, then continued to walk north as the front end loader backed away and went north towards the next pile. Worker #5 (in truck cab) stated he saw the truck operator look in both mirrors, then start to back up at idle speed, looking out the driver's side mirror. The victim continued to walk alongside the backing truck for several feet. According to Worker #4, he saw the victim walking alongside the backing truck with his hands in his pockets for approximately 35 feet, then move directly behind the truck, still facing away from it. He said that the truck continued to back slowly for approximately 65 more feet until it struck the victim. The victim attempted to turn towards the truck but it knocked him down under the rear axle. The truck had backed approximately 100 feet when the operator felt a "thump" and immediately stopped the vehicle. Worker #1 was in his vehicle approximately 100 feet from the dump truck. He saw the dump truck stop approximately 25 feet short of the pile, then noticed something underneath the rear axle. He immediately called Worker #2 who was 500 foot north of the dump truck in his vehicle to get there immediately. Worker #1 called 911 and local medical and law enforcement personnel responded. The victim was declared dead at the scene.
