## FACE INVESTIGATION

### **SUBJECT: Beef Farmer Pinned Under Overturned All-Terrain Vehicle**

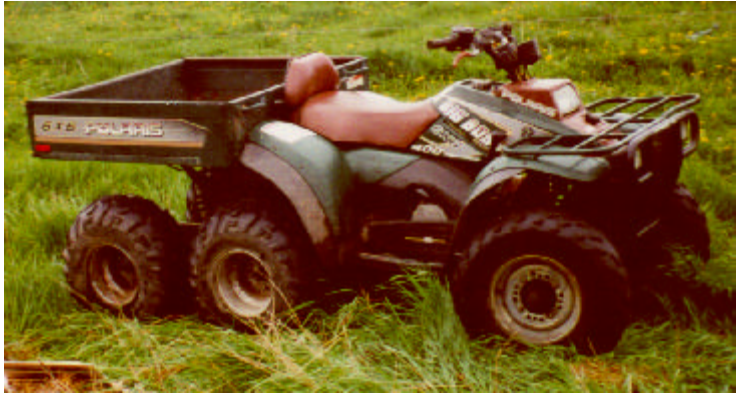
**Figure 1**

**SUMMARY:** A 50-year-old male farmer (the victim) died when he was trapped under a six-wheel all-terrain vehicle (ATV) that overturned on a hillside where he was repairing fences. The vehicle was equipped with a raised cargo box where he carried his tools and supplies (Figure 1). The vehicle apparently struck a small hay bale that was partially hidden in the grass on the uphill side, and rolled over sideways down the hill. The victim either jumped or was tossed from the vehicle as it overturned, and was pinned underneath. ATV's, including this model, are not equipped with ROPS or a seatbelt. When the victim did not return to the farmhouse for dinner as expected, his family searched the farm area but did not locate him. He frequently helped neighbor farmers with their work, so the family assumed he might be involved in a task off the farm and stopped searching for him. When he didn't return the next morning, they resumed their search and found him beneath the vehicle. Emergency services were summoned, and were onsite within six minutes. The coroner pronounced the victim dead at the scene. DNR conservation wardens were also summoned to determine if state all-terrain-vehicle (ATV) requirements applied to the incident. The FACE investigator concluded that, to prevent similar occurrences, farmers and other employers who use off-road utility vehicles should:

Discussion: In this incident, the victim was operating a six-wheel ATV equipped with a cargo box. The box was mounted high on the back of the vehicle, at the same level as the operator's seat, so the center of gravity was raised to a point that created a tipping hazard for the vehicle especially when the box was loaded with heavy items. If the vehicle had been fitted with ROPS and a seatbelt, the victim might not have suffered serious injury during a rollover. Employers with a need for off-road transportation and carrying small items should contact manufacturers and dealers to determine model specifications, and choose models that are fitted with ROPS and a seatbelt, and are designed to maintain a low center of gravity when operated with a heavy or bulky load.

### **Recommendation #1: Farmers and other employers who use utility vehicles should select a non-ATV utility vehicle equipped with ROPS and designed to maintain a low center of gravity.**

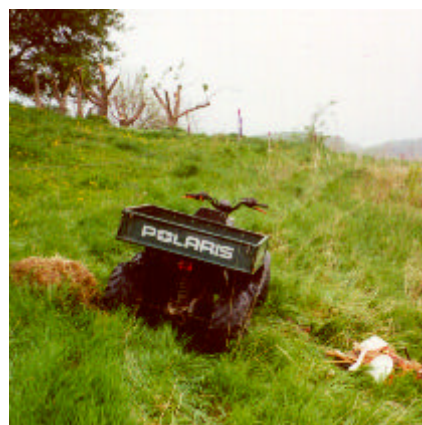
**Figure 2**

On the day of the incident, the victim completed his farm chores as usual from morning through mid-afternoon. He rested in the farmhouse, then told his wife he was going to check the fence that divided a grazing pasture. The fence was constructed of metal poles, with a single line of barbed wire intertwined with an electric strand. It was located midway down a hillside that led up to the county road. At this time of year, the grass in the pasture was about 15 inches tall, and partially hid a small haybale that may have been in the field from a previous year (Figure 2). The victim loaded some tools and fence repair supplies into the cargo box of the ATV, and drove along the fenceline on the hillside. At a place on the hill where there is about a 30E grade, the vehicle's left front tire apparently struck the small haybale on the uphill side and rolled over sideways down the hill.

Discussion: Off-road vehicle operators have access to terrain that may be laden with unseen hazards. Before driving through uneven, grassy or snow-covered terrain, the operator should view the pathway carefully to ensure that no hidden hazards are present. These could include solid objects, deep holes or fissures, water-filled depressions, biological hazards (e.g. stinging insects), etc. Even if an operator has traveled through the area before, the hazard may not have been present, or the operator's pathway may change to place him/her in line with an unsafe situation. In this case, the victim had driven the ATV through the pasture before the day of the incident, but may have avoided striking the haybale on those trips.

### **Recommendation #2: Farmers should conduct a thorough evaluation of the terrain to identify hazards in the pathway prior to beginning an operation with an off-road vehicle.**
