## FACE INVESTIGATION

### **SUBJECT: Florist Pinned Between Bucket of an Industrial Truck and Semi Trailer**

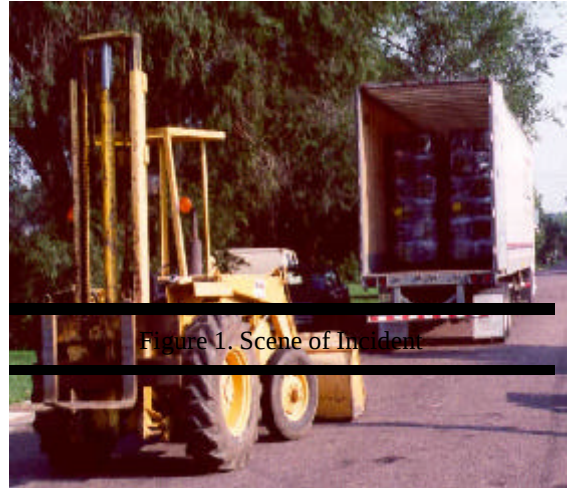
Figure 1. Scene of Incident

The co-worker had attached the chain to a pallet inside the truck, so the victim was ready to attach the chain to the bucket. He was standing in front of the trailer, but the chain didn't reach the bucket so he motioned to the operator to move forward a few inches. The loader lurched forward, pinning the victim between the bucket and the trailer. After several unsuccessful attempts, the operator backed the loader and the victim fell to the ground. The co-worker went to aid the victim while the operator called for emergency services. A police patrol car was in the neighborhood and responded within five minutes, and EMS services arrived soon after. The victim was transported to the hospital, where he died. An inspection of the loader after the incident revealed that after placing the machine in forward gear, it would take some time before the transmission fluid built enough pressure to move the machine. Then the machine would suddenly lurch forward and full force brake pressure would not stop the machine until it had traveled several feet. Mechanical brake adjustment on this loader can be achieved by tightening a bolt under the loader body.

Discussion: The provisions of a contract for forklift services should include provisions for safe equipment and operator training. An effective inspection and maintenance program should detect and correct defects in industrial trucks. If the loader in this incident had been inspected on a regular basis and before each use, the malfunctions of the transmission and brakes might have been discovered and repaired. Also, the operator had not had formal training for industrial truck operation and was inexperienced in
