FACE INVESTIGATION # 99WI07501

SUBJECT: Lineman at Hydroelectric Utility was Asphyxiated when the Safety Rope Attached to his Harness Became Entangled in a Revolving Turbine Shaft.

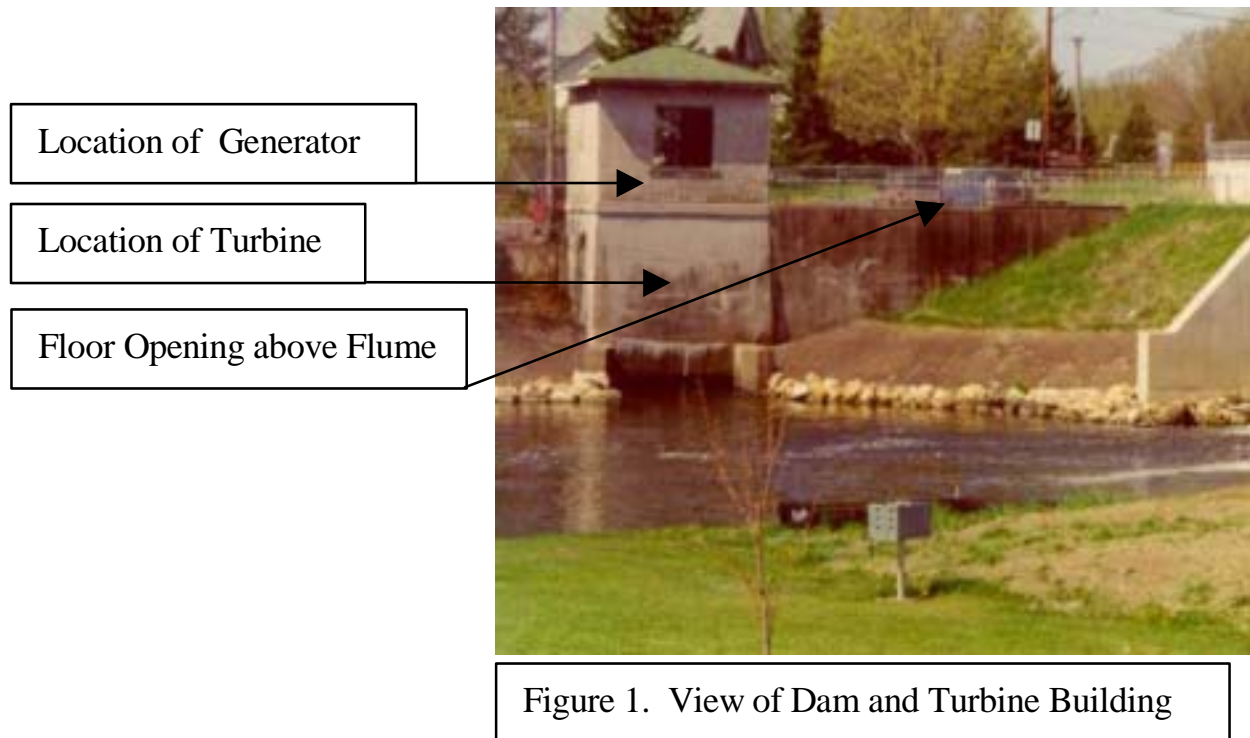
A 34-year-old male lineman (the victim) died of asphyxiation when the safety rope attached to his harness became entangled in a revolving turbine shaft. The victim was employed as a lineman for the city's hydroelectric utility, and was inspecting a 75-year-old turbine that was idle following replacement of a dam. He was working with a co-worker in the enclosed flume that channeled river water through the turbine. The victim donned a fall protection harness and entered the flume via a ladder lowered from a floor opening in the platform above the flume. His safety rope was held by a co-worker standing on the platform. Another co-worker held the safety rope of the co-worker who was working in the flume with the victim. Although the major portion of the water flow had been blocked off, a small steady stream of water leaked through the control gates and flowed through the area. The knee-high, flowing water struck the turbine vanes which caused the 4 1/4-inch diameter shaft to rotate about 20 rpm. The turbine was tagged out at the utility station, but there was no lockout device to stop the revolution caused by the leaking water stream. After inspecting the area around the turbine, the victim noted that many of the turbine vanes were "frozen" in place, rather than swinging on the bolts which held them in place. He and the co-worker in the flume began striking the vanes with a maul, to break the crust that prevented them from moving. After several strikes, the victim apparently slipped in the water and fell toward the spinning shaft. His safety rope

got caught on a shaft coupling, and his harness was pulled tight to the shaft. The victim's body stopped the rotation of the turbine shaft. The co-worker cut the rope after he realized what happened, and called for help up to the two co-workers. The co-workers secured the generator wheel so the victim could be cut loose without the wheel restarting. Emergency services responded, and cut the victim free of the shaft. He was transported to the hospital, where he was pronounced dead. The FACE investigator concluded that, to prevent similar occurrences, employers should:

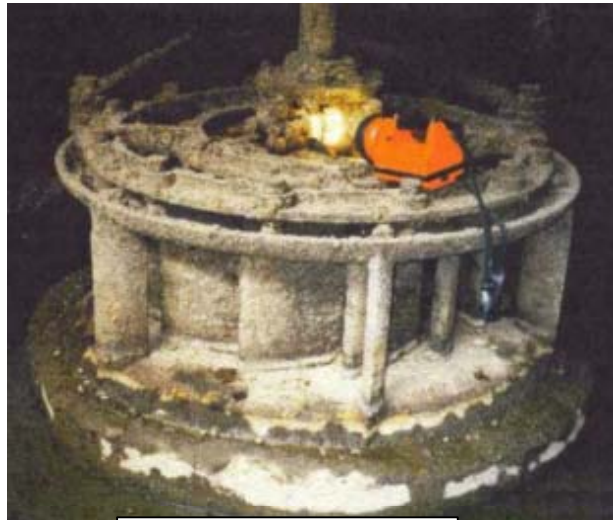
Figure 2. View of turbine.

Discussion: The generator and turbine had been installed about 75 years before the incident, and was not equipped with a braking mechanism that could completely stop the rotation of the turbine vanes during repair activities. Therefore, the turbine shaft continued to rotate while the victim was attempting to free the vanes.

Recommendation #1: Employers should install a locking brake which stops the rotation of hydroelectric turbines when maintenance and repair is necessary.

Note: The utility company has installed a brake on the generator that could stop the rotation of the turbine. The brake was in place at the time of the on-site investigation.
