## **FACE INVESTIGATION**

### **SUBJECT: Heavy Equipment Operator Pinned After Bulldozer Slides off Flatbed Trailer**

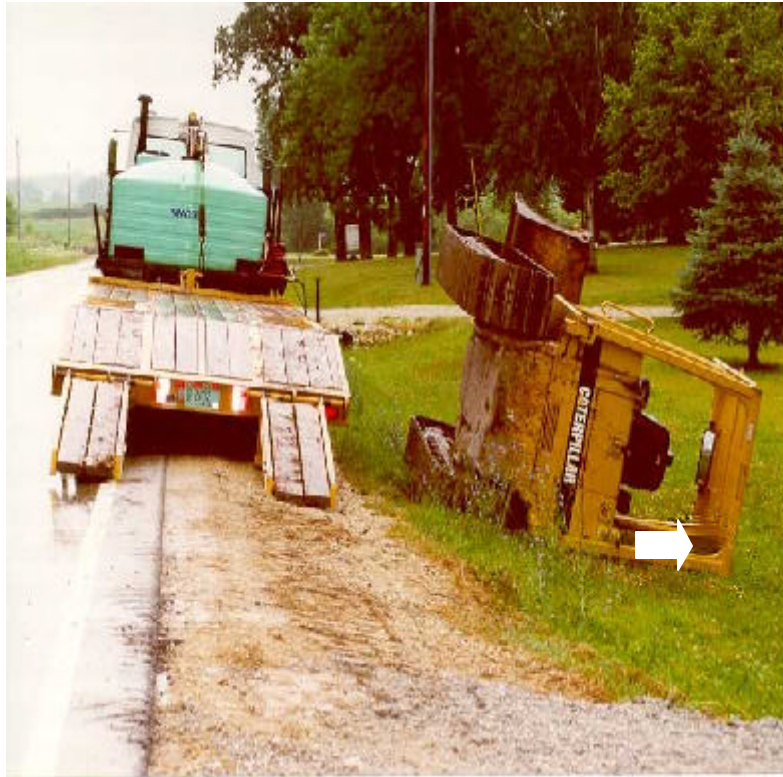
Figure 1. The arrow indicates the victim's location.
