FACE INVESTIGATION

SUBJECT: Farmer Dies After Becoming Entangled in Unguarded Driveline on a Corn Auger

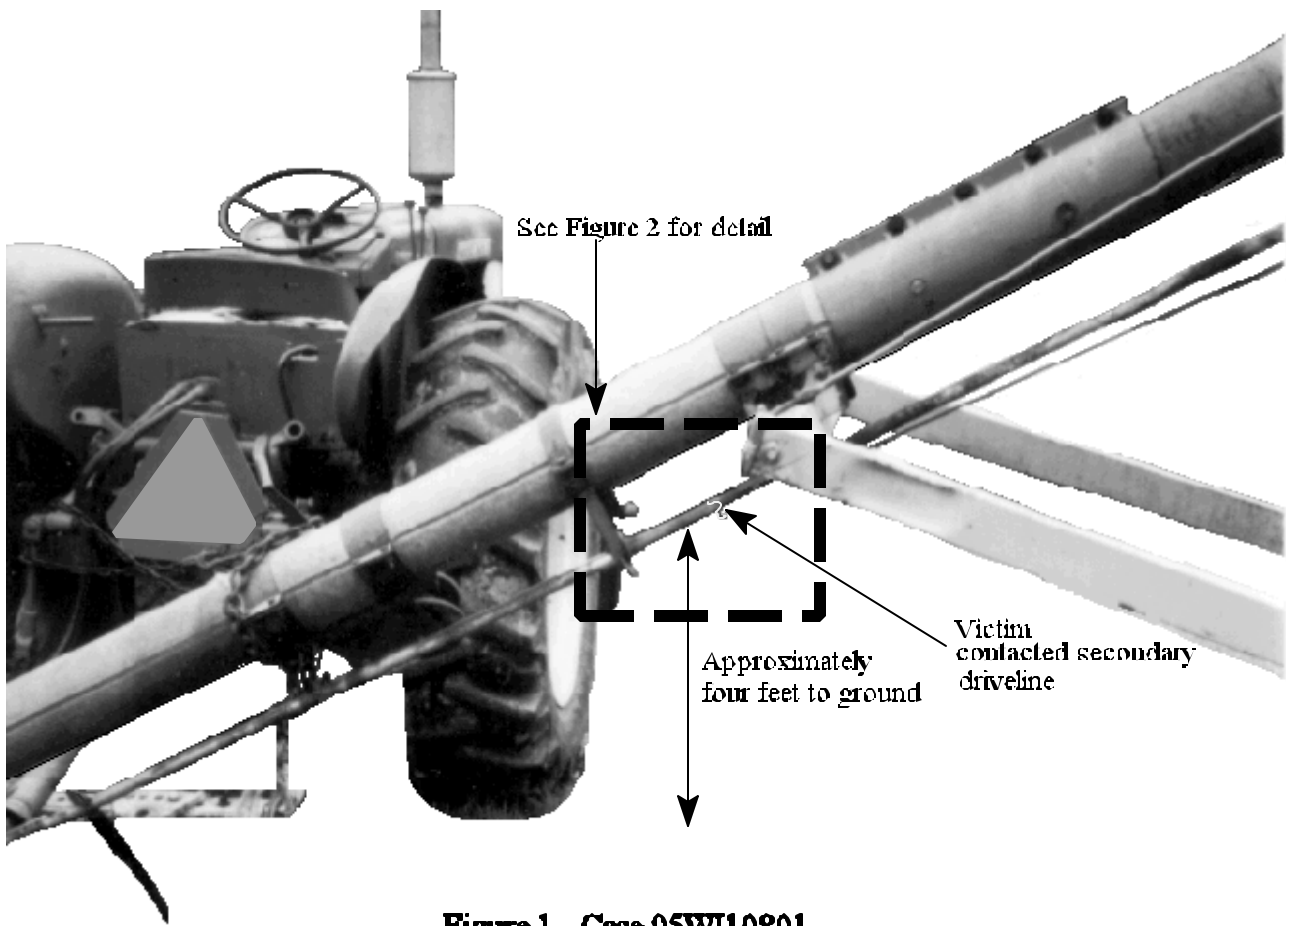
Figure 1 - Case 95WI10801

The farm property consisted of a farmyard with farmhouse, equipment sheds and grain storage bins, with crop and hay fields surrounding the farmyard. The grain auger involved in the incident was purchased used from an unknown source at least 15 years before the incident and was used each harvesting season since then. The auger was manufactured at least 35 years ago. A shielded PTO stub shaft on the tractor was attached to the completely shielded PTO driveline of the auger. A secondary drive shaft on the auger was positioned beneath the auger cylinder, and was unguarded.

Recommendation #1: Farm machine/equipment operators should identify all rotating machinery/equipment components, and ensure that appropriate guards, recommended by the manufacturer or dealer, are installed.

Discussion: Here, a rotating drive shaft was exposed during the operation of the auger. The aged auger had been purchased without a shield on the secondary driveline, and no guards had been installed in the 15 years since the purchase. Unguarded moving belts, sprockets, chains, and rotating drive lines expose workers to entanglement resulting in injuries and even death. If retrofit guards had been installed over the exposed drive shaft, the incident may have been avoided. To prevent installation of an inadequate guard, machine/equipment owners should consult with the manufacturer or dealer before installing any guard.
