## **FACE INVESTIGATION**

**SUBJECT:** Machinist is Pinned Between Parts of Metal Materials Handling Equipment

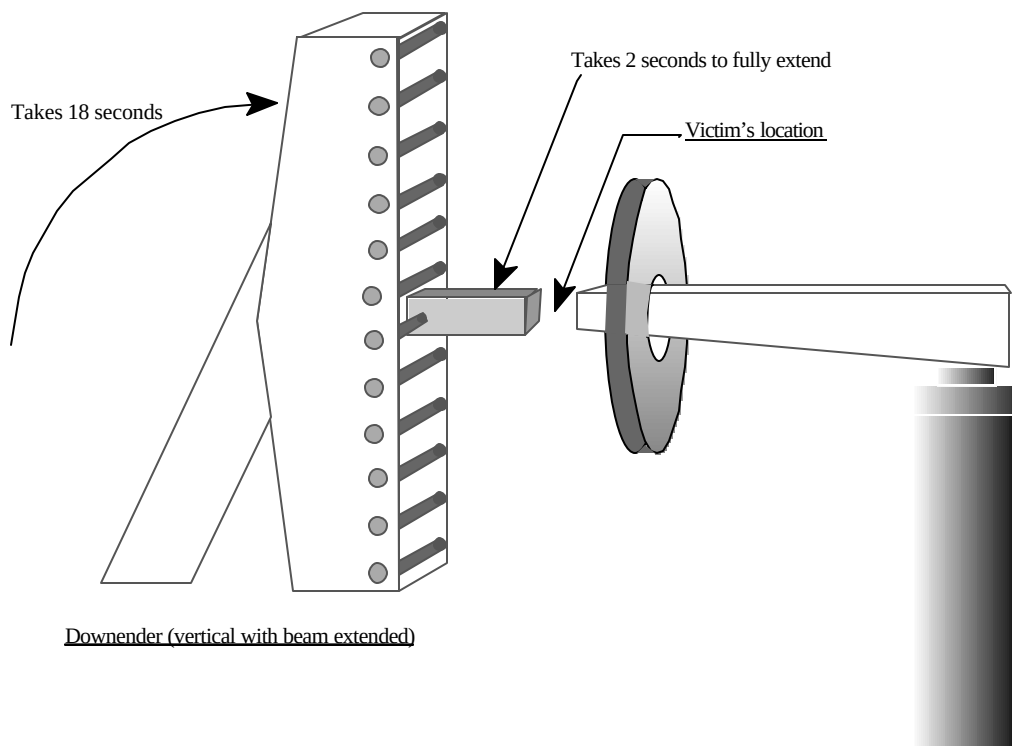
Figure 2 - 95WI05501

the supervisor pushed the button to lower the downender to the horizontal position. He left the control panel area to remove materials from the conveyor while the victim was standing near the turnstile arm. The event was unwitnessed, but apparently the victim pushed the control panel button that caused the downender to tilt to the vertical position, and the beam to project. The supervisor heard the victim call for help, and turned to see him pinned between the turnstile and the downender beam. He went to the control panel and tried to retract the beam by using the button controls, but was unsuccessful. He then pushed the emergency stop button, and cut the hydraulic line to retract the beam. The victim was transported to the hospital by EMS services, where he was pronounced dead.

Discussion:     Moving machine parts present dangers including pinching, crushing, entanglement, or shearing. Employers should ensure that access to hazardous areas is sufficiently controlled by guards or devices to prevent employee contact with the hazardous machine parts. In this case, a crush point between the turnstile arm and the downender beam was fully exposed to employees working near the machine. OSHA standard 29CFR 1910.212(a)(1) requires machine guarding to protect employees from hazards created by moving equipment. An additional factor of the hazard was the automatic feature of the machine controls, which permitted continued machine activity after the control buttons were pushed, regardless of an employee's presence in the hazardous area. Interlocked guards or gates, pressure sensitive floor pads, or presence-sensing devices or other physical measures to prevent employee contact with moving machine parts, and might have prevented this fatality
