## **FACE INVESTIGATION**

**SUBJECT: Crew leader crushed when forklift load carrier falls from forklift**

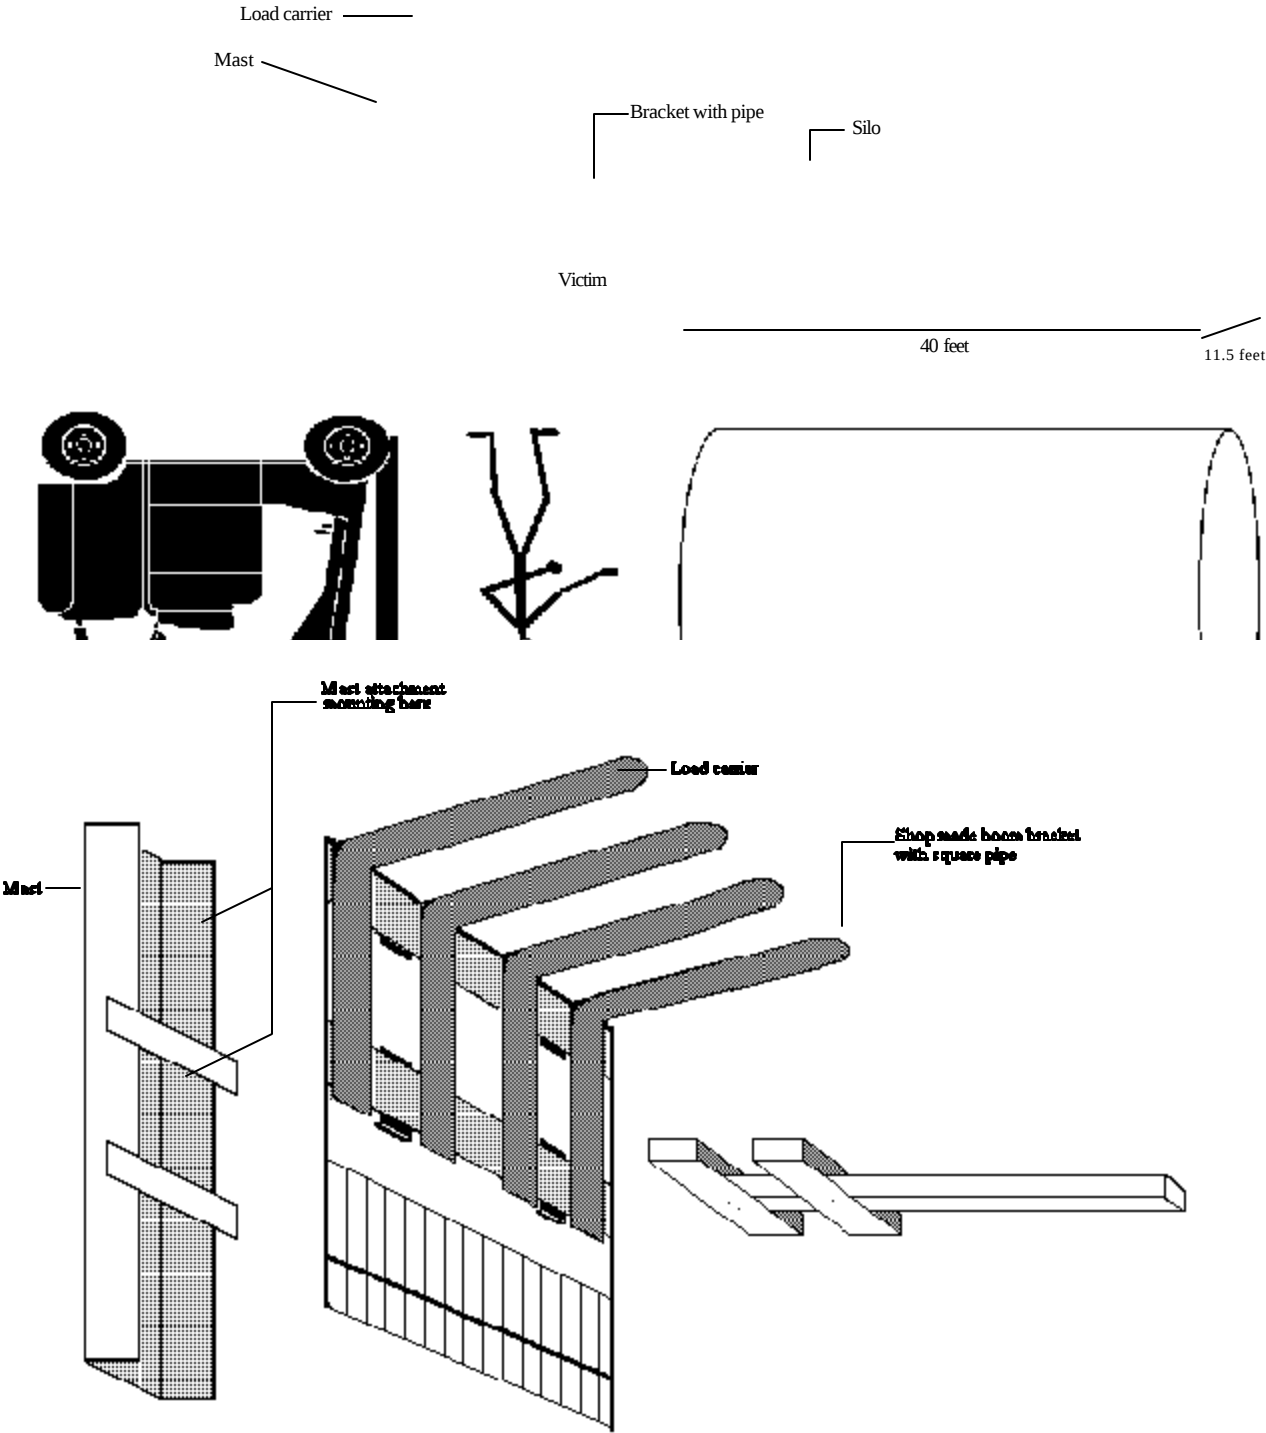
Figure 1

The company site included an indoor shop with a separate office area, and an assembly yard where the silos were finished and prepared for shipping. The company used a 1983-model forklift to lift the silos for finishing. The forklift was equipped with a load carrier, attached to brackets on the forklift mast. The load carrier was commercially-produced, but the forklift manufacturer had not been contacted for recommendations about attaching non-manufacturer equipment. The carrier had four forks, and the two center forks held a shopmade bracket welded to an 8-foot long, 4" square pipe (See Figures 1 & 2). The load capacity of the original loader was 5000 pounds at 24 inches, but the load capacity of the loader with the carrier and shopmade attachment had not been determined. A decal on the forklift included a warning against standing or passing under elevated portions of the truck.

Discussion: The forklift in this incident was equipped with a load carrier and shopmade bracket with lifting pipe that had not been approved for use by the forklift manufacturer. The additional and modified equipment may not have been secured firmly enough to the forklift to hold the lifting equipment and load. The OSHA standards 29 CFR 1910.178(a)(4) and 1910.178(q)(6) require manufacturer approval before modifications or additions are made to industrial trucks.

**Recommendation #1:**        **Employers should use appropriate equipment, such as a crane, when lifting heavy and massive objects.**

**Recommendation #2: Employers should obtain and follow forklift manufacturers' recommendations for attaching and using modified equipment.**
