## **MIFACE INVESTIGATION: #03MI066**

### **SUBJECT: Farmer Dies When He Is Crushed Under Overturned Tractor in Ditch**

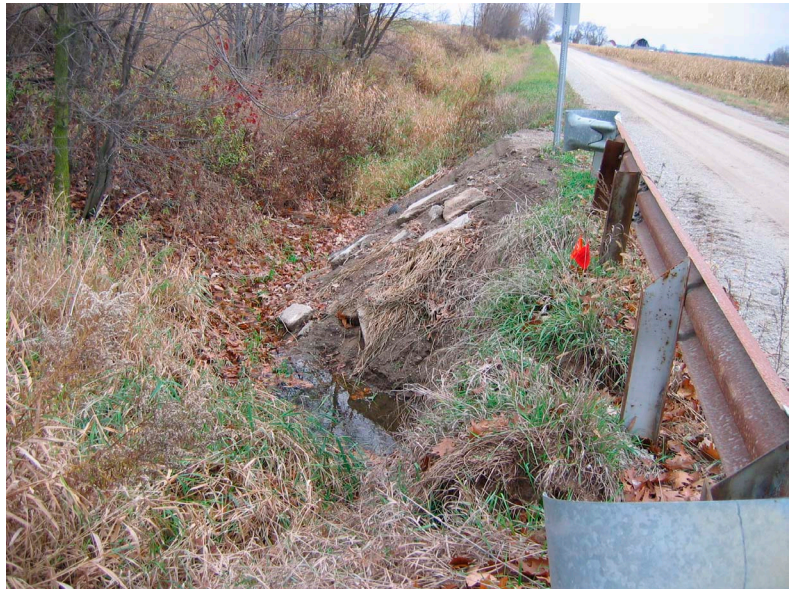
On June 13, 2003, a 74-year-old male farmer was killed when his wide-front, Massey Ferguson model 65 Diesel tractor and 10-12-foot pull-type antique disc overturned into a 6- to 8- foot, steeply cut ditch that contained water. (See Figure 1) This was an unwitnessed event. It appeared that the victim exited a private drive after he completed turning over the soybean stubble in his field so he could plant corn. After exiting the private drive, he turned to his left and drove northbound in the southbound lane of a gravel road. He may not have completely straightened the tractor's front wheels. The tractor's gearshift did not work properly and he may have been having difficulty placing the tractor in a higher gear. He unknowingly drifted to his left and left the roadway because the wheels were not completely straightened and his attention was diverted to manipulating the gearshift. The tractor's left front tire contacted the soft dirt near the ditch edge, the tire entered the ditch, and the tractor overturned to the side, pinning the victim in the ditch. All four of the tractor tires were pointing in the air. A passerby found him and called for emergency response. Emergency response arrived and declared the victim dead at the scene.

Figure 1. View of ditch from 2-track road. Looking to operator's left.

- Equip older tractors with a roll-over protection structure (ROPS) and a seat belt; the local county extension agent, local equipment dealer or equipment manufacturer should be contacted to see if a retro-fit ROPS/seat belt system is available.
- Ensure farm equipment is maintained according to manufacturer specifications.

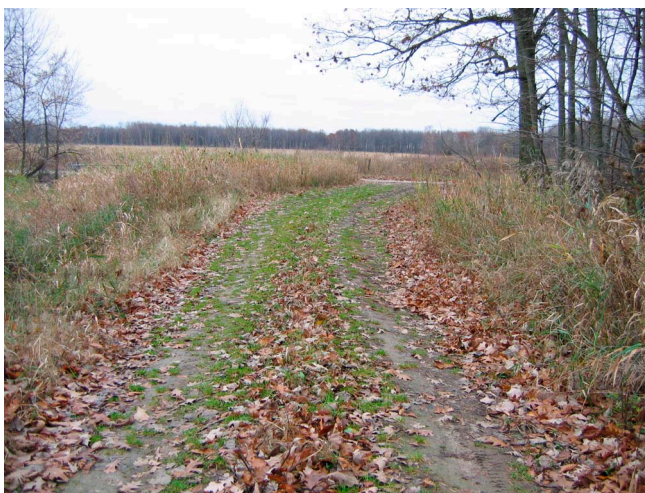
Earlier in the day, a family member visited him around noon and the victim spoke about going out later that day to disc the soybean field. This family member left approximately one hour later. Sometime after the family member left, the victim traveled to the site of the field, which was approximately one-half mile from his home. This road was a dirt road with soft shoulders. On one side of the road was a 6- to 8- foot, steeply cut ditch that contained water. To travel to the field from the dirt road, the victim traveled a private "2-track" road. The width of the 2-track road was approximately 25 feet. See Figure 2.

Figure 2. View driving from field down 2-track road to main road

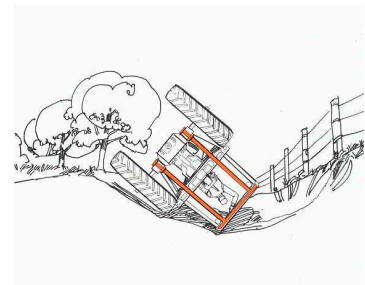
Figure 3 – Operator Zone of Protection

ROPS are designed to help limit a tractor overturn to 90 degrees and to provide the operator a “zone of protection” (See Figure 3).

- Equip older tractors with a roll-over protection structure (ROPS) and a seat belt; the local county extension agent, local equipment dealer or equipment manufacturer should be contacted to see if a retro-fit ROPS/seat belt system is available.
