## MIFACE INVESTIGATION: 03MI146

### **SUBJECT: Electrician Dies From Being Pinned Between Iron Pipe and Articulated Boom-Supported Aerial Work Platform Control Panel**

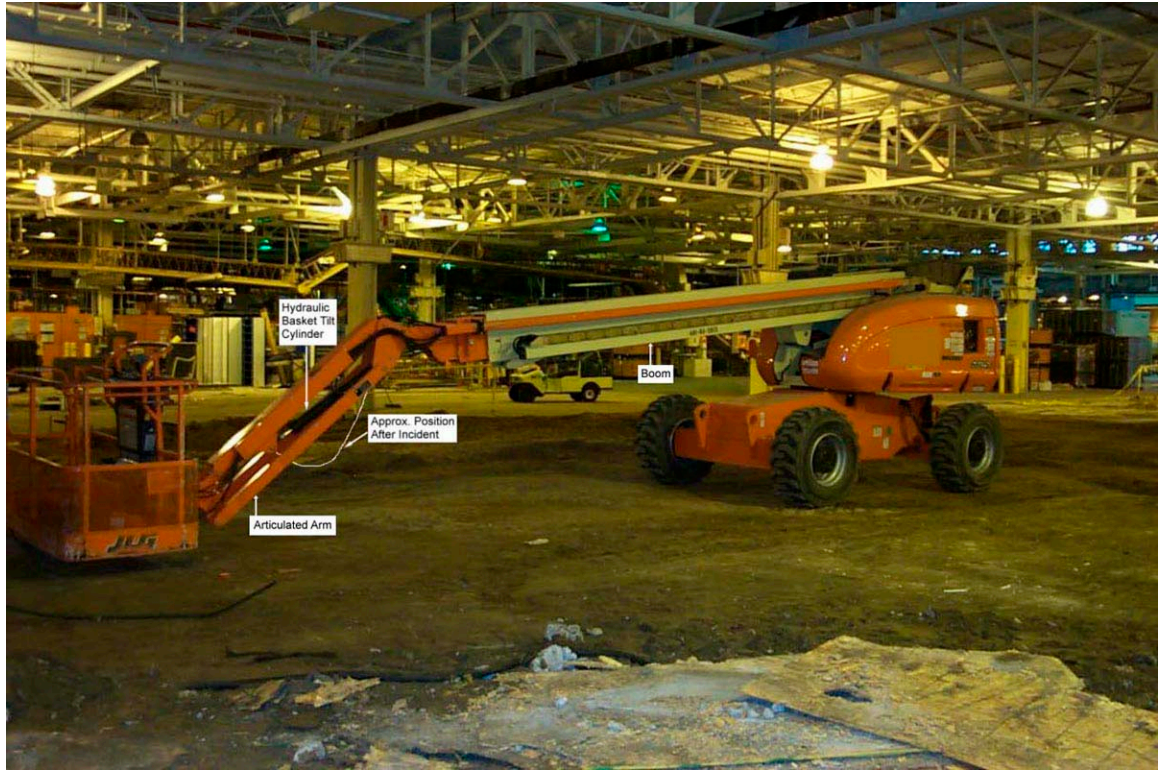
On Monday, November 3, 2003, a 55-year-old electrician had been given an assignment to strip out a section of wiring and conduit from an overhead electrical service. He was operating an articulated boom-supported elevated work platform, JLG Model 660SF, (Figure 1) to access an overhead junction box. Another worker had been assigned as a ground person during this construction activity. The ground person indicated he had walked to the front of the unit when he heard a scraping sound. He called out but received no response. As he called out, he and two other employees looked up and saw the decedent pinned with his back against a 6-inch diameter iron fire protection water pipe and his chest against the control panel at the front of the work platform basket. The relationship of junction box and water pipe is shown in Figure 2. They tried to override the basket panel controls (Figure 3) the decedent had been using to operate the work platform, but could not do so, because the key that would allow them to access the controls from the ground was missing from the ground control panel switch (Figure 4). They estimated that three to four minutes passed until they could find a key that allowed them to lower the basket. Another employee used a non-JLG key to gain control of the work platform and lower it to the ground. When they did gain control, the basket and the boom fell abruptly to the dirt floor of the plant. The local fire department and its EMS squad responded to the incident. They found the decedent in the basket on the floor of the plant. Emergency treatment was administered at the plant. He was transported to a local hospital where he was pronounced dead approximately one hour after the incident occurred.

Figure 1. JLG Model Similar to One Involved in Incident

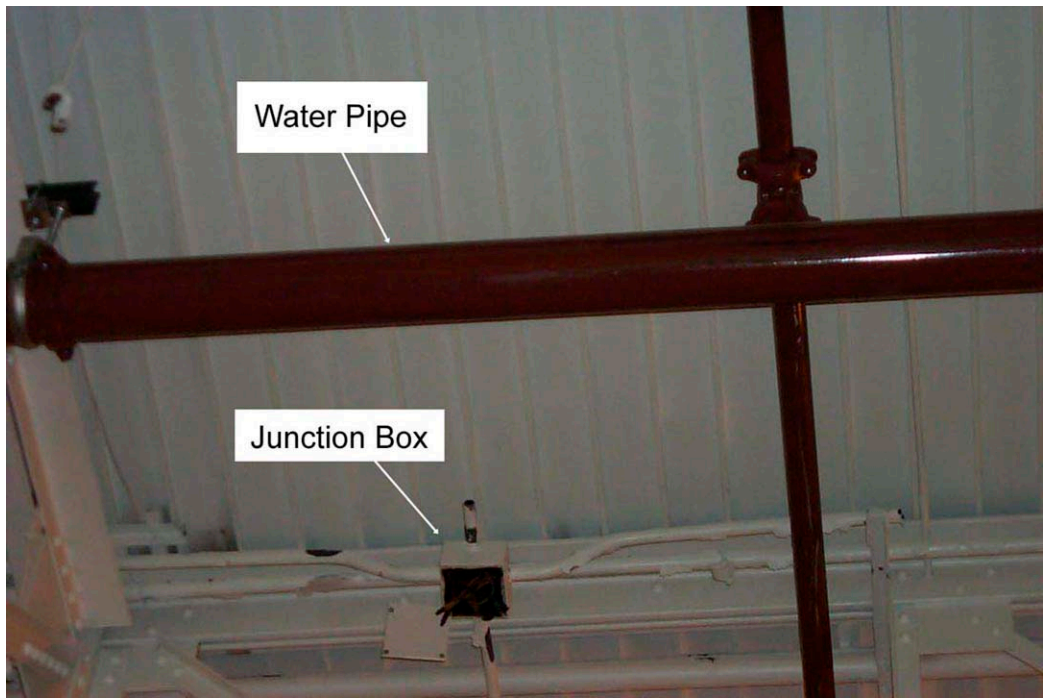
Figure 2. Junction Box and Water Pipe Involved in the Fatality - Truss is not Visible.

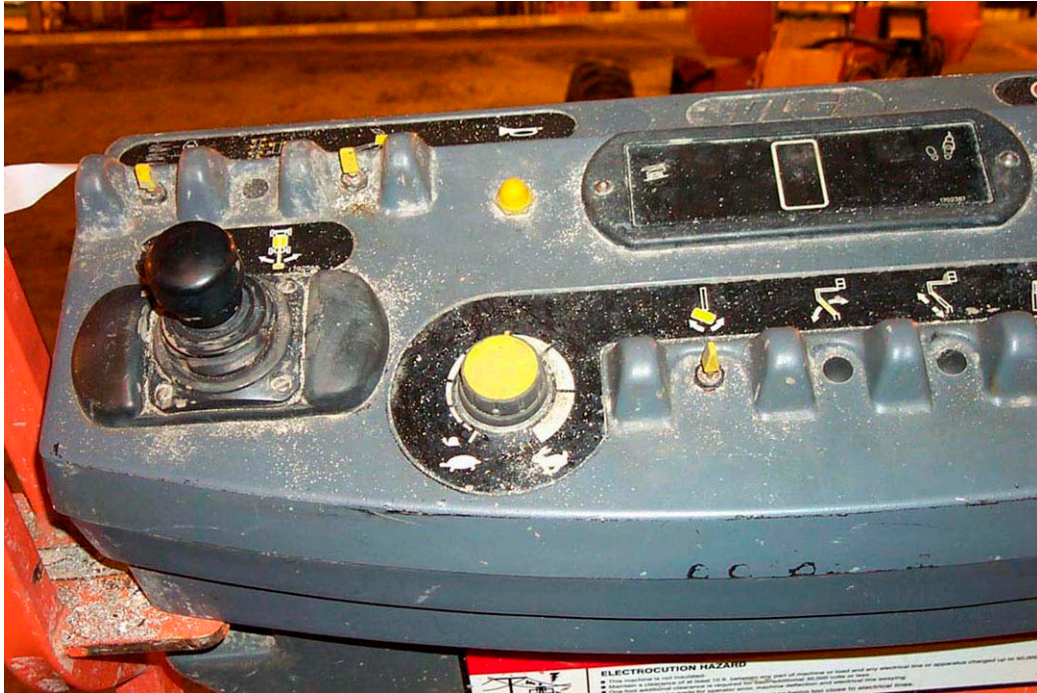
The unit had been rented from an equipment rental company. The decedent's company required a pre-use inspection be conducted and documented on a written form for this type of equipment, but no written inspection form was found for it on this day. Examination of the unit after the incident revealed that the hydraulic basket tilt cylinder located on the boom had failed catastrophically. The hydraulic tilt cylinder was bent into a "C" shape indicating a large amount of pressure had been exerted on the cylinder. The basket controls were found to be in good working order.

Figure 3. Basket Control Panel

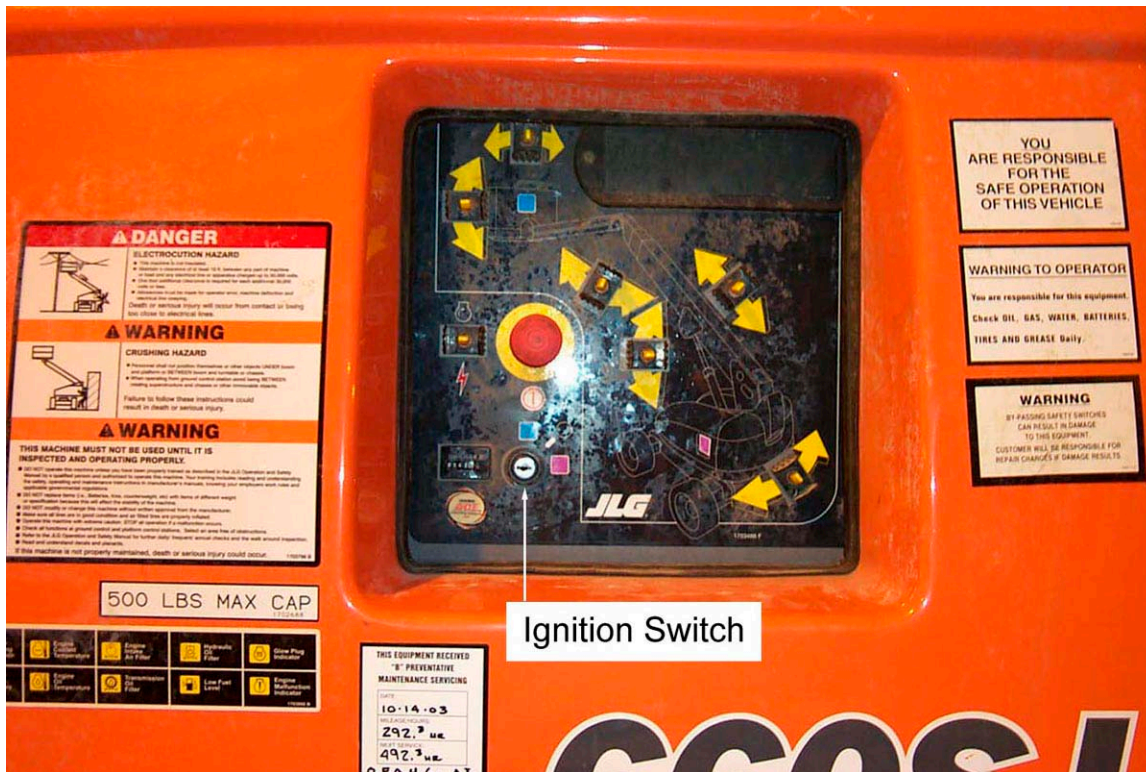
Aerial Work Platforms, Part 32, Rule R408.43209(24) addressed the fact that the key necessary for the ground control panel's emergency control operations was not in the ignition while the employee was operating the equipment.

According to the manufacturer, the unit was designed such that the key in the ignition switch at the ground controls is held captive when the equipment is engaged in either the platform or ground control mode. No key was found in the switch when the workers tried to operate it from the ground. When the unit involved in the incident was tested with a manufacturer's key, it was discovered that the key could be removed in either the platform or ground control mode. Control of the unit had been accomplished with a non-manufacturer key at the time of the incident. Interviews with workers familiar with the operation of the articulated boom-supported aerial work platforms indicated that the ground control captive key feature of the equipment could be easily defeated. Also, they indicated that over time the keys became loose, vibrated out of the ignition switch, and were misplaced or lost.

Figure 4. Ground Control Panel - Taken Immediately Following Incident Illustrating Missing Key

- Tether the key that operates the equipment from the ground controls to the ground control panel.

Because having the key in the ground control ignition in order to operate the work platform apparently is easily defeated and the keys are often missing or lost, tethering the key to the panel

would help ensure it was present in case a ground person would have to gain control of the equipment.

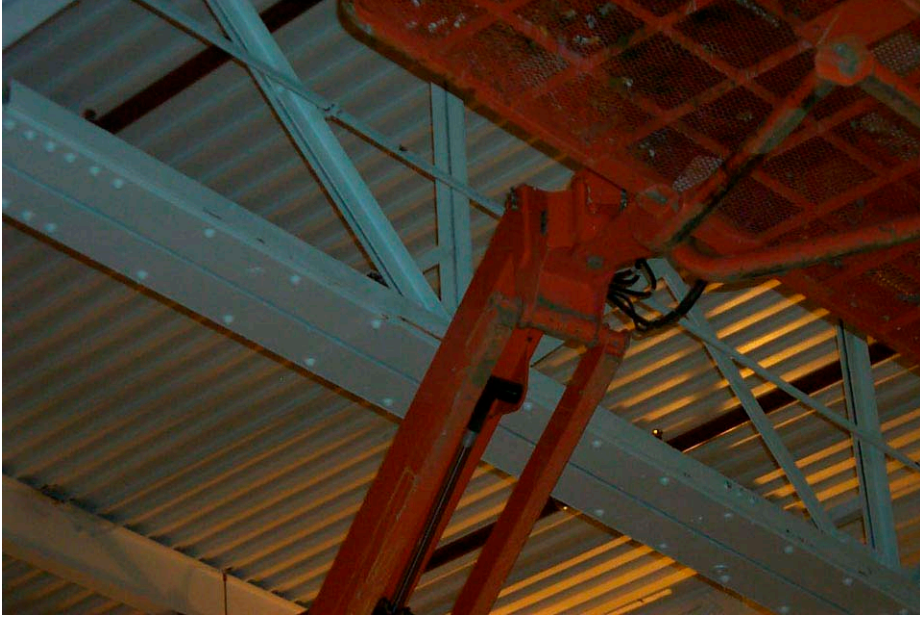
Although no one observed the events immediately preceding the incident, it appears that the decedent was close to the junction box he was trying to access near the plant ceiling but could not quite reach it. As he attempted to reach it, either the controls momentarily malfunctioned driving the articulated arm against a roof truss, or he inadvertently continued to operate the tilt controls after the arm had become wedged against the lower side of a roof truss. The hydraulic lift cylinder failed presumably because of excess pressure exerted on it. When the hydraulic lift cylinder failed, the basket snapped backwards toward an iron water pipe causing the decedent to be crushed. Paint from the roof truss and a scrape were found on the articulated arm near the

basket. Paint from the articulated arm was found on the truss. A simulation of where the articulated arm contacted the truss is shown in Figure 5.

Figure 5. Simulation of Arm at Truss
