October 26, 2004

Nebraska FACE Investigation NE 2004-07

Engineering Technician Run Over and Killed by Backing Dump Truck

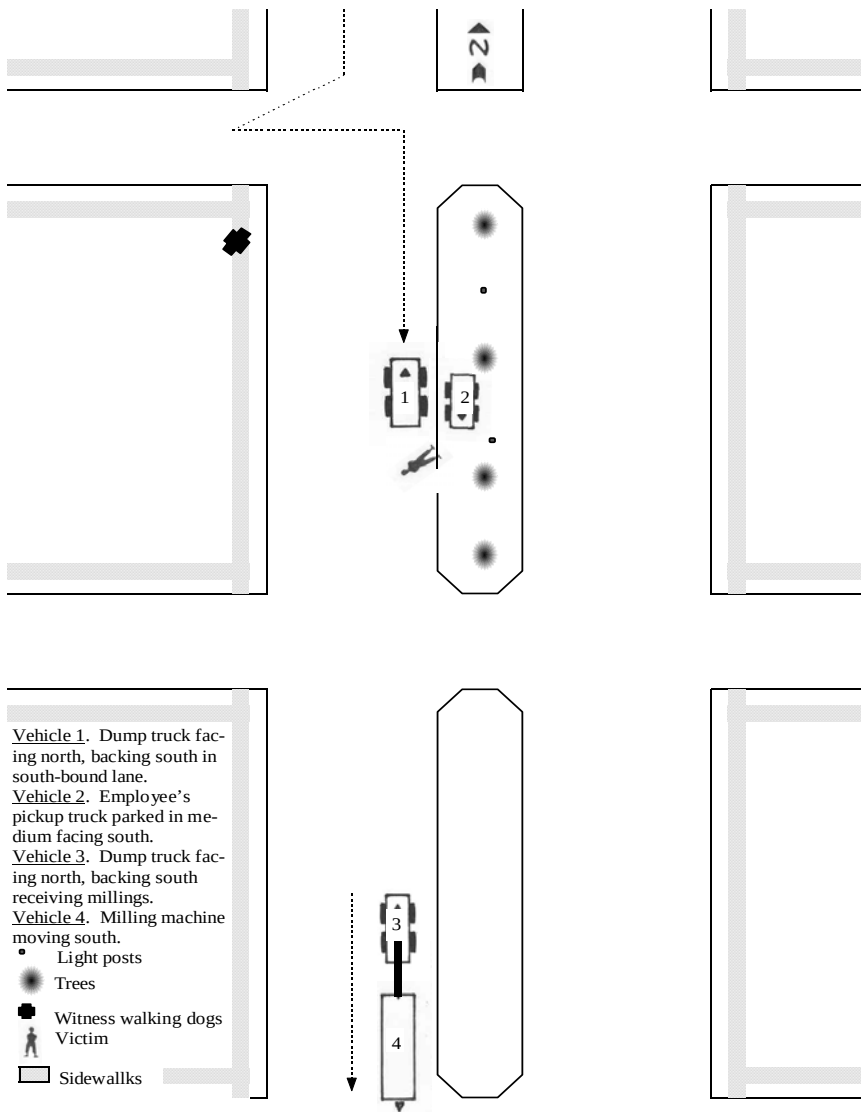
Attachment #1

Attachment 1. Site diagram (not to scale).

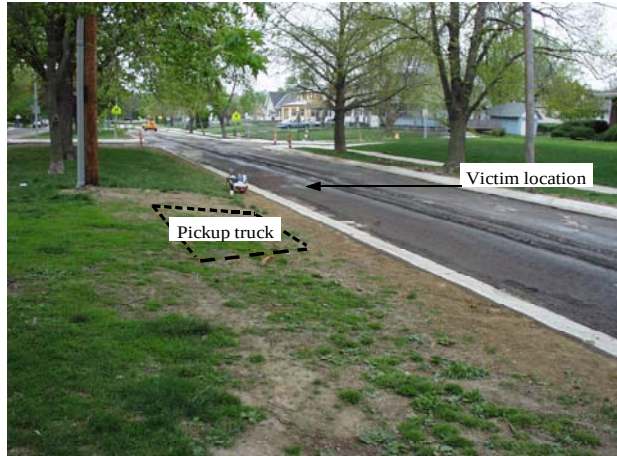
Attachment #2

Whenever practical, equipment, worker's private vehicles, materials, and debris should be stored in such a manner so it will not impede a vehicle operator's line-of-sight while operating construction equipment. The employee's personal vehicle that was parked in the median along the inner southbound curb may have hindered the dump truck operator from seeing the victim walking towards her in the median. She was only able to see behind her truck through the use of the door-mounted mirrors, as the dump box obscured her rear vision through the cab's rear glass.

Attachment 2. Top: Mishap site looking south. Note dotted line showing location of parked pickup truck and arrow indicating victim’s location when struck.  
Bottom: Milling machine discharging asphalt residue into waiting dump truck.

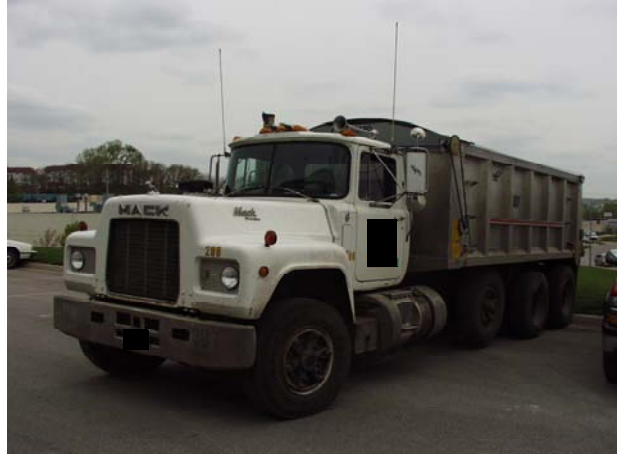
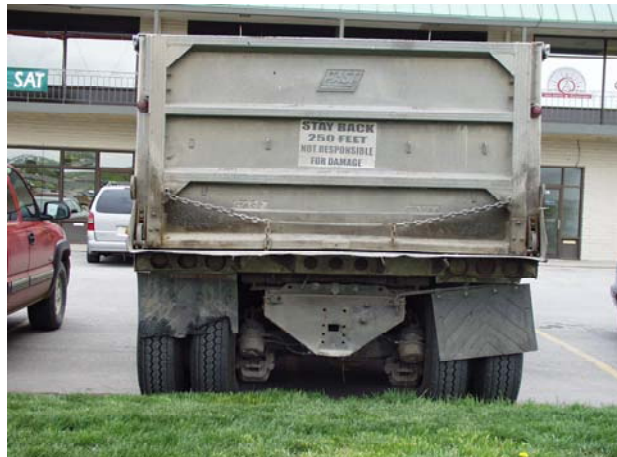
Attachment #3

The dump truck had passed the required annual DOT inspection conducted just prior to this incident. All safety related items were checked and were in working order. The operator conducted the pre-operational checklist prior to moving the truck from its parking location to the job site. Again, all lights and audible signals were working. Witnesses stated that they heard the back up alarms working on the dump truck just prior to the incident, and when Carrier Enforcement inspected it shortly after the incident, all were operating properly.

Attachment 3. Top: Side view of incident dump truck.  
Bottom: Rear view of incident dump truck.

1. Hard hat mounted mirrors. These are similar to those worn by bicyclists. They allow the worker to have some rear vision to possibly see approaching hazards.
2. Changing the audible tone on equipment. This can be done using either mechanical or electrical warning devices. Workers that are exposed to the same warning tones every day may tend to become complacent when these audible signals are used. Changes every so often may help to alleviate this.
3. Parabolic mirrors. The use of parabolic mirrors on construction equipment and vehicles, similar to those used on school buses, allows the operator to view what is

directly behind their vehicle. These mirrors normally produce a “fish-eye” type view, which must be taken into consideration when judging distances between a vehicle and the obstacle.

4. Ultrasonic backup sensing system. These devices attach to the left and right rear of trucks, and wired to either the left or right back up light, allowing it to only function when the vehicle is in reverse. The device emits an audio warning and sends a wireless signal to a video display to indicate in feet and in tenths of feet how close the vehicle is getting to the obstacle. The audio alerts and the red-flashing video display warning begin at about 6 feet and continue as the distance decreases to the obstacle. The audio warning becomes continuous when the video display indicates the distance to be one foot and/or less from the obstacle.

5. Reverse camera systems. These are normally mounted near a rear license plate and have a wide angle lens (up to 120 degrees cone of vision), and a visibility range of 165 feet. These are similar to ones used on larger recreational vehicles.
