Nebraska FACE Investigation NE 2003-27

Irrigation System Serviceman Electrocuted

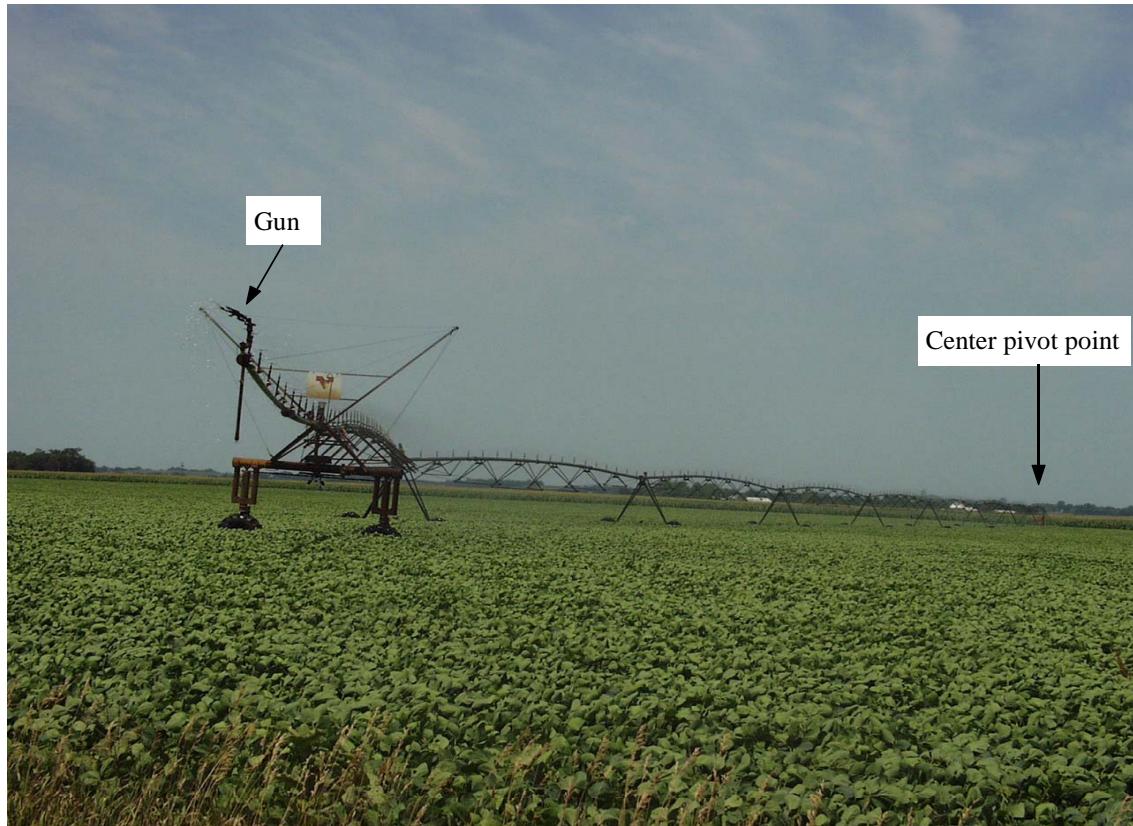
On the afternoon of the incident, the victim and his son (co-worker) were dispatched to repair a center-point pivot irrigation system several miles from the company headquarters. The "gun" (picture #1) at the end of the swing arm (farthest section) was not shooting out water. They assumed that the end booster pump was inoperative.

Picture #1: Incident irrigation system.

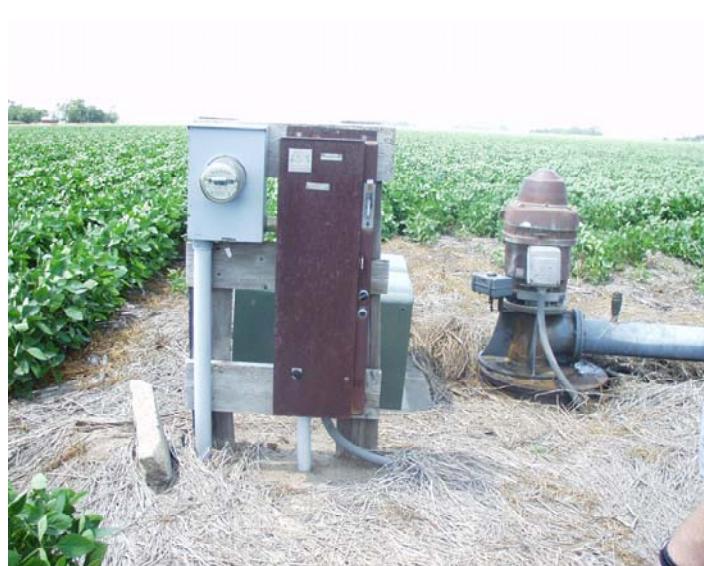
Power for the pivot is supplied through commercial lines to an electrical engine-driven generator (picture #2), which conveys its electric power (480 volts), to the center pivot (picture #3). It is then distributed throughout the length of the system to the booster pumps and control heads (picture #4). The equipment owner stated that the system was grounded using a ground rod, but was not sure if there were any types of fuses, breakers or ground fault circuit interrupters (GFCIs) located at the center point pivot head or along the system length. Age of the system or installation dates could not be determined.

Picture #2: Commercial power source used to run well head water pump.

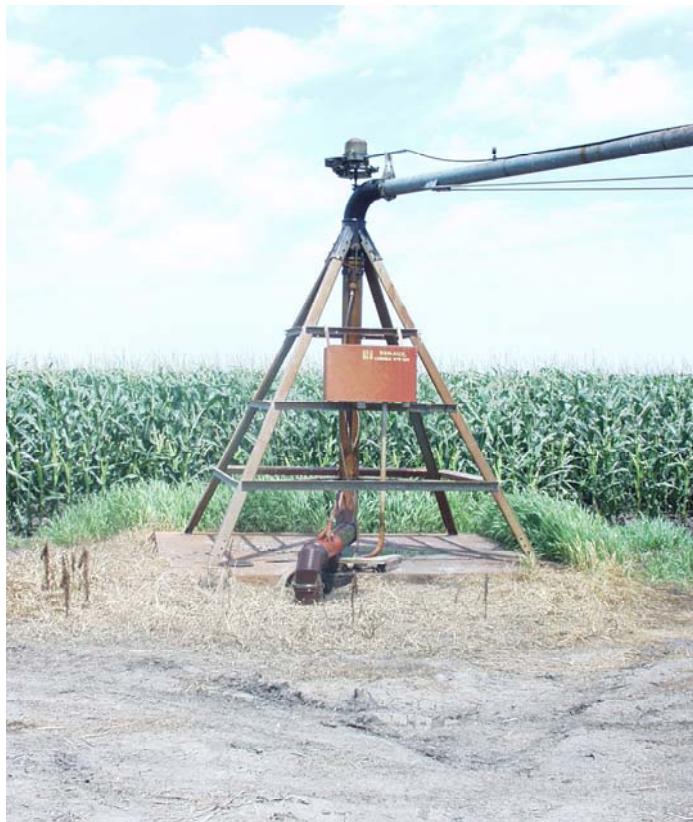
Picture #3: Center point pivot head.

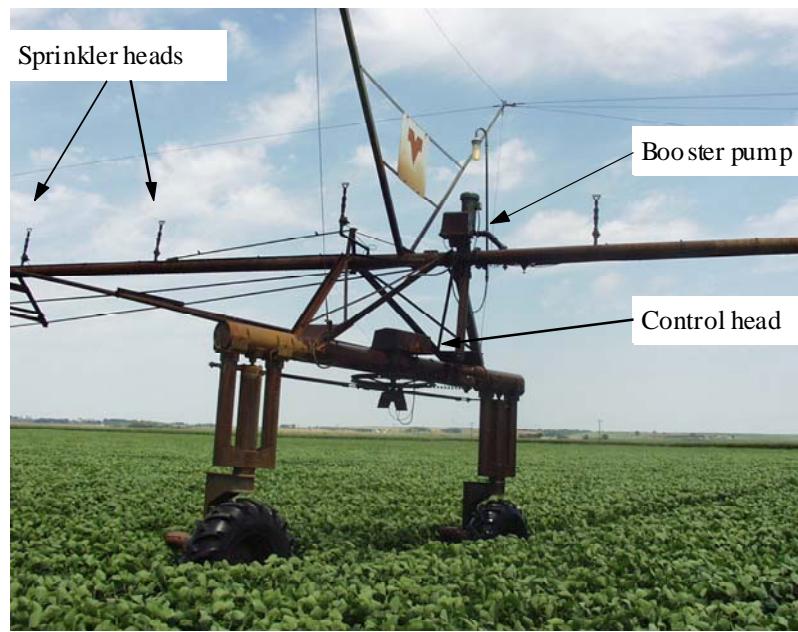
At some point, the power had been shut off at the pivot point. The new booster pump did not solve the problem so they began to try to isolate electrical circuits to find the break. The victim climbed onto the system's tower structure next to the new booster pump to work on the control head. It is believed that he had his legs wrapped around the tower structure for support. He told his co-worker to go turn on the power. The co-worker walked back to the center point pivot head where power had been shut down. Due to the height of the corn and the position of the pivot head, it is possible that the co-worker could not physically see the victim. . The victim and co-worker both had cell phones that they could use to remain in communication, but it could not be determined if they were being used.

Investigating officials stated that the control head cover was lying on the ground beside the tower structure when they arrived and there were exposed wires showing.

Picture #4: End tower structure where victim was working.
