Nebraska FACE Investigation NE-2003-22

Farmer Electrocuted Exiting Grain Bin

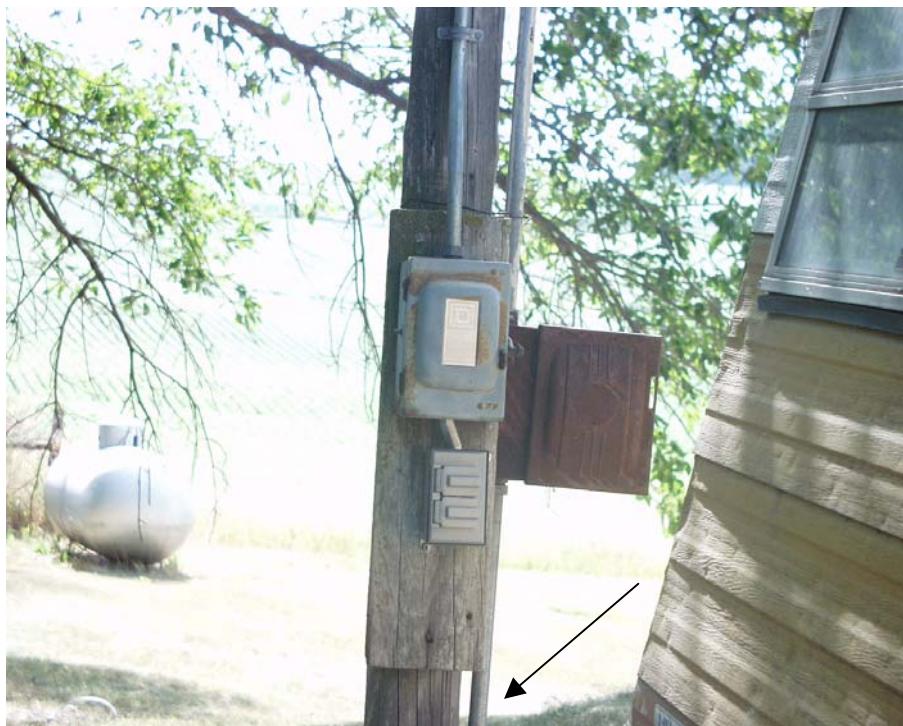
Electrical Power Source: Power for the auger (110 volts) originated from a power pole (see picture # 1) located near the house. This pole and pull box were installed during the late 1940s. Knockout plug holes had not been covered, allowing birds to build inside the box (see picture #2).

Picture #1. Pull box with conduit running to adjoining bins.

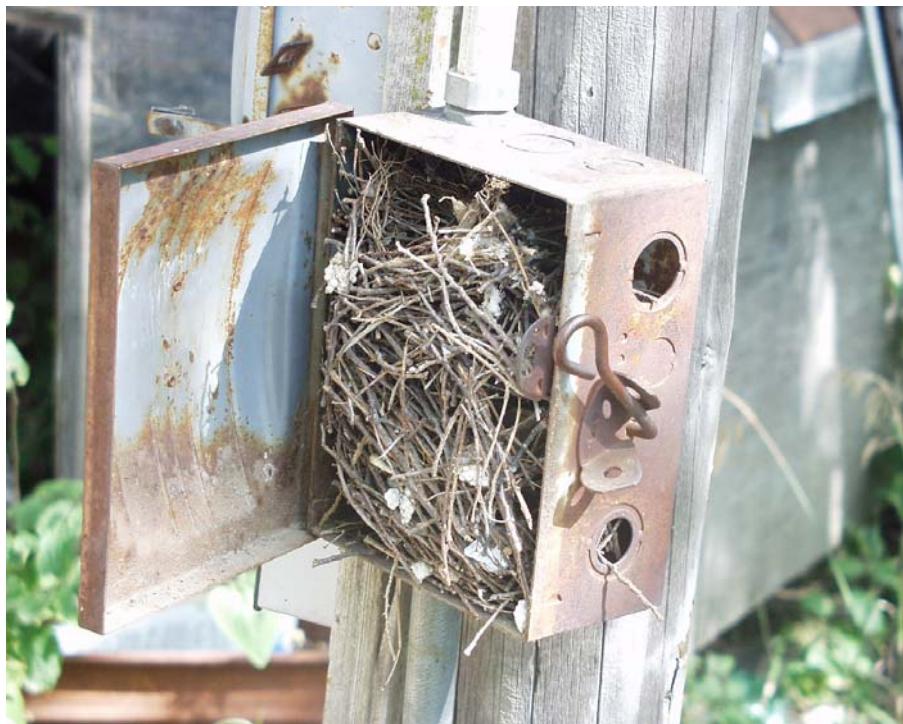
Discussion: The pull box located near the house had several of the knock-out plugs missing, which allowed birds to fill it full of nesting materials. If an attempt had been made to shut the box off at this location, chances are good that the actions would have been blocked due to the extreme amount of materials inside. The pull box located between the bins also had knockouts removed. The duplex box attached to the bottom was missing one of the receptacles and also the cover plate. Both the black flexible extension cord from the pull box, and also the cord hard wired into the electrical auger motor had numerous areas where the external insulation had cracked and been taped over with black electrical tape. Black electrical tape does not have the same insulating properties as the original insulation. There were also areas on the motor wire where the internal insulation surrounding the copper wiring was exposed. The male end of the black extension cord was missing the protective insulation wafer that fits over the two prongs.

Picture #2. Pull box with nesting materials.

Suggestion: Remove equipment from service that has damaged electrical cords, missing ground prongs, and/or missing or cracked insulation.

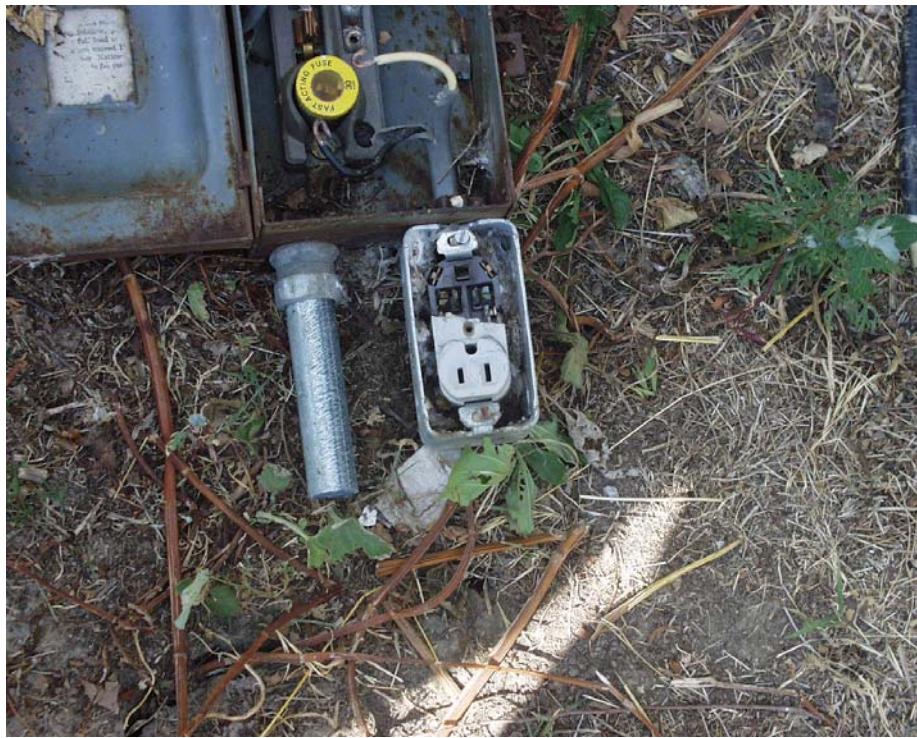
The wiring runs approximately 88 feet underground through metal conduit to another pull box located between the two grain bins (see pictures #3 & 8). This box contained a 30 amp screw-in type fuse (see picture #3). A duplex metal outlet box had been attached to the bottom of the pull box. It was wired using the same 10-gauge wiring.

Discussion: At the time of construction, there were no federal, state or local requirements for grounding grain bins or installed electrical service beyond the service entrance. Since the incident, the breaker box between the bins has been grounded by inserting the ground wire into the ground. To check if this is a proper ground, the servicing power company should be contacted to conduct a test to ensure its adequacy.

Picture #3. Pull box that was between bins, removed after incident.

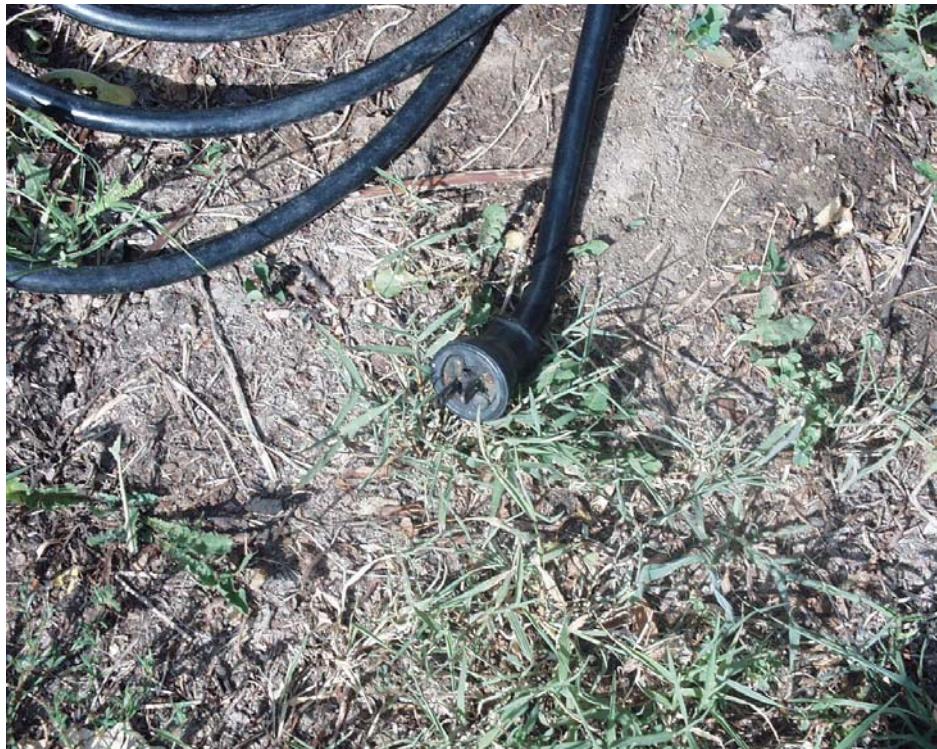
A black flexible electrical cord was then plugged into the outlet box. The male end of this cord was the older two-pronged style with no ground prong (see picture # 4). The female end of the flex cord had another metal duplex outlet box attached (see picture #5).

Discussion: Both cord male ends were the old two-prong style. The black cord's male end was missing the protective insulating wafer. Neither of the duplex outlets attached to the pull-boxes had protective covers. The duplex outlet box attached to the black extension cord was made for indoor use only and should never be used outdoors. Any time a fixture that is intended for inside use is used outside there is a high probability that moisture will enter the fixture through the manufactured cutouts, holes, etc. Fixtures intended for outside use do not have these openings and are made to withstand extreme environments.

Picture #4. Black extension cord, male end.

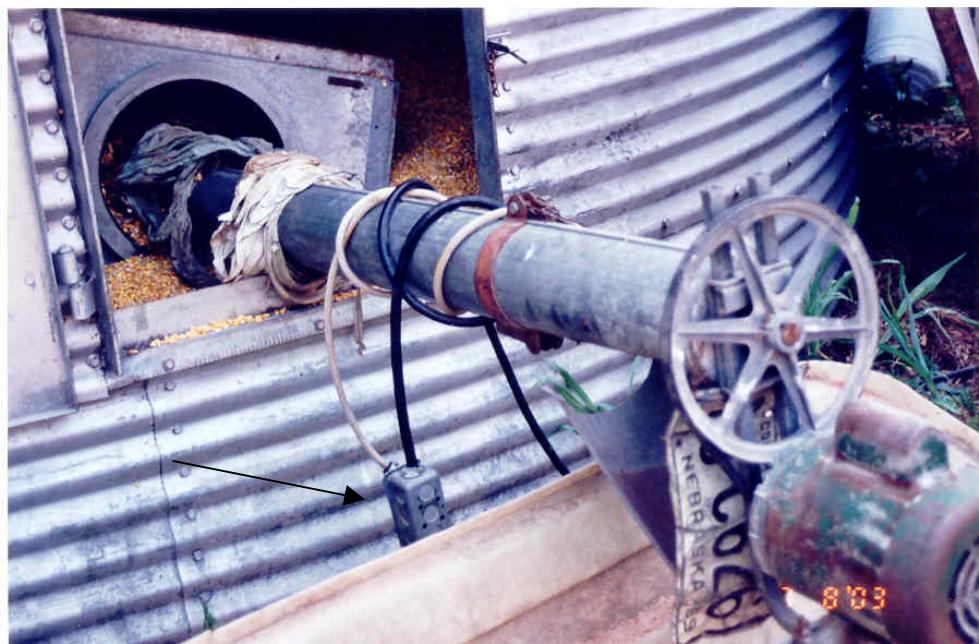
Picture #5. Black extension cord female end.

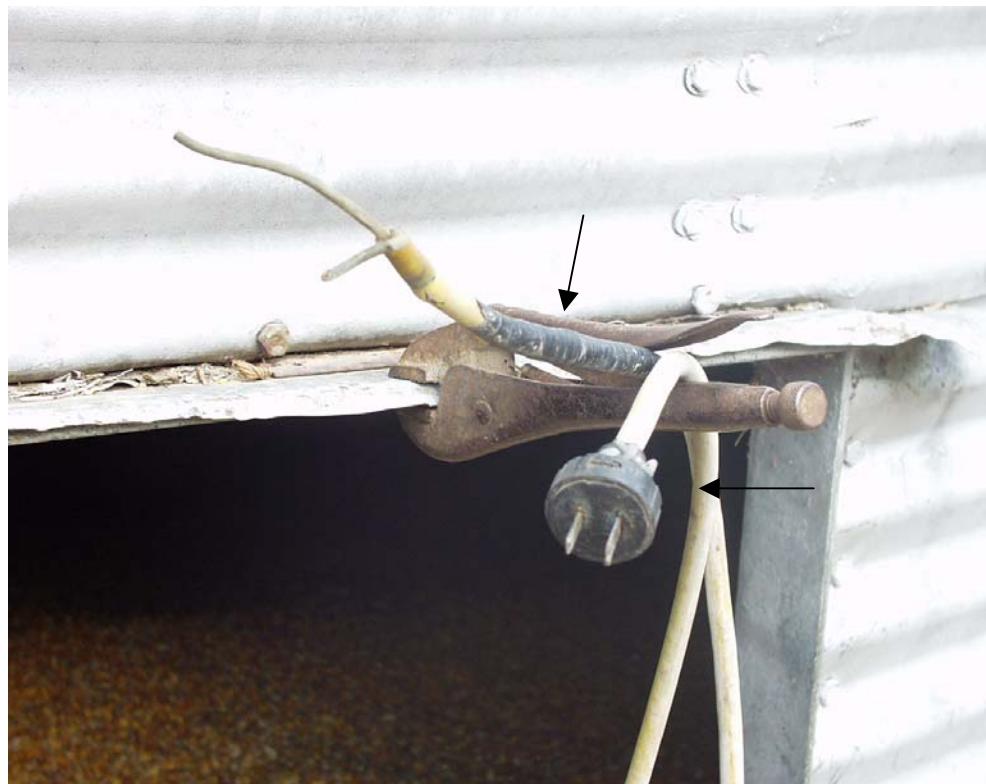
The portable auger was wired with a flexible two-wire cord (see picture # 6), connected internally to the motor. The male end was the two-pronged older style.

Picture #6. Portable auger motor cord with tape and two-prong male end.

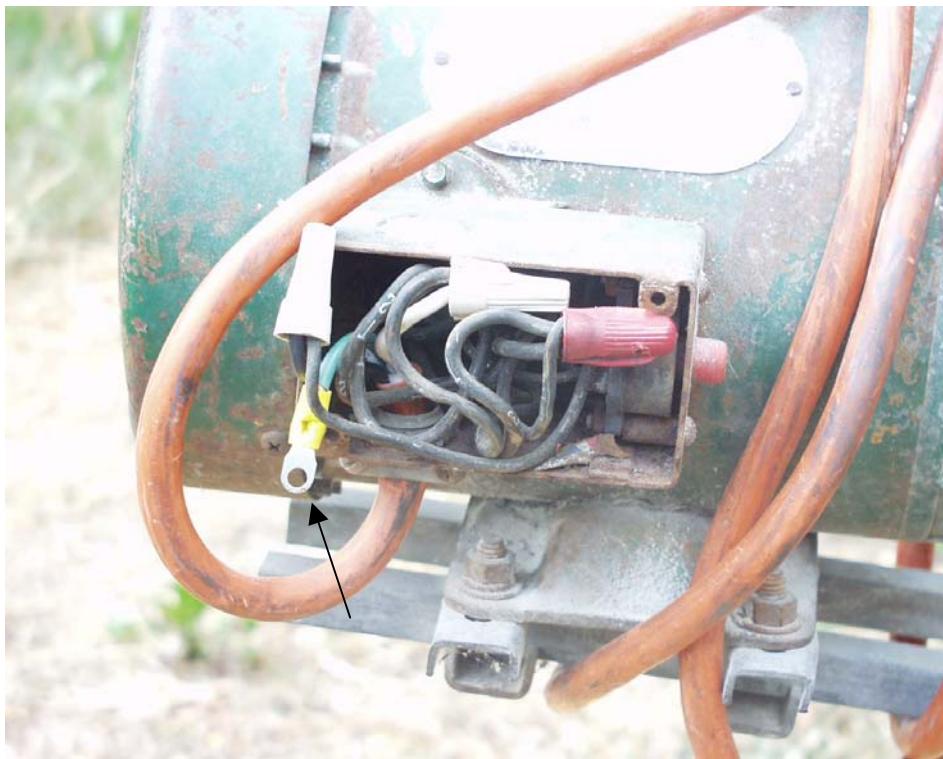
Several days afterwards the victim's father and brother dismantled the portable auger's electric motor. They stated that there was a bare wire touching the inside case, which had caused the motor to become energized. They repaired the bare wire, and also installed a new flexible cord with the ground wire attached to the motor housing plate (see picture #7). The old pull box between the bins was replaced with a newer breaker style box. A ground wire was run from the new box directly into the ground underneath in an attempt to establish a ground. The servicing electrical company was going to be contacted to inspect the grounding system. The victim's spouse stated that once the bins were emptied, they would be torn down.

Picture #7. Portable auger motor housing opened with new ground wire.

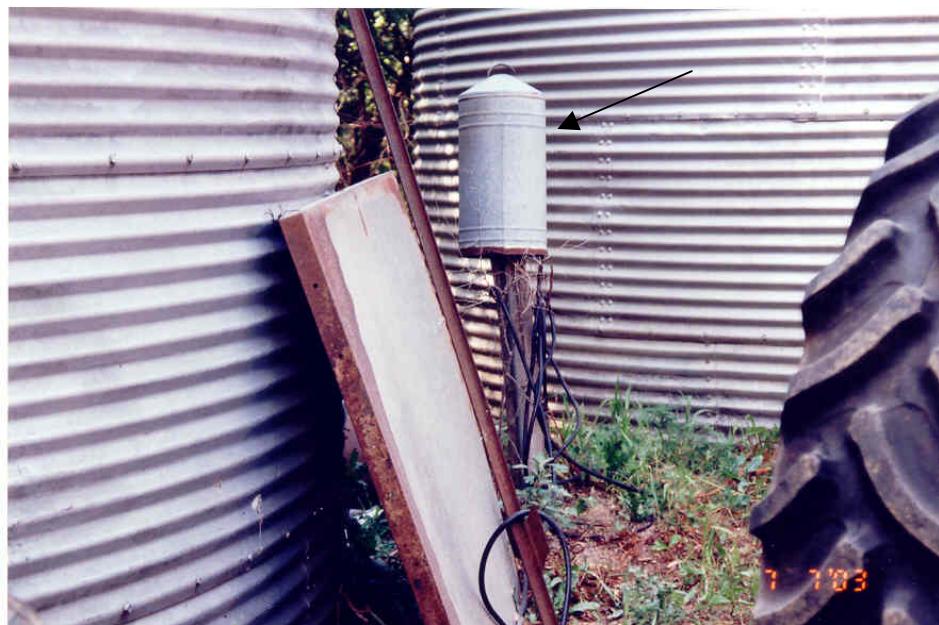
Picture #8. Pull box between bins day of incident with protective covering.
