**FATALITY ASSESSMENT & CONTROL EVALUATION
OCCUPATIONAL FATALITY REPORT**

Subject: Hispanic Tower Erector
Falls to Death from Television Tower

January 4, 2005

Nebraska FACE Investigation NE 2003-019

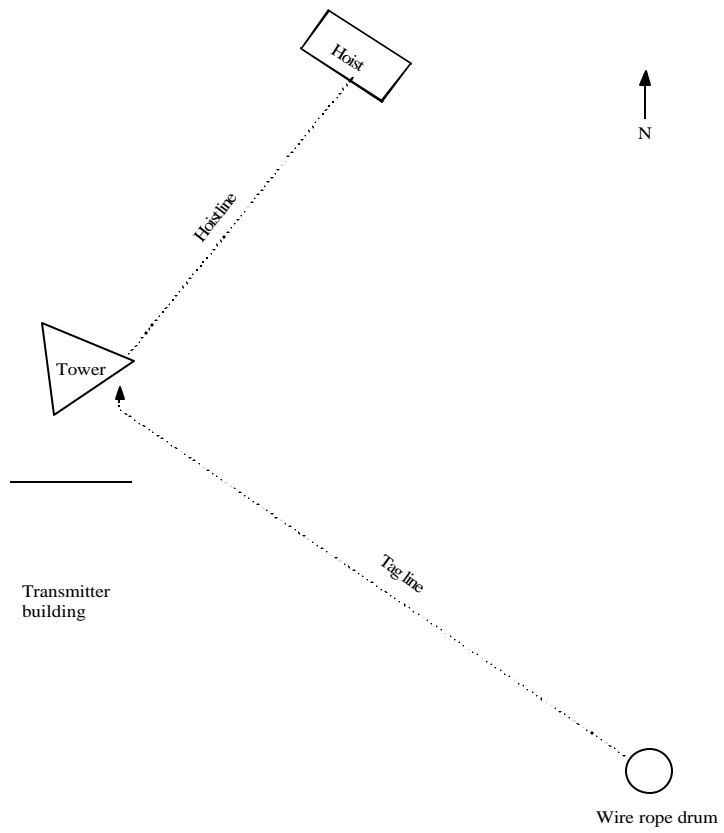
Attachment 1

Site Diagram (not to scale)

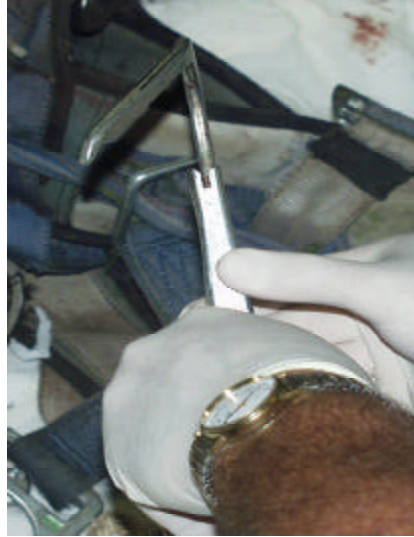
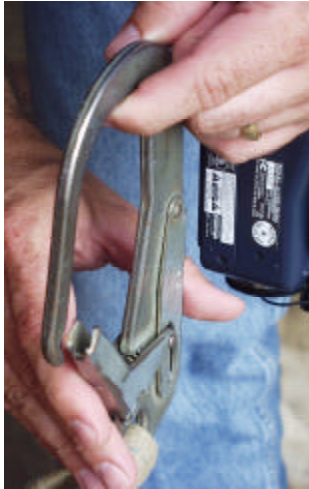
Several Symon's pelican hooks that were inspected in the company's on-site equipment trailer also showed that they had been exposed to a side load, causing the tip of the hook to be offset from the latching mechanism.

Two examples of other off-set pelican hooks found in the on-site equipment trailer. Note both have the tip off-set from the latching device due to side load pressures being applied.

³It is the responsibility of each employee to check their PPE on a daily basis, or each time they wear it for signs of wear, damage and other deterioration and defective components. Any equipment that is faulty must be removed from service and either repaired, replaced and/or destroyed.
