Nebraska FACE Investigation NE-2002-44-1

Worker Falls Into Mixing Tank

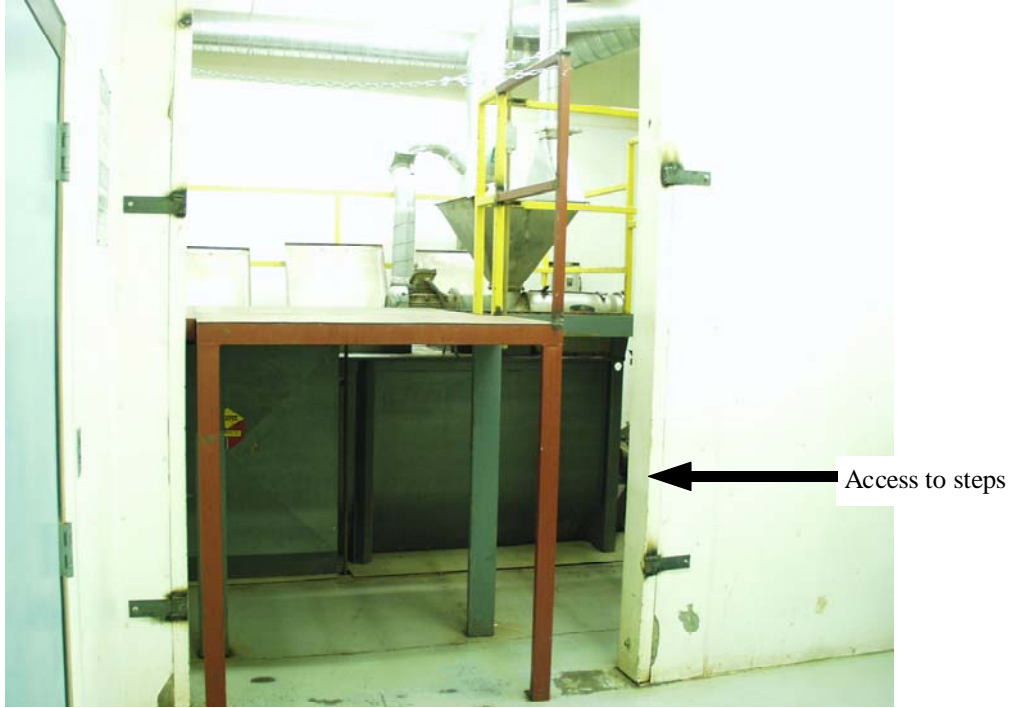
Picture #1

The tank is set against a wall on the far side, while a metal platform built against the mixer on the near side allows personnel access. This is gained by walking through a 16 inch opening between the platform's right support leg and a wall, then proceeding up 7 expanded metal steps on the mixer's right side to a working platform. This platform is 59 inches high with safety rails on two sides and a 1/4" safety chain on the "load" side. It is 78 inches square.
(See picture 1)

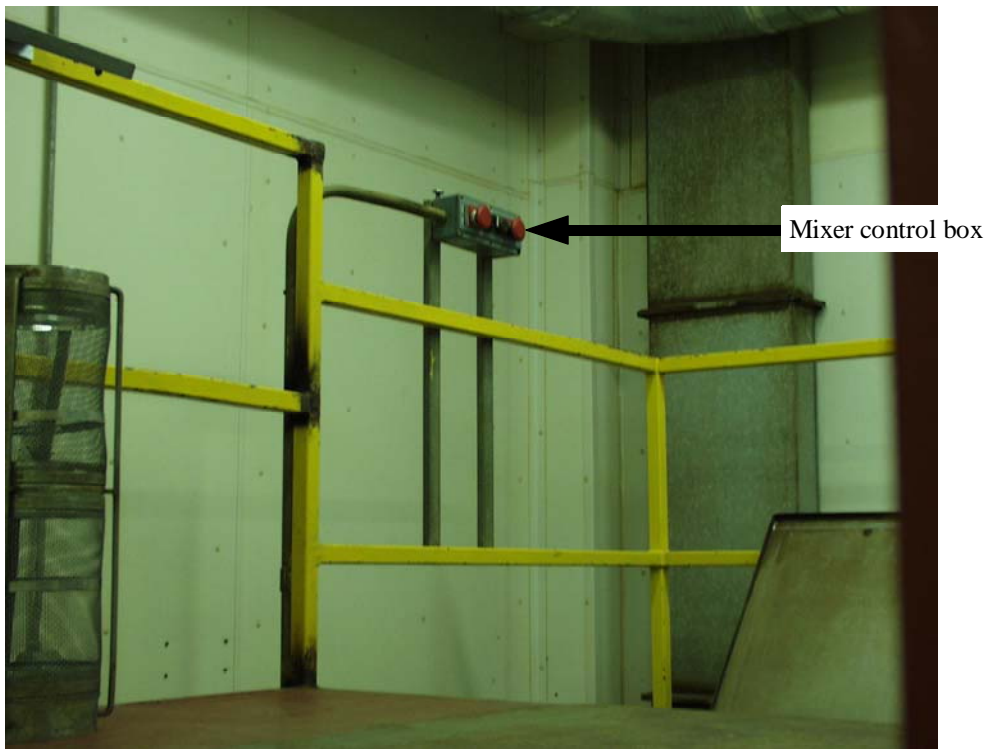
Picture #2

The controls for the mixer are located on the left side outside edge of the upper safety railing, directly in line with the three mixer openings. The control box has a red EMERGENCY STOP button on both the left and right side. In between is a green START button and a three position function (hand/off/auto) switch. Depressing either EMERGENCY STOP button on the control box would automatically stop the machine (See picture 2). There is also an EMERGENCY STOP button located directly below on the second floor where the final mixed product emerges.

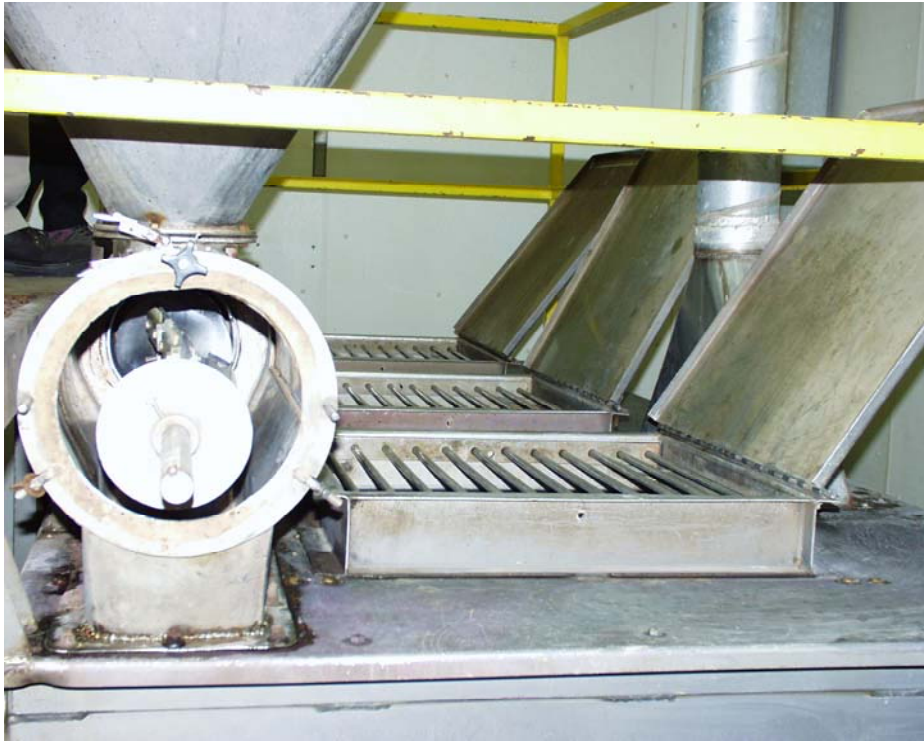
Picture #3

On the far side of the platform there is a 6 inch "step down" to the mixer top. On top of the mixer are three square grates, each with an external measurements of 27 inches square, and internal measurements of 23 1/8 inches square. The grates consist of 12 tubular steel rods embedded in bar steel, spaced equally along the length of the opening. Each end bar is laid over a piece of steel welded inside the opening to prevent the grates from falling inside.
(See pictures 3 & 4)

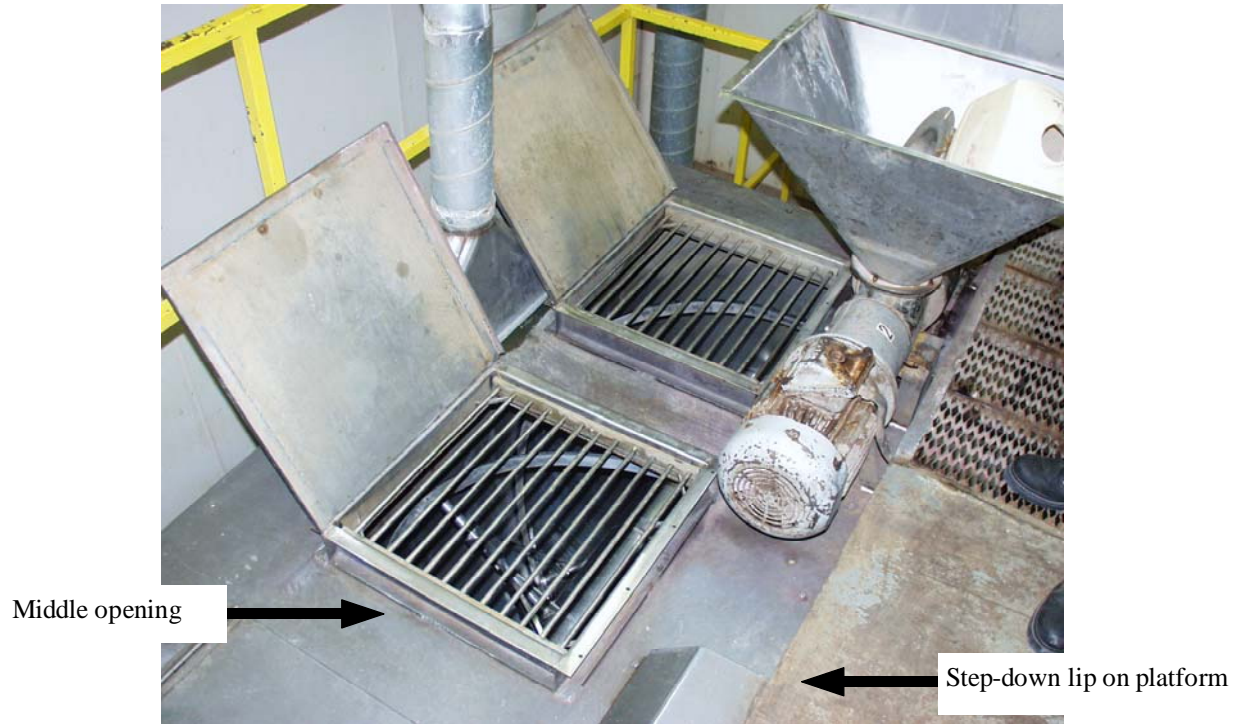
Picture #4

Equipment: The incident mixer (Mixer #6) is 4 years old. It was purchased new and installed in its current location on the third floor in 1998. The basic function of the mixer is to mix the water soluble ingredients used in the company's products. The mixing tank is 5 feet deep and 20 feet long. It has an impeller that runs the length of the tank. It is centered inside the tank and the blades extend to each side in order to ensure materials are mixed thoroughly.
(See pictures 4 & 5)

It is believed that the victim removed the center grate to allow easier cleaning. The victim either stepped backward onto the lip of the opening and fell inside or reached inside to spray and was pulled into the opening.

have entered mixers without the employer ensuring that all procedures set forth in the regulatory standard were followed. Since the incident the company has bolted all of the safety grates on each mixer so that operators can not remove them. A system was implemented where only authorized personnel, not the mixer operators, are able to remove the grates.

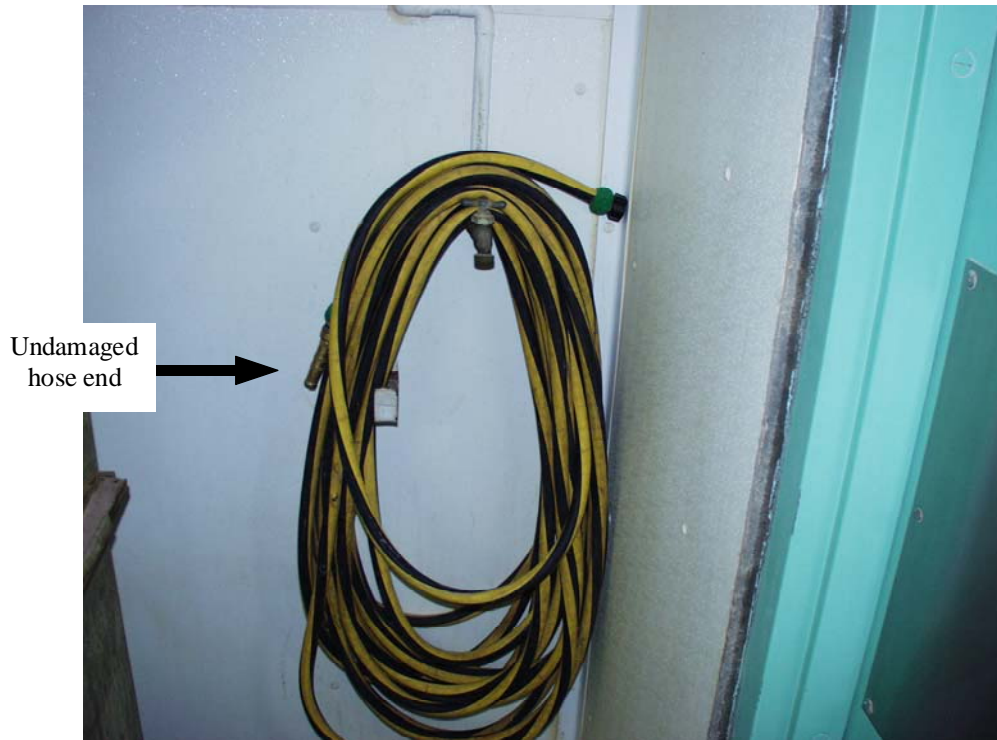
Picture #6

The water hose did not show any physical evidence of being drawn into the mixer.
(See picture 6)
