March 19, 2002

Nebraska FACE Investigation 01NE038

Construction Worker Caught Between Forklift and Cement Truck

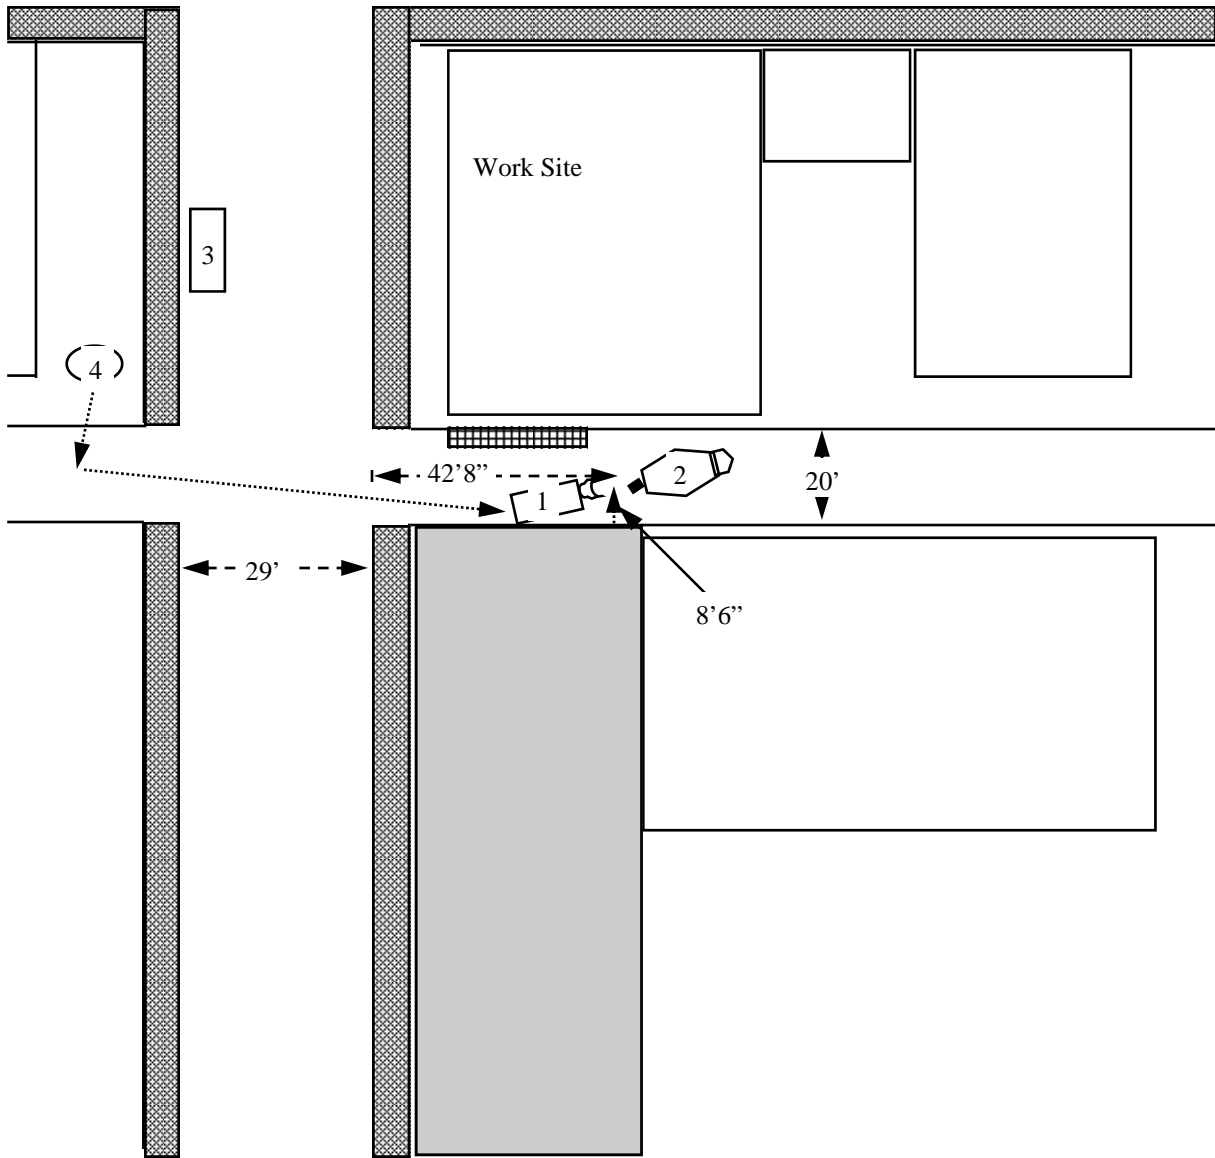
Sidewalk

Scaffolding

Gravel parking lot	
1	Forklift	
2	Cement Truck	
3	Supervisor's Truck	
4	Forklift starting point

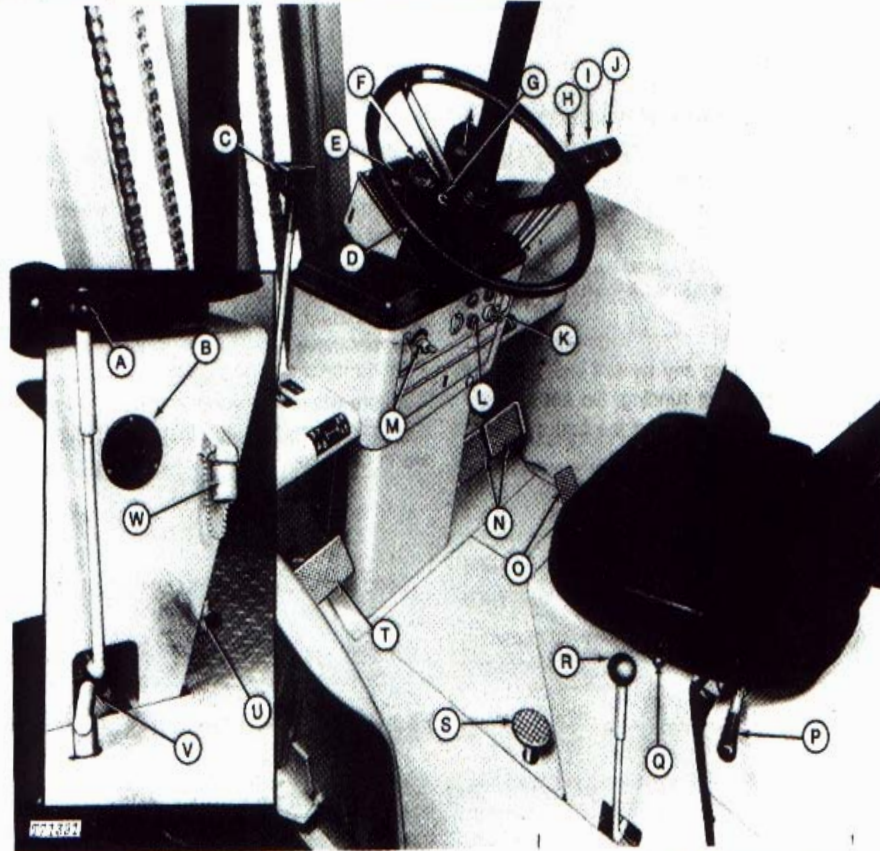
Photo #1: Control and Instruments for the John Deere 480 Forklift

A—Range Shift Lever
B—Hour Meter
C—Reverser Control Lever
D—Alternator Indicator Light
E—Coolant Temperature Gauge
F—Fuel Gauge
G—Engine Oil Pressure Indicator Light
H—Lift Lever

I—Tilt Lever
J—Side Shift or Allied Equipment Control Lever
K—Key Switch
L—Horn Button
M—Light Switch
N—Brake Pedals
O—Foot Throttle
P—Hand Throttle

Q—Seat Adjustment Lever
R—Gear Shift Lever
S—Differential Lock Pedal
T—Clutch Pedal
U—Transmission Filler Cap
V—Clutch Disconnect Lever
W—Starting Fluid Adapter

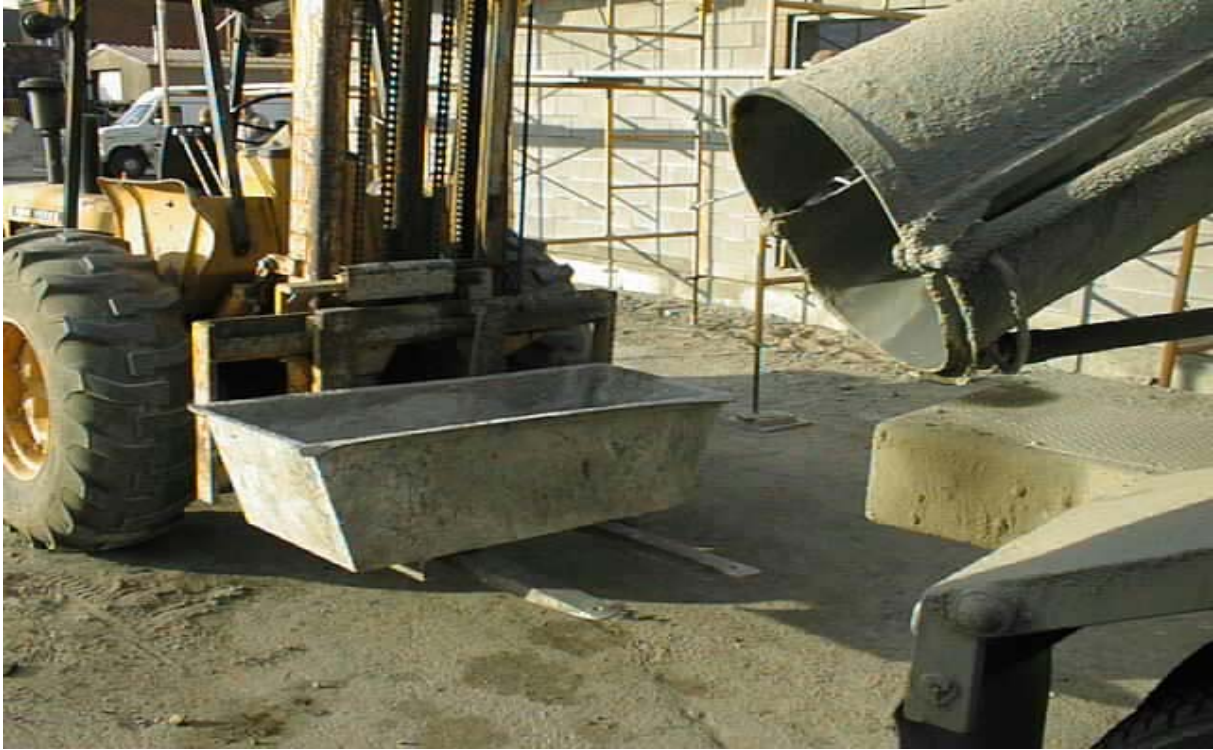
Picture # 6: Forklift and cement truck shortly after accident.

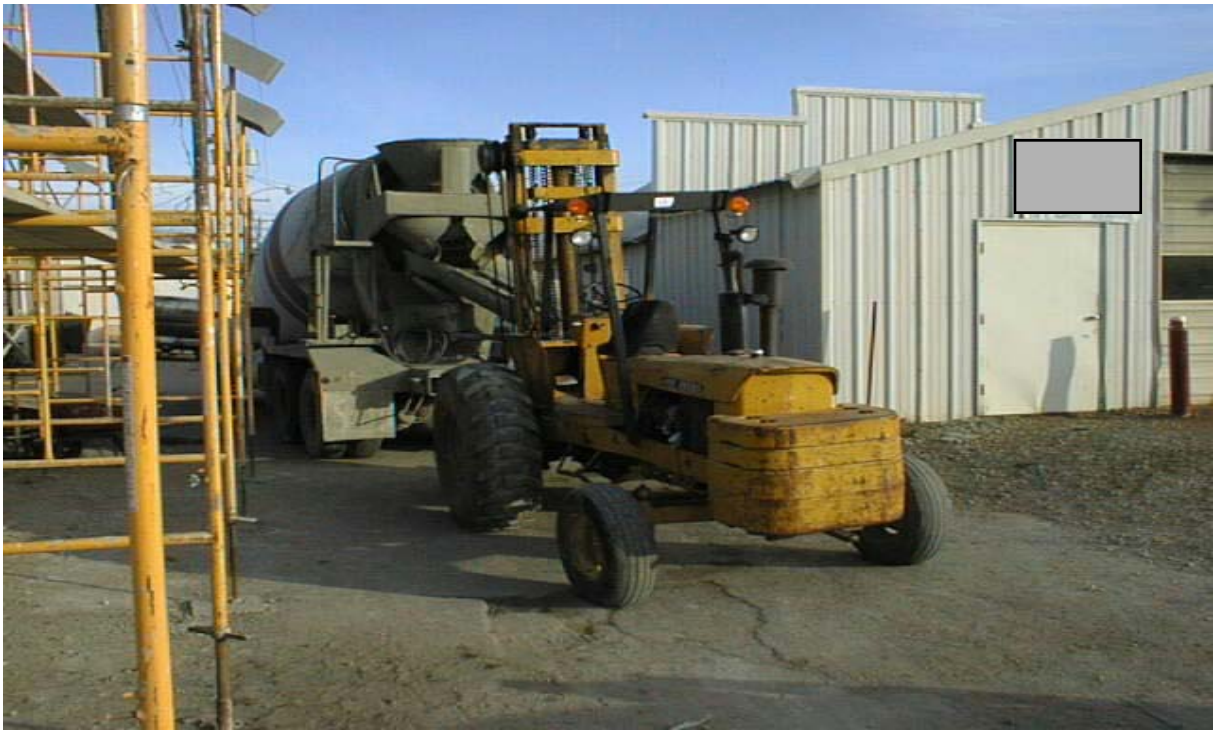
Conclusion: For the forklift to roll forward, the gear shift lever had to be in the NEUTRAL. The fact that the forklift's rear wheels were on an elevated lip at the road edge coupled with the vibration of the running forklift might have contributed to the forklift rolling forward.

Picture #7: Forklift facing north towards cement truck, taken shortly after accident.

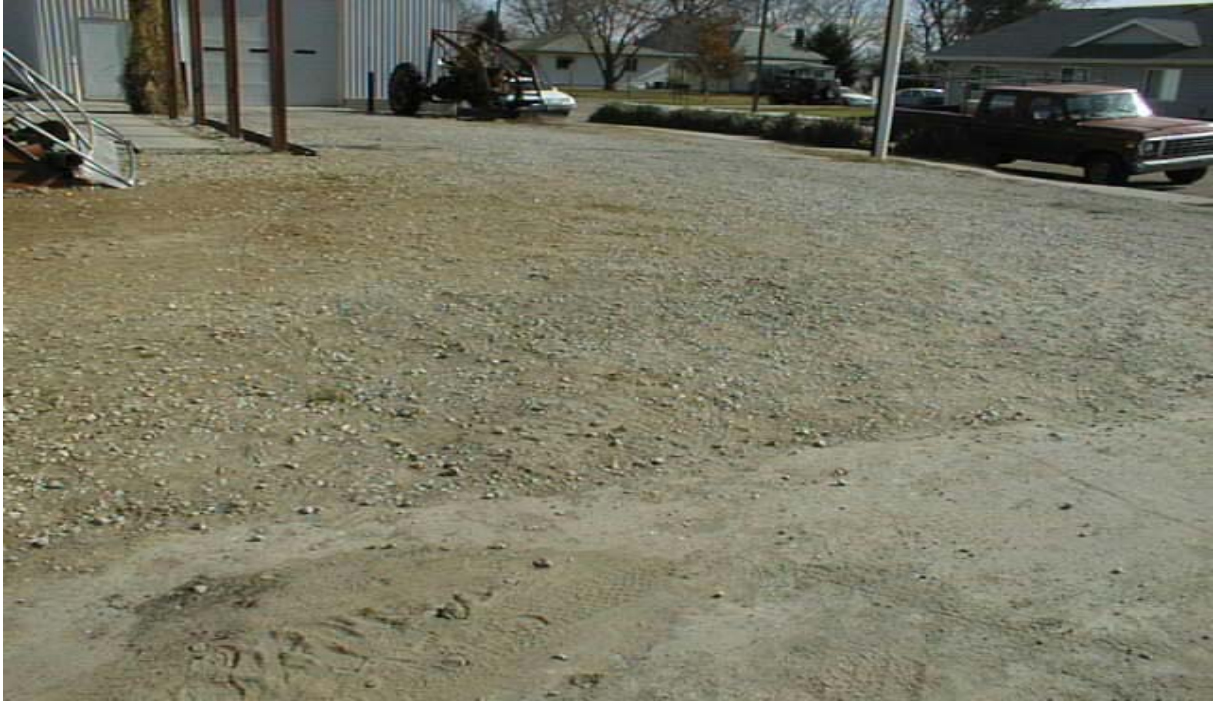
Worksite: The construction company was adding an addition to the rear of a grocery store. The alleyway where the incident occurred is at the rear of the store. The alleyway is concrete and fairly level, although it was cracked in numerous locations. The outer edges have a slight "cupping" or "lip", especially noticeable where the concrete meets the gravel driveway of an adjoining business's parking lot.

Picture #8: Shows adjacent gravel parking lot is slightly higher in elevation than alleyway.

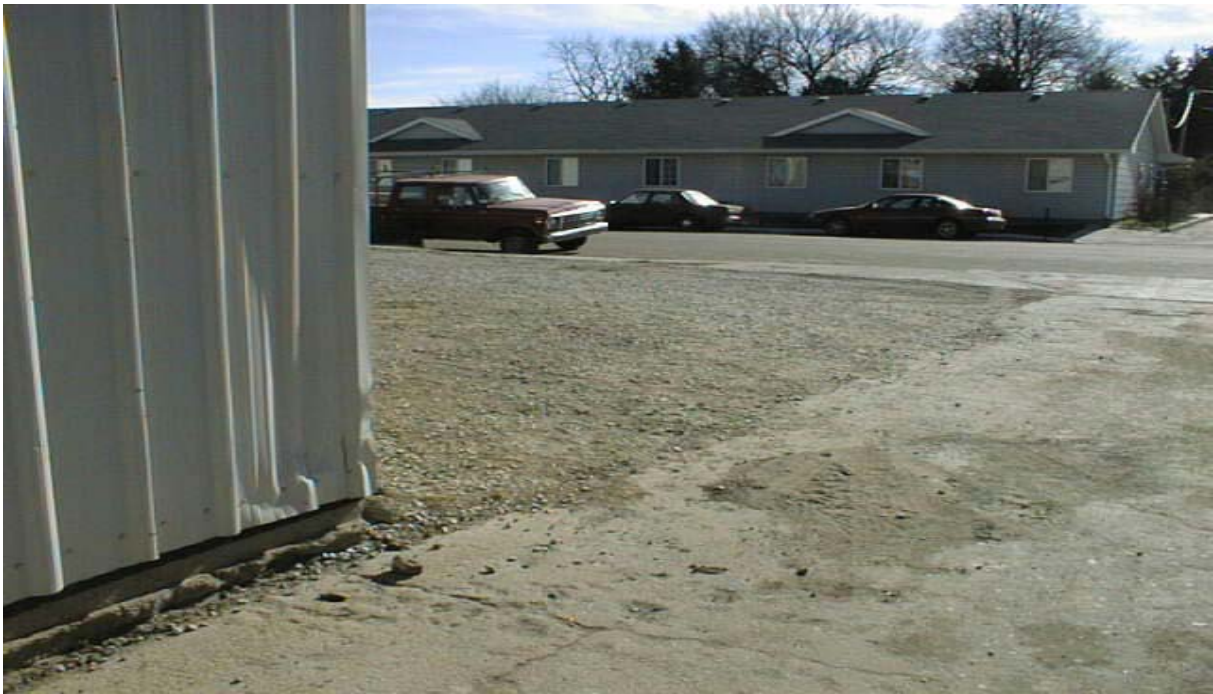
Picture #9: Shows adjacent gravel parking lot and alleyway, taken from spot where victim was located, looking south.
