January 25, 2002

Nebraska FACE Investigation 01NE026

Youth Landscaper Pinned Underneath Front End Loader

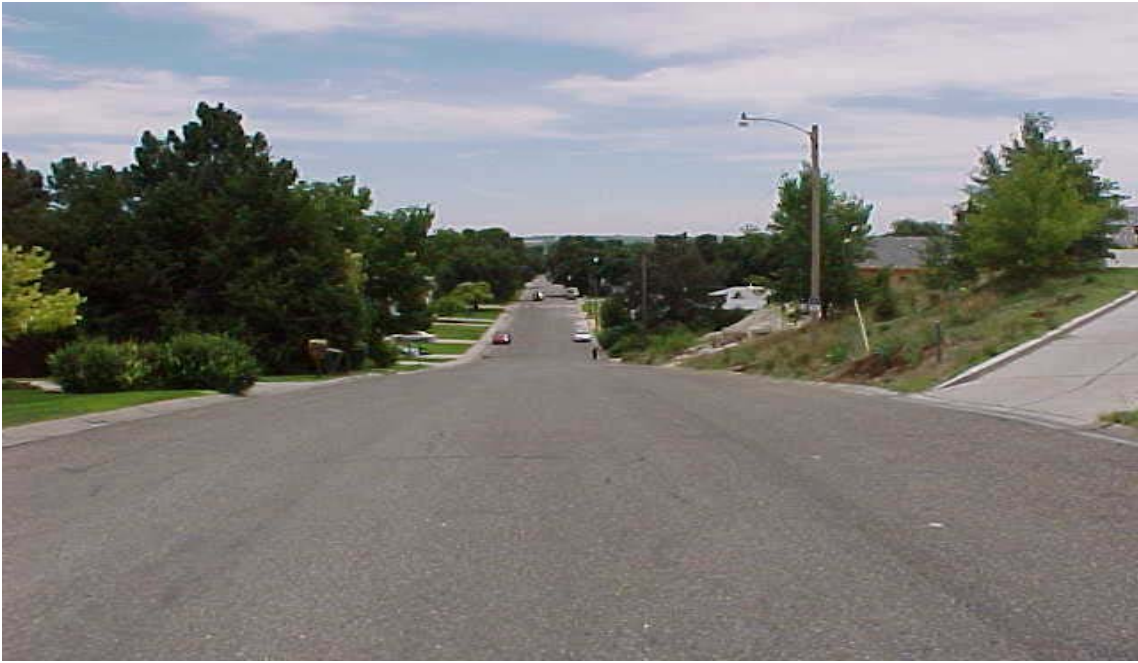
Photo #1. Looking south down the hill.

Discussion: Verbal instruction was given to the victim on the incident day pertaining to the job task, but not on which route to return on. The route used to access the work site does not have a hill with that much slope. If the employer and/or supervisor had been specific concerning the return route of travel, the incident may not have occurred.

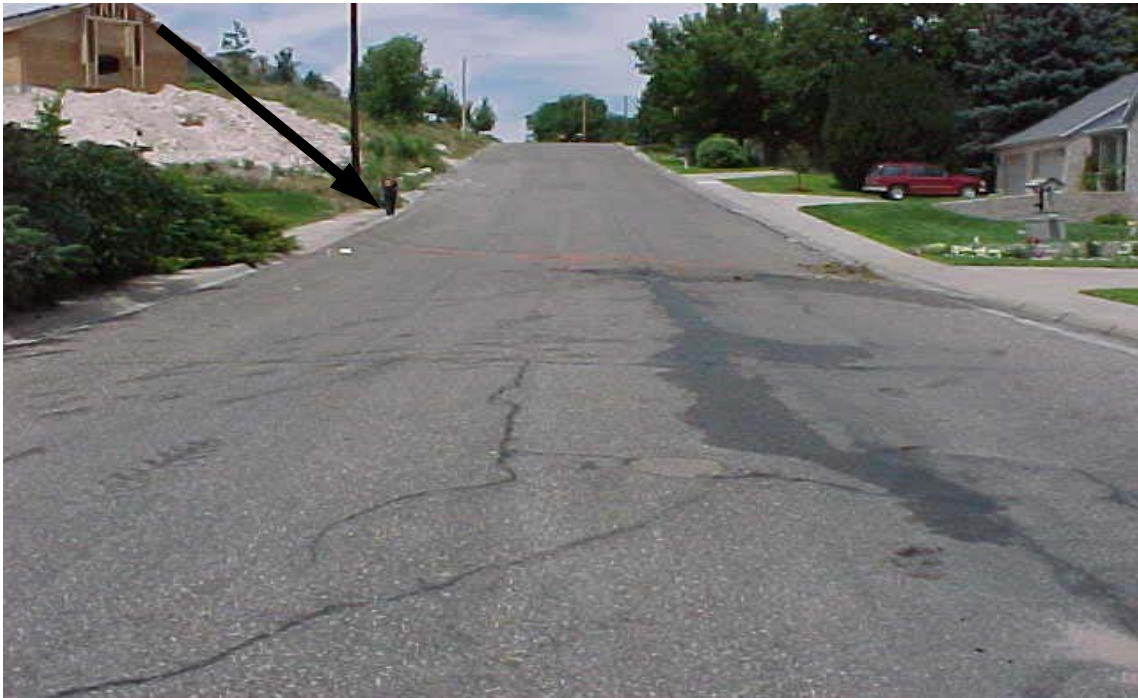
Photo #2. Looking north up the hill. Arrow indicates where equipment struck the cement curb.

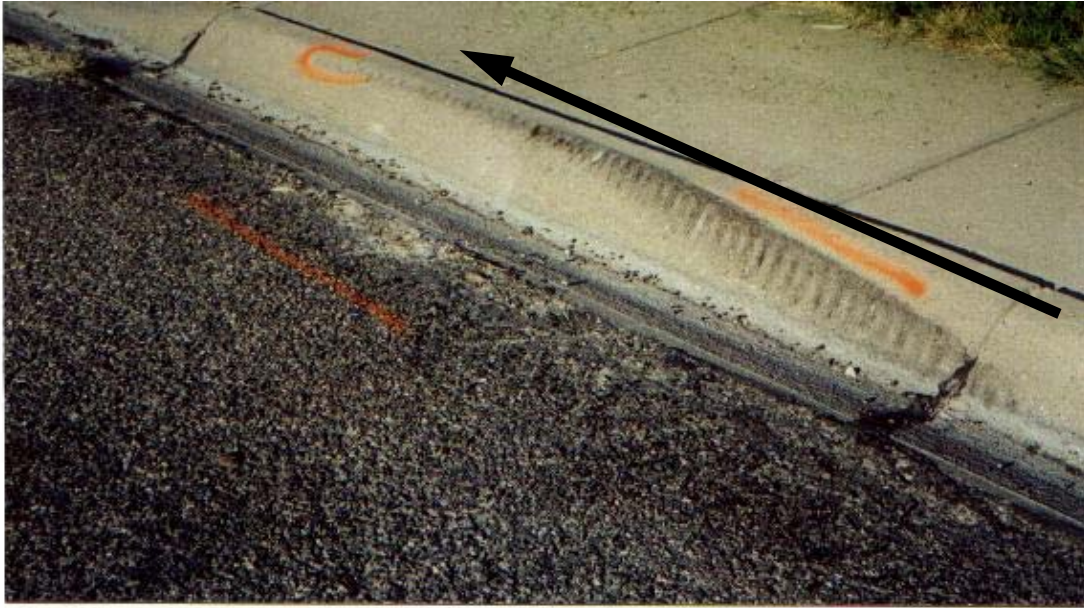
Photo #3. These are skid marks left when the machine veered to the right, striking the concrete curb. Arrow notes direction of equipment travel

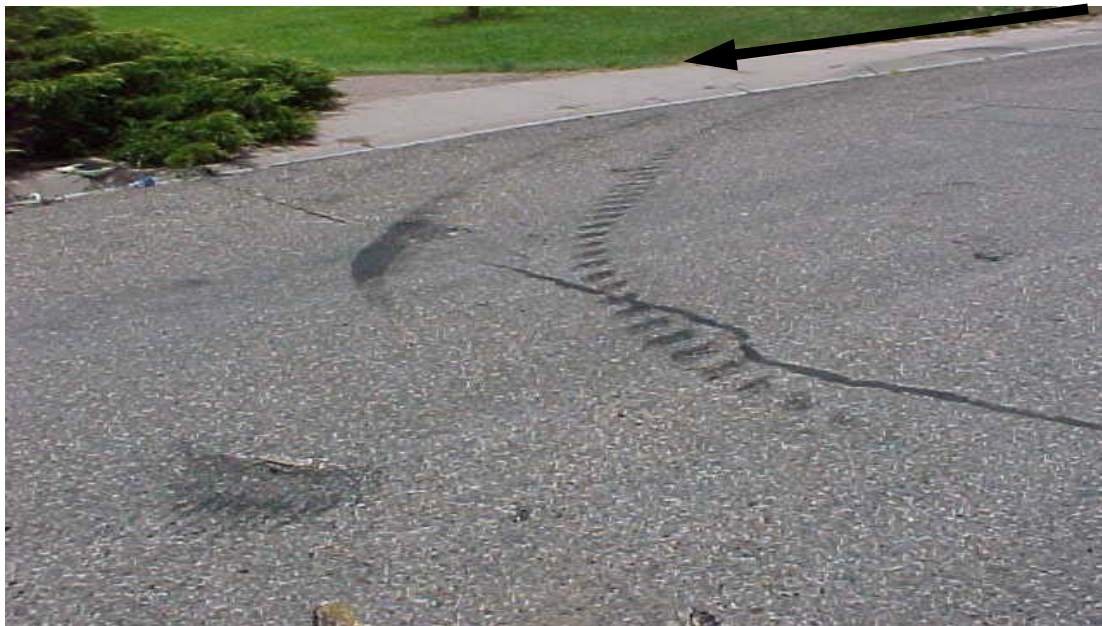
Photo #4. Tire skid marks left after equipment contacted concrete curve and veered to the left, before completing a 3/4 roll. Arrow notes direction of equipment travel.

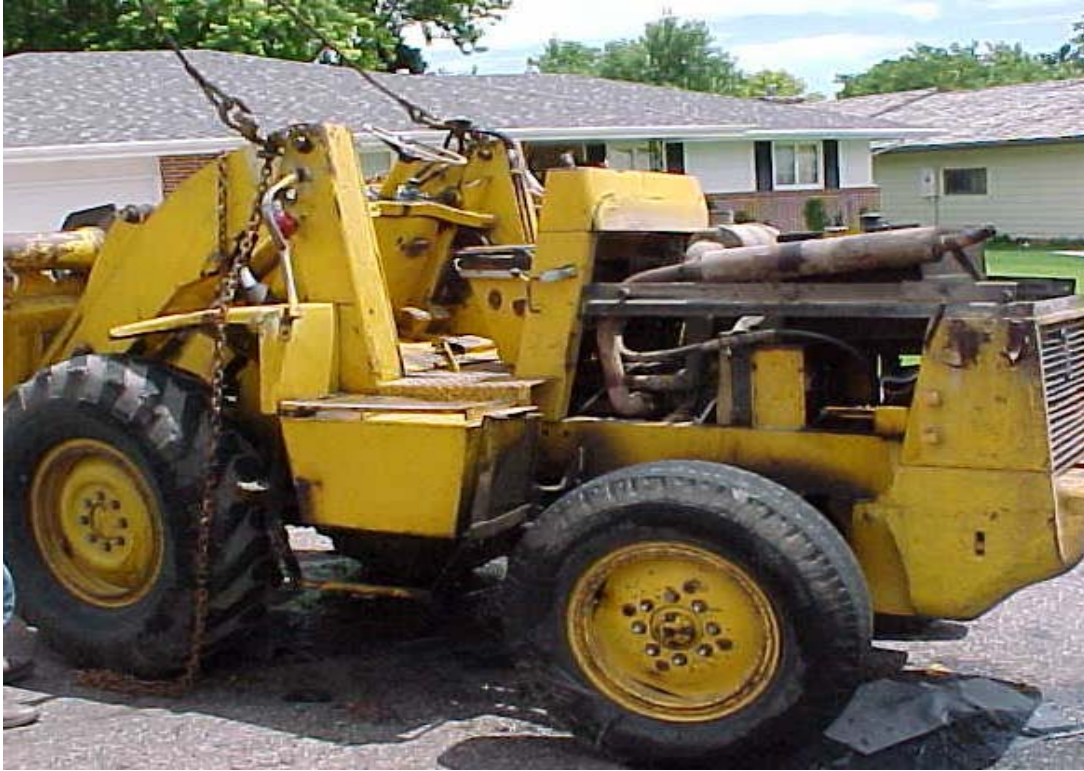
Equipment: The equipment involved in the incident was a Massey Ferguson MF 11 Front Wheel Drive Loader (**see photos #5 & #6**). It is powered by a Perkins A4-238 four cylinder diesel engine that supplies power via the transmission and torque converter to the front wheels.

Wheels/Tires: The front drive wheels are larger than the rear-steer wheels (**see photos #5 & 6**). The loader was originally equipped with 17.50 x 25 tires on the front and 9.00 x 20 tires on the rear. Due to the condition of the tires the investigator could not make out the sizes presently used. The front tires (drive) were worn down considerably (**see photos 9 & #10**). The rear tires (steering) had very little tread remaining. Both rear tires had chunks missing from the sides of the tread area (**see photos #12 & #14**). On the left rear tire there were 2 of 8 lug nuts missing (**see photo #11**). The lug bolts were rusty, indicating they had been gone for some time. The right rear tire was worn at an angle starting approximately in the middle of the tread area, sloping to the outside (**see photos #6 & #14**). Out of 8 lugs, one lug bolt and an additional lug nut were gone (**see photo #13**). Again, the bolt and empty hole were rusted over.

Photo #5. Left side view of equipment.

Discussion: The equipment involved in the accident had been purchased a few weeks before from another landscaping company, along with other pieces of equipment. When the mishap equipment was bought, it did not have the factory-equipped cab or four-point bar systems that served as rollover protection (ROPS). It is unknown when they were removed. If the ROPS and seat belt restraint system had still been in place and utilized, it is unlikely the victim would have been crushed.

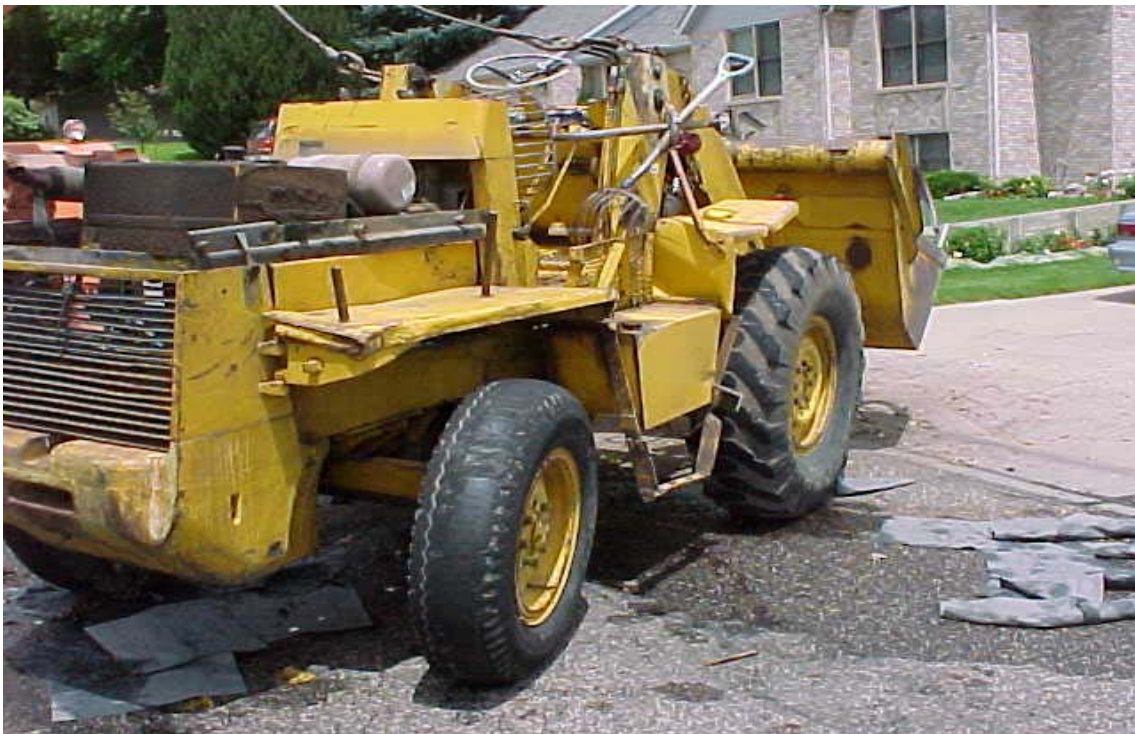
Photo #6. Right side view of equipment.

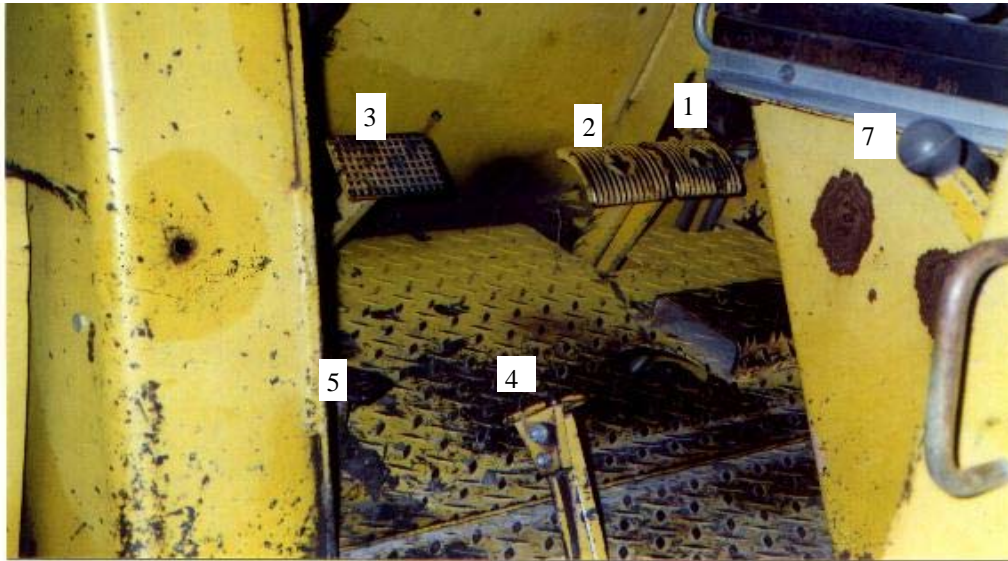
Photo #7.

Forward or reverse motion is selected by depressing the appropriate throttle pedal. These two pedals are located on the floor, upper right hand corner beside one another (**see photo #7**). Each has a molded arrow to indicate which direction they operate. The operator presses the left pedal for reverse and the right pedal for forward. Either pedal operates the fuel pump before it engages the appropriate set of clutches.

Brakes. The loader is fitted with a dual brake system on the front axle (drive wheels), having a pair of hydraulically operated disc brakes for normal use and a pair of mechanically operated wheel drum brakes for parking. Each disc brake is a fully enclosed, six plate, oil immersed unit operated by hydraulic fluid drawn from a reservoir situated at the floor level on the operator's left hand side. Each drum brake is a 14" x 2", two shoe, double acting, floating cam unit and is mechanically operated by a foot pedal. When depressed, this hydraulically operates the fully enclosed disc brakes. The foot pedal is located to the left side of the throttle pedals (**see photo #7**). The parking brake pedal is located on the left hand side of the operator's seat (**see photos #7 & 8**).

1. Forward throttle pedal.
2. Reverse throttle pedal.
3. Foot brake.
4. Parking brake.
5. Differential lock.
6. Dual range selector lever.
7. Gear shift lever.

Discussion: All employees should be trained on all equipment they are expected to utilize in performance of their tasks. Training should consist of written, verbal and hands-on task evaluation. The company did not have a copy of the Owners Manual for training/maintenance use. These manuals are available from the equipment distributors and can be used as part of the training program. There is a section that covers operating the equipment on hills and slopes. It is very specific on throttle placement and pedal control.

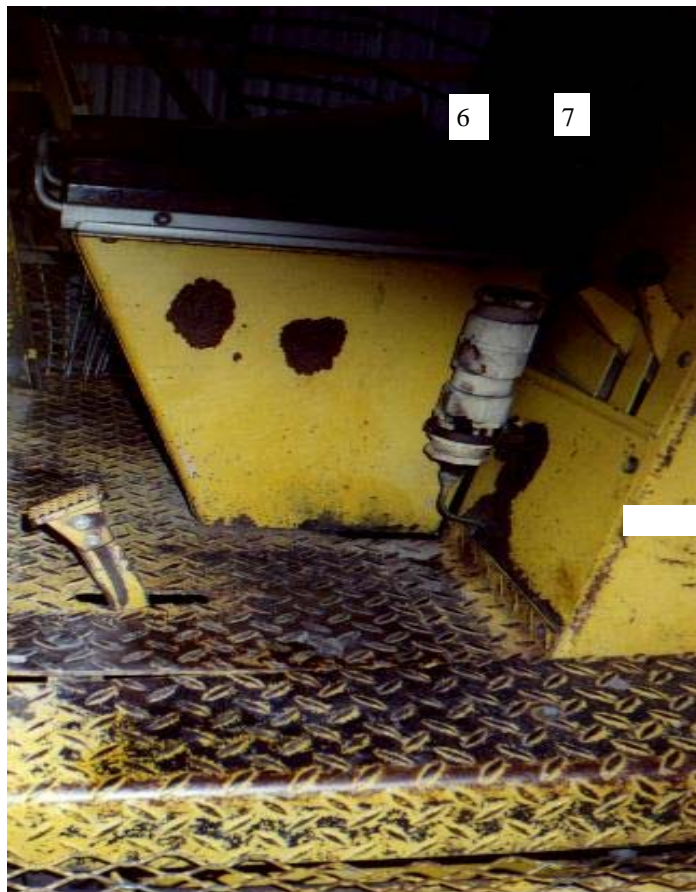
Photo #8.

The gear shift lever is situated at the lower left hand side of the operator (**see photos #7 & #8**). It operates a range of two gears. It moves down for the first gear and up for the second gear. When the lever is in the central position it is in neutral. **Note: pictures taken immediately after the mishap indicated this lever was in second gear.** The dual range selector lever is situated at the lower left hand side of the operator, next to the gear shift lever (**see photo #8**). The lever moves up for high range and down for low range. When the lever is in the central position it is in neutral. **Note: pictures taken immediately after the mishap indicated this lever was in the high range.** The overall dimensions for the loader are approximately 87" high without a cab, 183" long with bucket and 82" wide.

- Photo #8: Picture taken apx. 28 hours after the accident after equipment had been moved to impound lot. Shows position of dual range selector lever and gear shift lever.

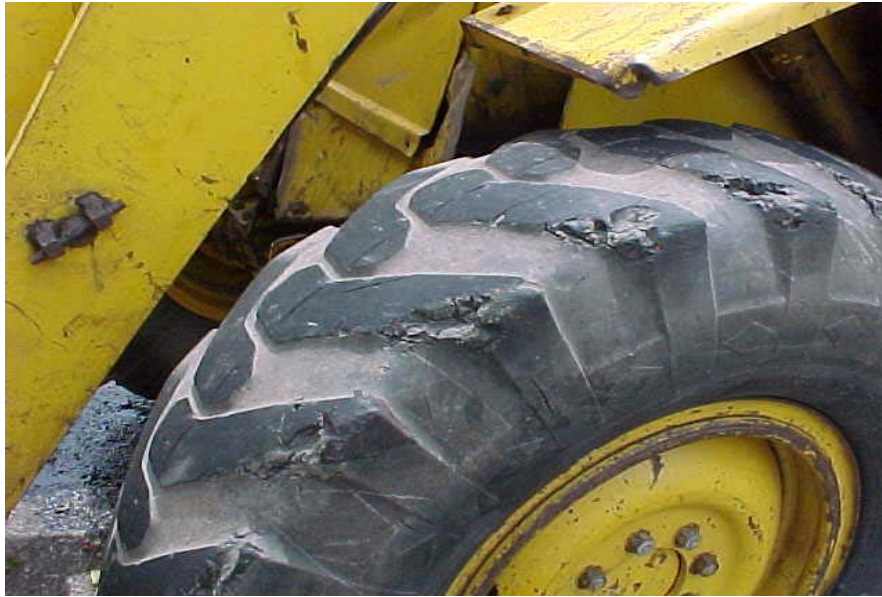
Photo #9. Left front-drive tire. Note missing tread and chunks of rubber.

Discussion: Since its purchase, no maintenance schedule had been established on this piece of equipment. No Owners Manual was received during purchase, which specifically lists the maintenance requirements for each equipment component including brakes and tires. The poor condition of the rear steer tires may have contributed to the loss of control experienced by the victim, allowing the equipment to veer to the right.

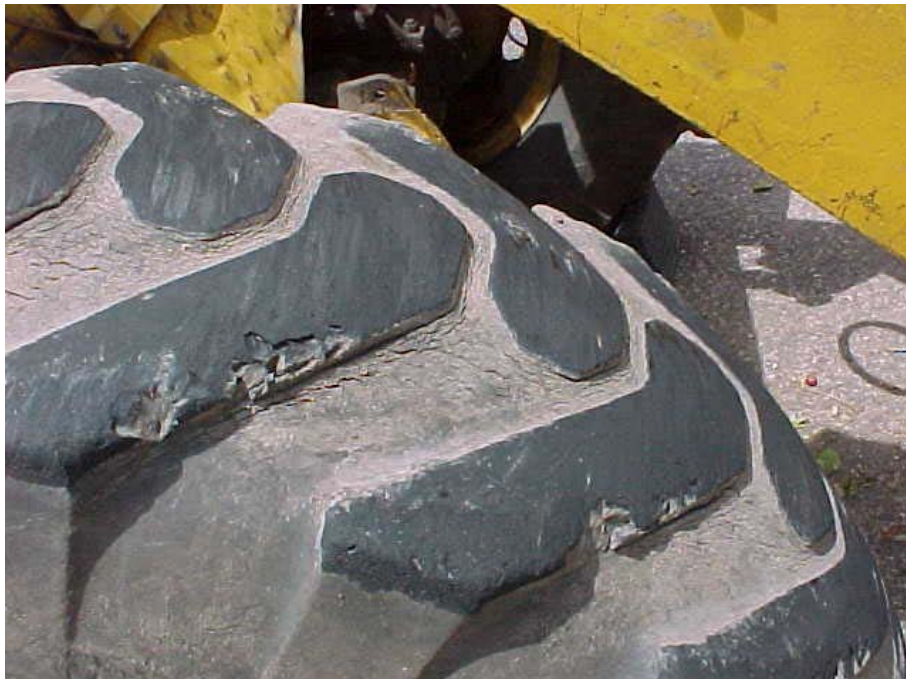
Photo #10. Right front-drive tire. Note missing tread and chunks of rubber.

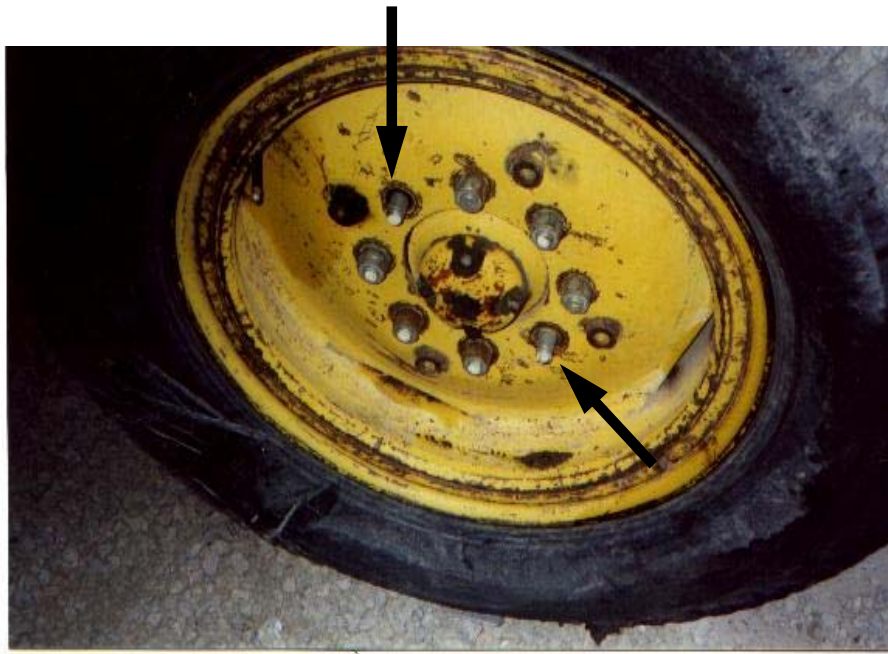
Photo #11. Left rear-steering wheel with two missing lug nuts.

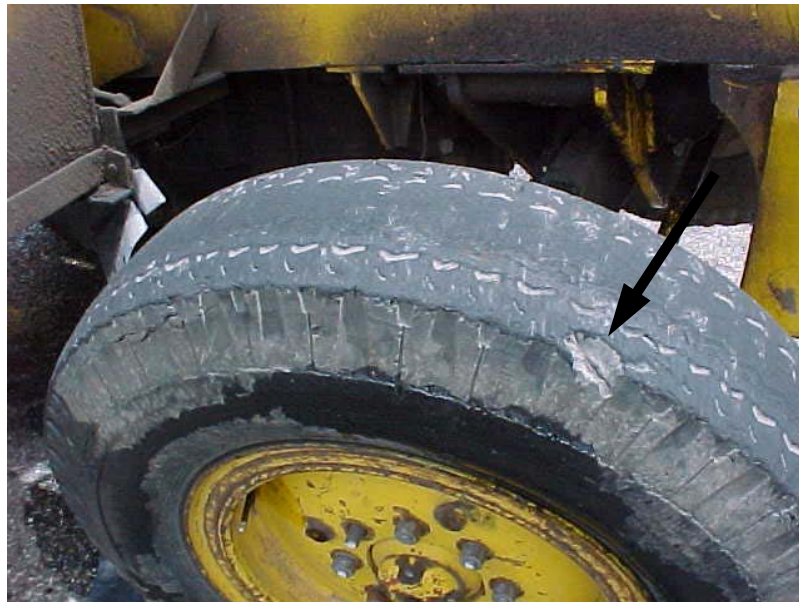
Photo #12. Left rear-steer wheel. Note the large chunk of rubber and most tread missing.

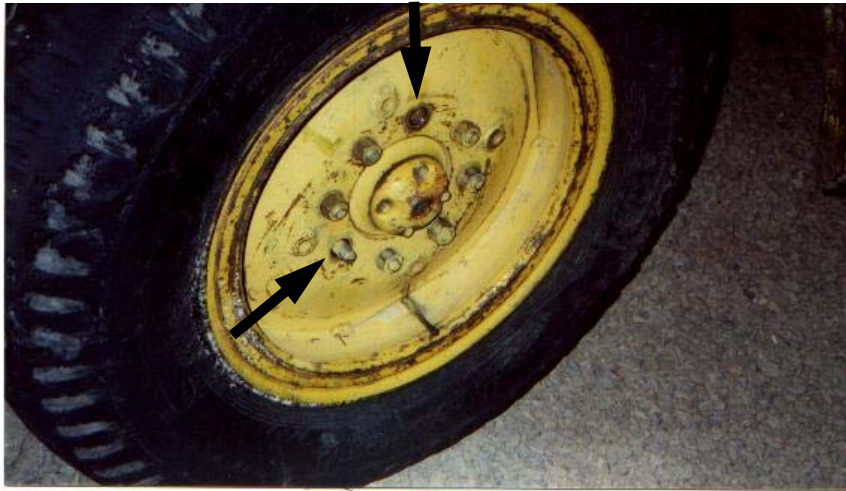
Photo #13. Right rear-steer tire showing missing lug bolt and lug nut.

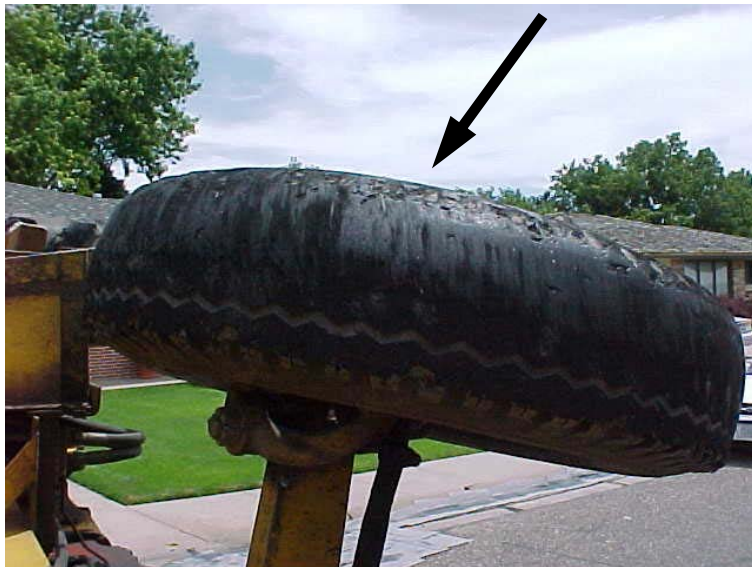
Photo #14. Right rear-steer tire showing missing tread and chunks of rubber missing from outside of tire.
