July 23, 2001

Nebraska FACE Investigation 01NE008

Snowplow Operator Caught Between Two Trucks

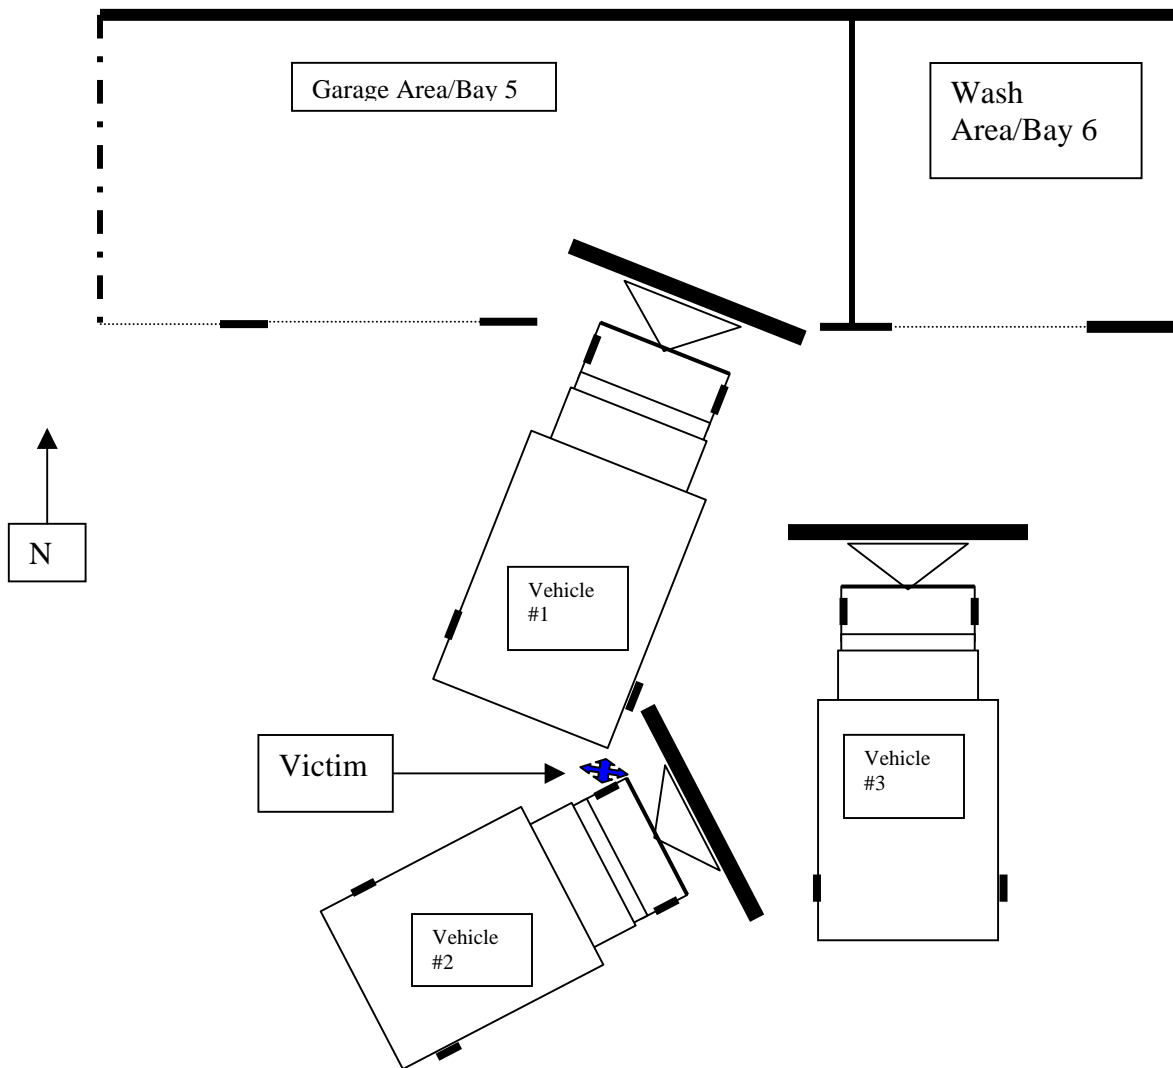
(See figure #1) The victim had parked his truck facing the bays (north), lined up slightly to the left of center to bay #6, the wash bay entrance. Before assuming his route duties, the victim was using a steam power washer to remove ice, dirt and debris from his truck's windshield and lights. He was standing beside his vehicle's front driver's side tire facing the truck. Operator #1 could not get the belt on his spreader to work properly, and was going to pull into bay #5, located next to the wash bay on the west (left) side. He was going to perform either minor maintenance or acquire a replacement vehicle if necessary. He exited his vehicle to go inside to raise the door, and told the victim his intentions. The victim acknowledged the warning and continued cleaning. Operator #1 opened the bay door, pulled in apx. three quarters of the vehicle length, but realized he was at too great an angle to the stall to proceed safely. The stall width was restricted approximately 3-4 feet due to several buckets and a barrel stored along the east (right) side wall. To continue would have caused the driver's side rear dual wheels to hit the door jam. He stopped his forward motion, placed the truck in reverse and immediately started backing out at an angle to square up to the stall. As he backed out, the plow blade did catch one of the buckets and drag it a short distance. He did not honk his horn to indicate he was backing up.

Figure #1 – Accident Site Diagram. This diagram represents the approximate positioning of all three vehicles at the time of impact. The X marks the area where the victim was standing.

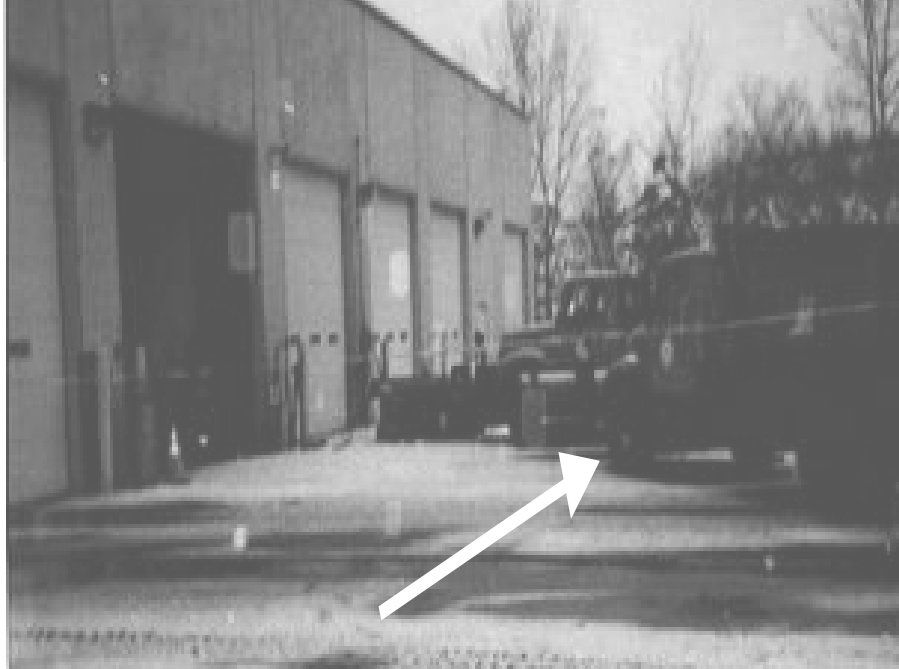
(See photo #1) At this same time, Operator #2 saw the victim using the steam power washer. He pulled up directly behind the space just vacated by Operator #1. His truck was pointed in a northeast direction adjacent to the front of bay door #5 at an angle facing the driver's side of the victim's truck. He rolled down his driver's side window and asked the victim if he would wash his ice covered windshield off also. The victim said "yeah" and walked over to the driver's side of truck #2 beside the front tire and started spraying the windshield, which left him facing away from vehicle #1 in the bay. Operator #2 rolled up his driver's side window, closed the wing window, then leaned over to ensure his passenger side window was rolled up completely and sat back upright. His headlights and plow lights were still on.

Photo #1. This picture shows vehicle #2 (foreground) and vehicle #3 (background) as they sat during the accident. Vehicle #1 is inside the bay (see open bay door).
NOTE: Arrows on Photos #1 and #2 point to where victim was standing.

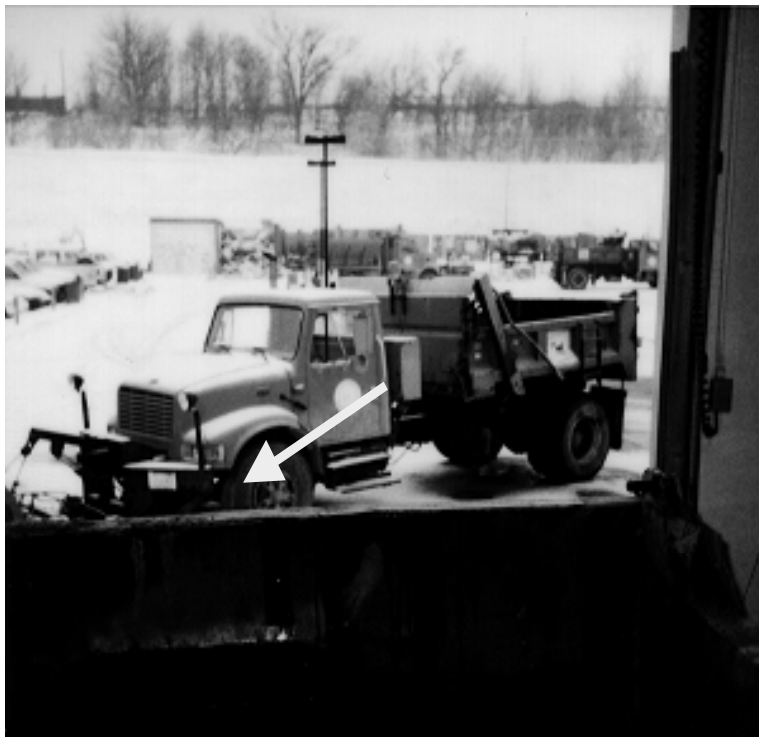
(See photo #2) At this same time, Operator #1 was backing up. He was looking at his driver's side mirror to ensure he cleared the door frame. When he looked out of his passenger side mirror, he was unable to see the victim or vehicle #2, but able to see the victim's truck cab lights. The victim just finished making a pass over Operator #2's windshield as Operator #2 sat back upright, seeing vehicle #1's backup lights through the receding water on his windshield.

Photo #2. This picture, taken from the box of vehicle #1, shows the close proximity to vehicle #2. This picture was taken when vehicle #1 was completely inside the maintenance bay.

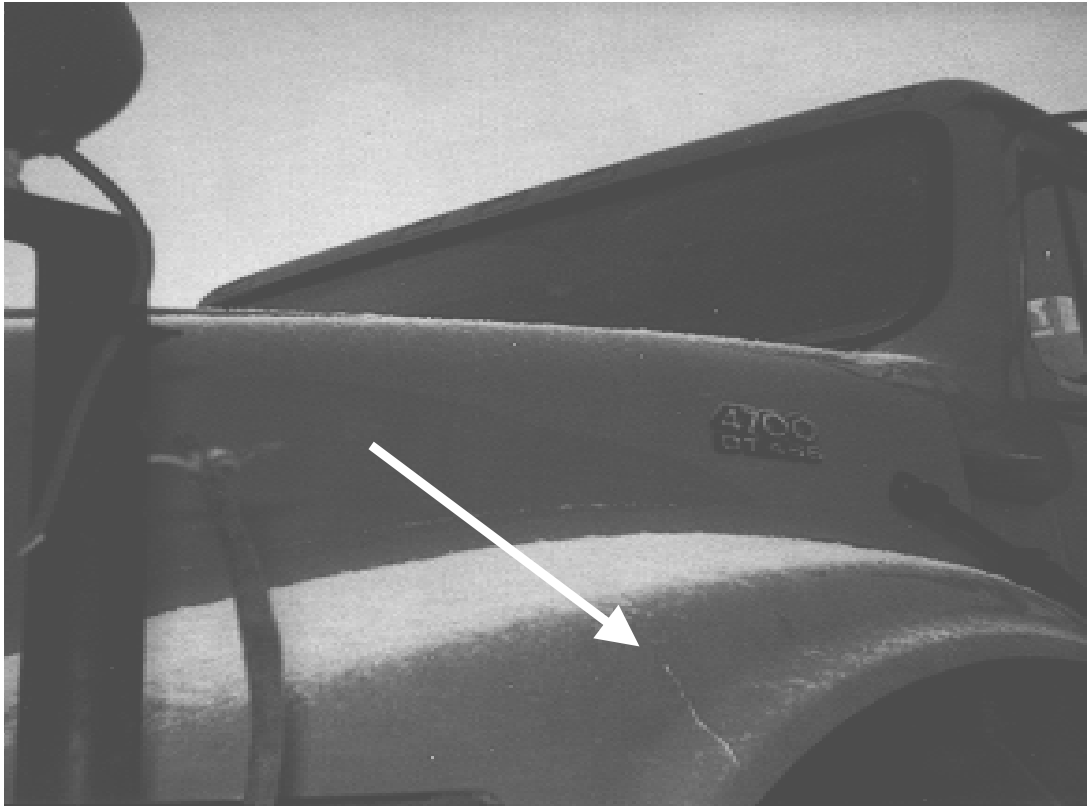
Post accident investigation was conducted by the employer's safety personnel and local law enforcement. Vehicle #1's backup alarm was tested and in proper order. This alarm activates when the transmission is placed into reverse, and continues to sound until the transmission is shifted to another gear. The truck does not have to be in motion for it to sound. The mirrors were also properly adjusted, although dirty. All tail, backup and break lights were functioning properly. The only new damage to either vehicle #1 or vehicle #2 consisted of a new crack and smudge mark in the fiberglass fender of vehicle #2, directly over the left front wheel area (**See photo #3**). The crack still had fresh, minute fiberglass particles sticking from it. It is believed that this is the area where the victim was pinned between the trucks.

Photo #3. This is vehicle #2's front driver's side fender where the point of impact occurred. Note the crack in the fiberglass fender. Arrow points to crack in fiberglass fender.
