April 25, 2001

Nebraska FACE Investigation 00NE050

Steel Erector Falls From Scissors Lift

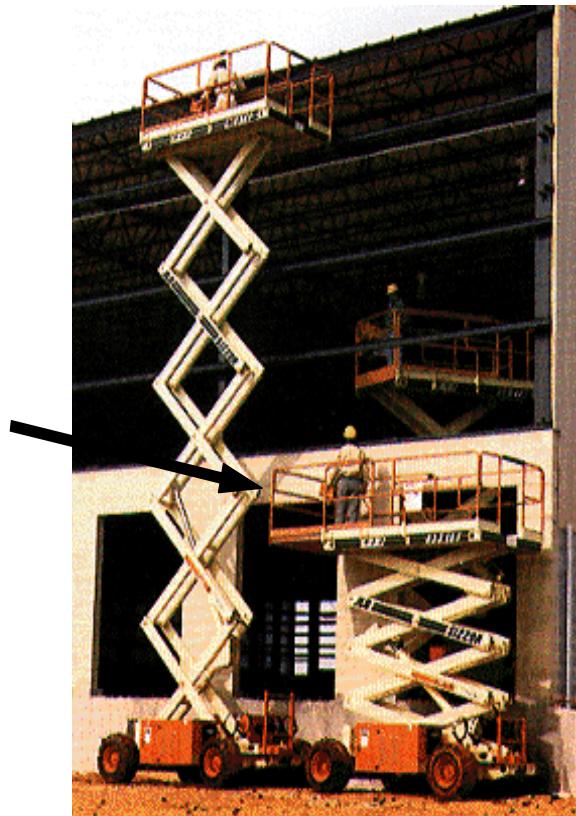
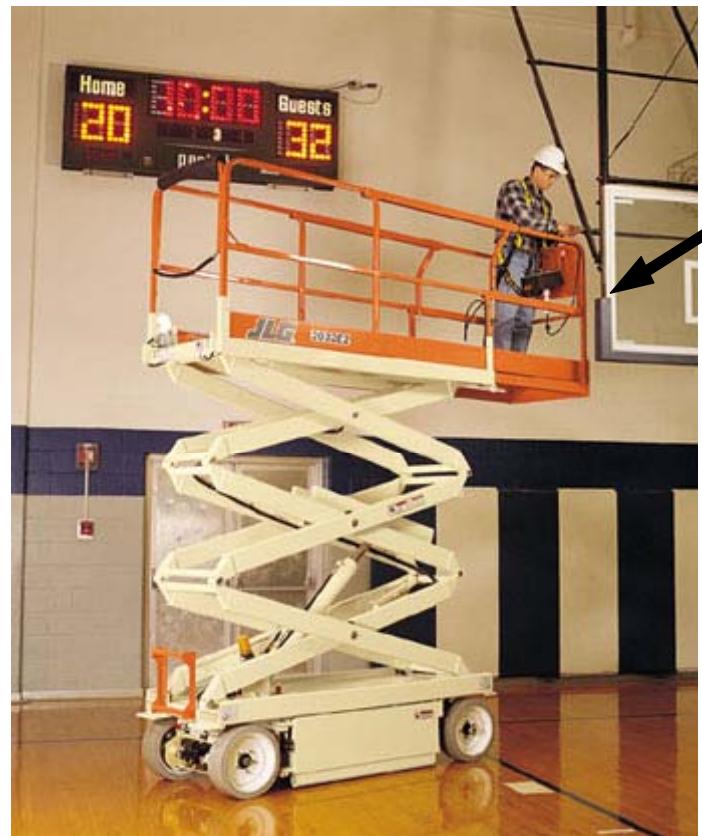
Photo #1

Examples of lifts with extension platforms in the extended position.
