January 31, 2001

Nebraska FACE Investigation 00NE034

Construction Zone Worker Hit By Gravel Truck

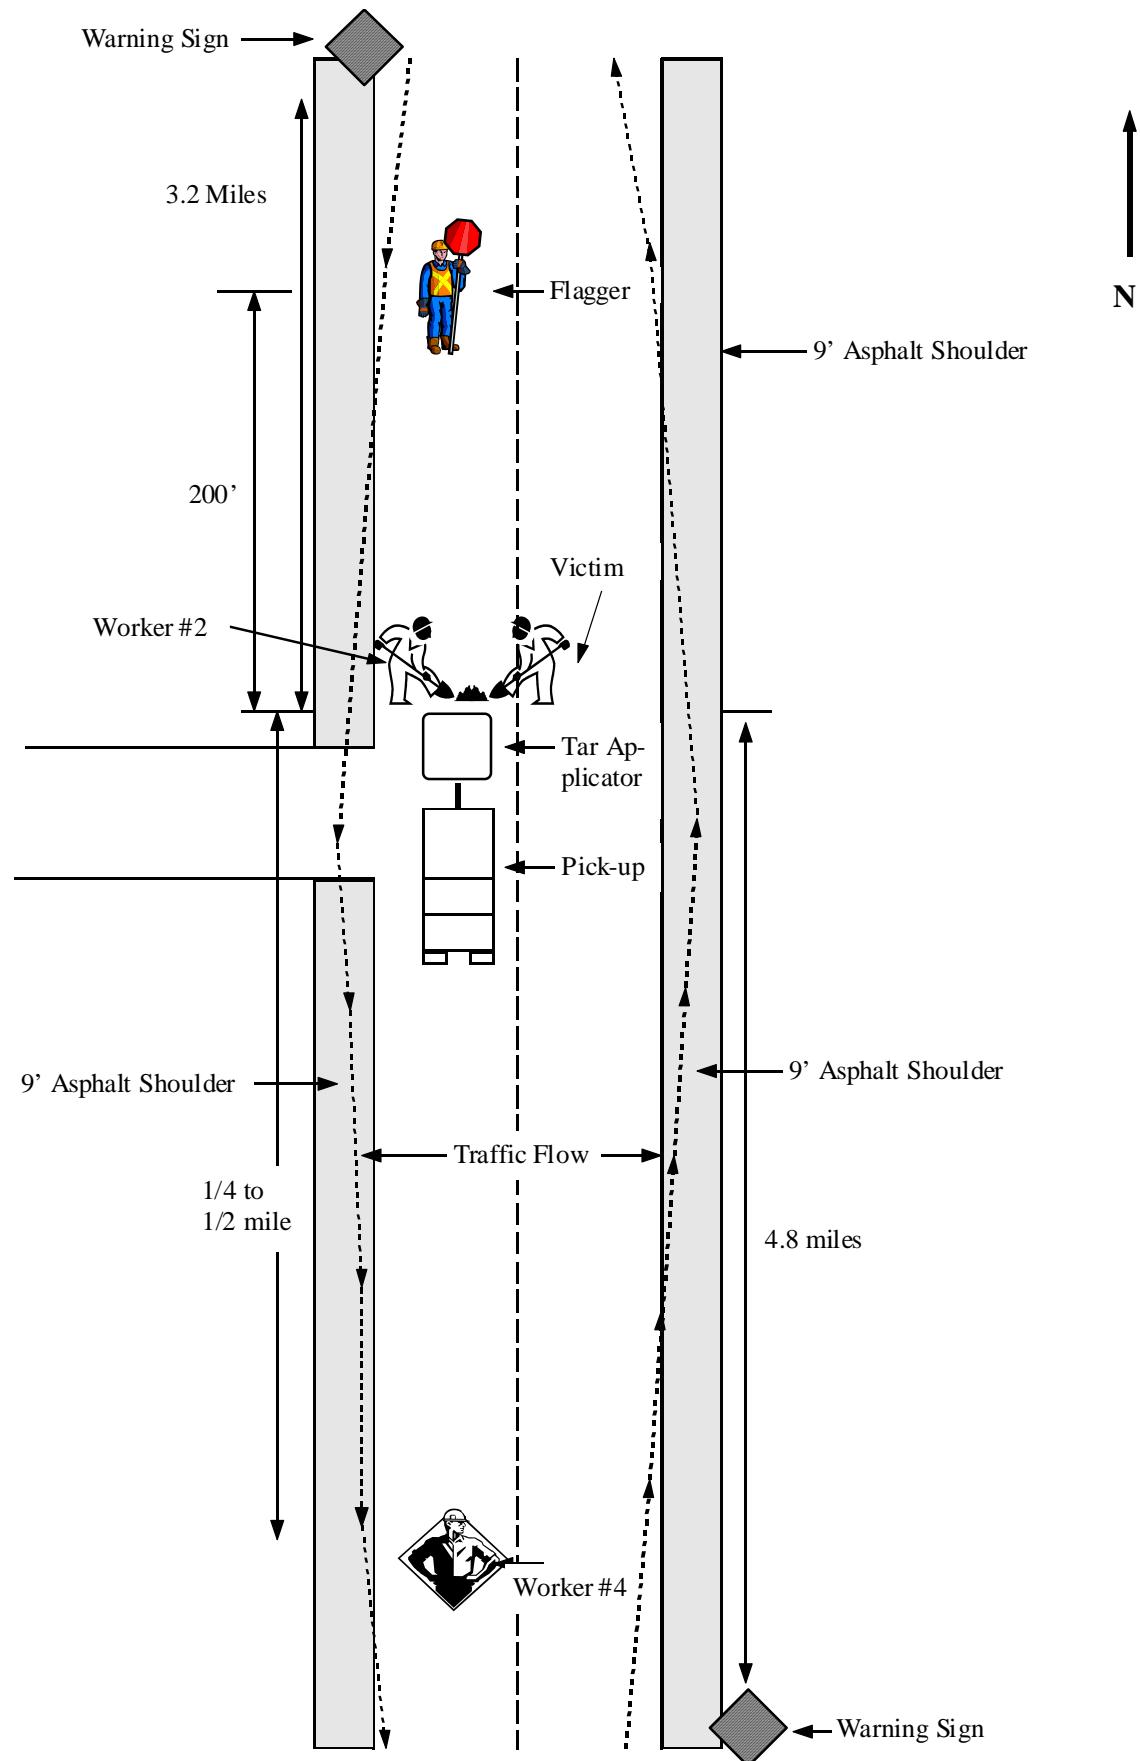
There were 4 workers from this company involved with filling the cracks. Worker #1 (victim) and worker #2 were operating the tar applicator, which was parked in the southbound lane attached to the pickup. Worker #3 (flag person) was approximately 200 feet north of the mishap site, standing in the middle of the southbound lane. Worker #4 was approximately one quarter to one half mile south of the accident site also in the southbound lane using compressed air to remove any foreign debris that may have accumulated in the cracks. Southbound traffic was being diverted by the flagger to the southbound (west) shoulder. Northbound traffic was uncontrolled. The tar applicator and pickup truck were also in the southbound lane. This created an "island effect" for the work crew. The gravel truck driven by Operator #1 is a 1995 International Model 920, which was towing a "pup" 1979 Fruehauf trailer. The truck was in good mechanical condition.

Figure 1— Incident Scene Prior to Impact
(Drawing Not to Scale)

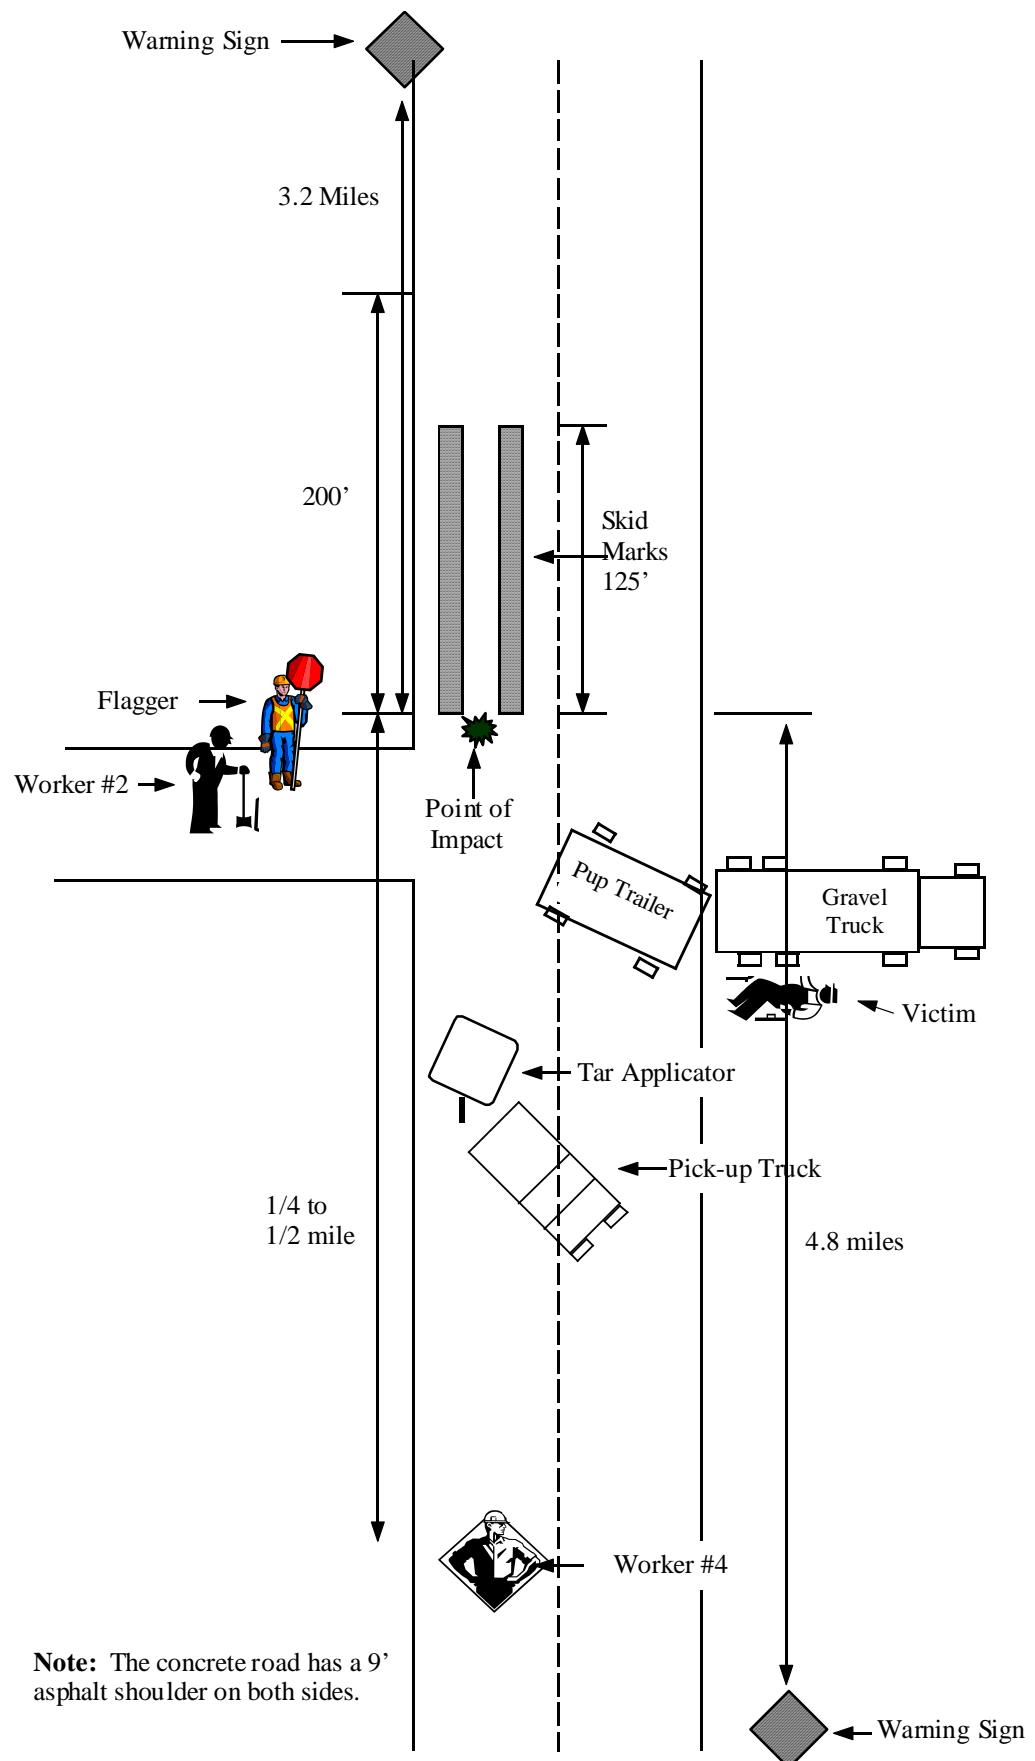
As the gravel truck approached the work site at approximately 50 mph (posted limit), Operator #1 saw the flagger in the middle of the southbound lane just as she turned the sign from STOP to SLOW. He applied his brakes hard and started to skid straight towards the work site. The flagger realized the truck was not going to stop in time and yelled a warning to the other workers. She ran to the west, across the shoulder into the ditch and escaped. The victim and worker #2 had just finished filling the center crack and had shut the tar wand off, preparing to move south several feet to the next crack. The victim and worker #2 heard the verbal warning and attempted escape in different directions. Worker #2 also ran west into the ditch and escaped. The victim attempted to run to the east across the northbound lane. The truck continued in a straight skid until the last few seconds when it started to jackknife, turning counterclockwise and angling towards the opposite lane. The victim was caught between the outside dual passenger rear axle/tire and the tar applicator machine, knocking him onto the east roadway shoulder. The truck came to rest facing due east with the rear wheels on the shoulder and the front wheels off the roadway. The "pup" trailer was facing southeast. The pickup truck and tar applicator were shoved ahead and came to rest facing east and southwest respectively. The tongue on the applicator was broken by the impact and the pickup and applicator were not attached at the hitch. Rescue personnel were called by a motorist and arrived within minutes. The victim was pronounced dead at the scene. The truck operator was issued a citation for Motor Vehicle Homicide.

Figure 2— Incident Scene After Impact
(Drawing Not to Scale)
