Nebraska FACE Investigation 00NE016

Equipment Operator Drowns in Canal

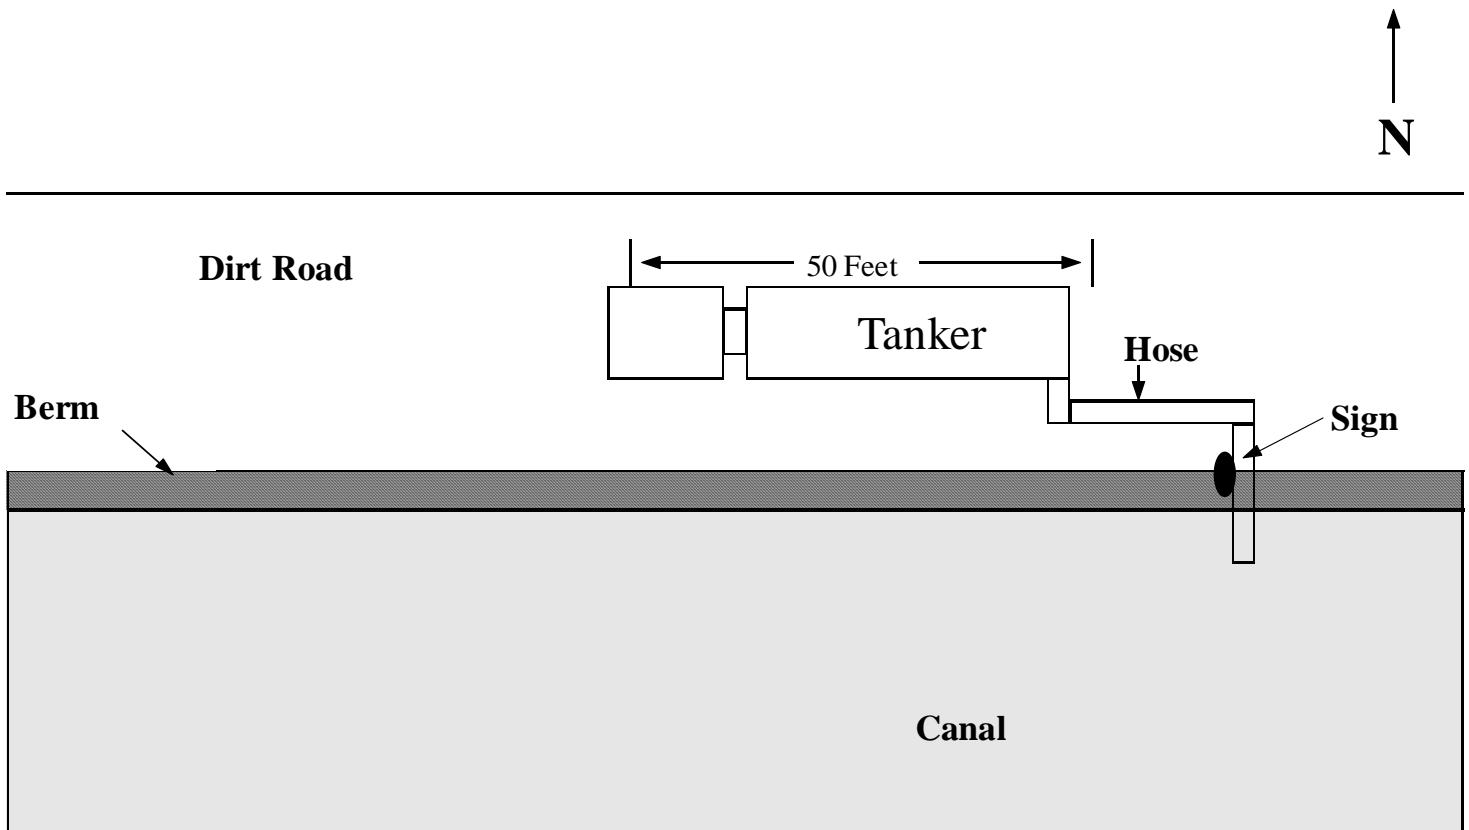
Standard procedure for filling the tanker, at the incident location, is to pull the tanker up parallel to the canal and connect one end of the fill hose to the tanker. The other end of the hose is in the canal. The hose is tied to a "Stop Ahead" sign to keep it from moving around (see figure 1).

Figure 1—Location of Tanker Prior to Incident

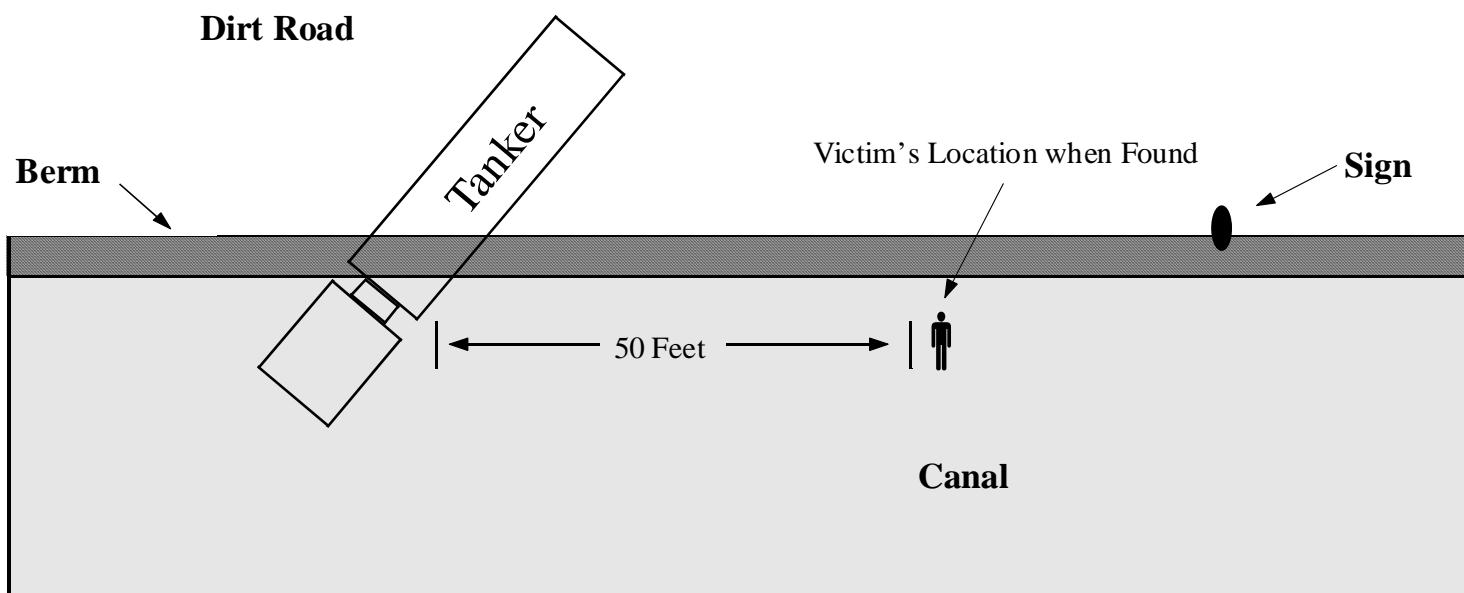
On the day of the incident, an employee of another company noticed that the tanker was in the canal (see figure 2). This individual notified a representative of the incident company who responded to the scene. The victim was discovered about 50 feet east of the cab of the tanker, which was underwater. The canal was flowing from west to east. Either the victim was swept out of the cab by the flowing water or he got out of the cab and was possibly attempting to return to shore. Rescue personnel were called and the victim was transported to a hospital where he died two days later.

When the truck was pulled out of the canal, it was in 8th gear and the emergency brake was set. Standard procedure was to have the transmission in neutral with the brakes set. Although the brake was set we cannot be sure it was set prior to the tanker rolling into the canal. It could have set itself due to lack of air pressure.

Two plausible scenarios are: 1. The victim had prepared the tanker for refilling and returned to the cab. While in the cab he revved up the engine to get the water pumping. With the transmission in 8th gear, the tanker could have lunged forward into the canal. 2. The victim could have suffered a heart attack or seizure and stepped on the gas pedal, running the tanker into the canal. An autopsy was not performed, however the victim was a diabetic and was on several types of medications.

Figure 2—Location of Tanker After Incident

Recommendation #1: **Employers and employees should ensure the transmission on the water tanker is placed in neutral and the emergency brake set during water filling.**

Recommendation #2: **Employers and employees should ensure the wheels on the tanker are chocked.**

Recommendation #3: **Employers and employees should ensure the wheels on the tanker are turned away from the canal, or other water source.**
