Nebraska FACE Investigation 99NE017

Machine Operator Crushed by Robotic Platform

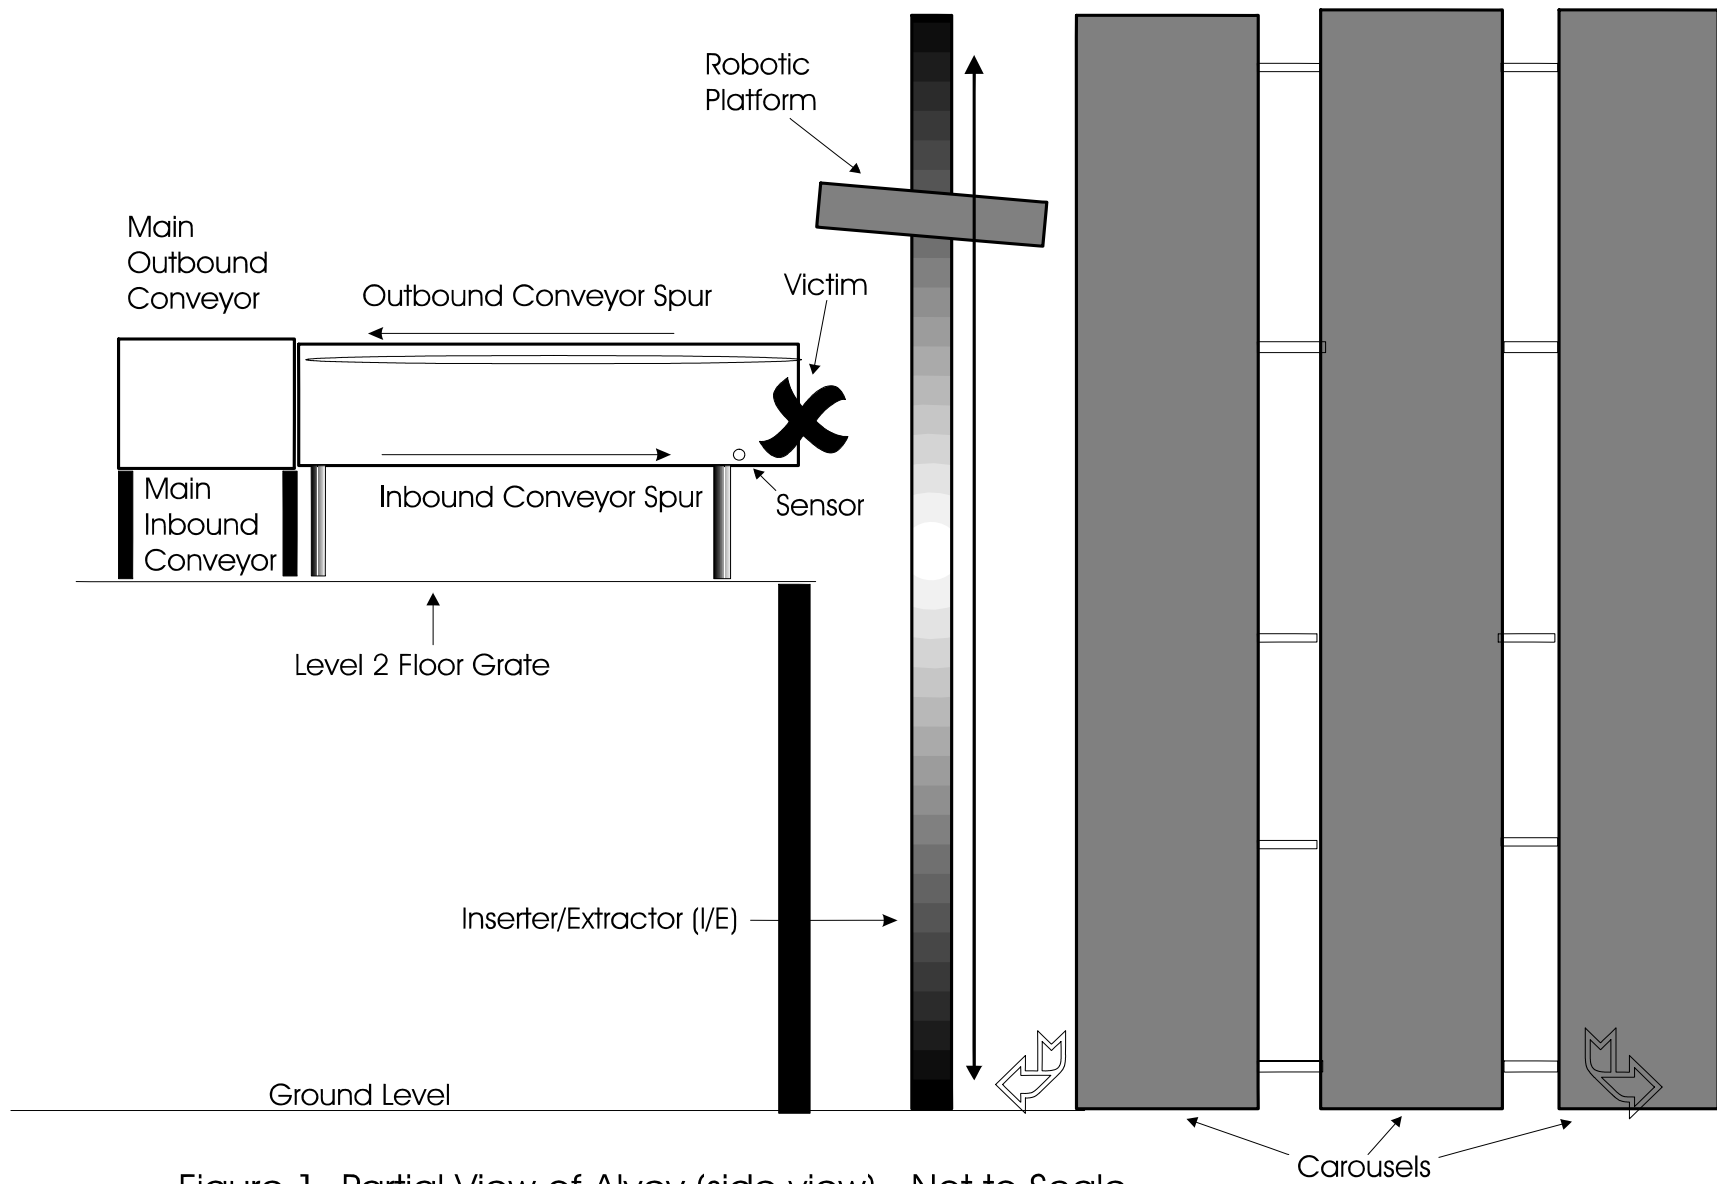
Figure 1- Partial View of Alvey (side view) - Not to Scale

The victim was apparently interested in watching worker #1 perform maintenance and went to the upper level to observe. Apparently to get a better view of the maintenance being done on the outbound conveyor spur, the victim stepped on the inbound conveyor spur (see figures 1 & 2). Toward the end of the conveyor spur is a light sensor. This sensor is designed to be triggered when a box breaks a light beam. This indicates to the system that a box is ready to be picked up and put on the carousel. A robotic platform (which is part of the I/E) then moves up or down, depending on where it was, to extract the box and insert it into the carousel.

Apparently when the victim stepped on the inbound conveyor spur, which is located below the outbound conveyor spur, his foot triggered the light sensor and the robotic platform (which weighs approximately 300 pounds) came down from above. It traveled a distance of between 10 to 15 feet and struck the victim in the head, doubling him over on the conveyor. Worker #1 went to level one to remove power from the robot so it could be removed from the victim. He was not able to get the robot to go back up at this time and told another coworker to call 911. Employees tried to move the platform from the victim manually, but to no avail. The main controls to the I/E were cycled and the

Discussion: A protective grate around access to the robotic platform at the end of each conveyor spur would enhance employees protection in that area. The grate could protect employees from getting any part of their body into the movement area of the robotic platform. An access gate could be installed in the grate with a micro switch that would remove power to the I/E when the gate is opened. **NOTE:** This company has already implemented this recommendation.
