SUBJECT: Two maintenance mechanics died when a suspended steel dock plate fell on them.

California FACE Report #04CA013

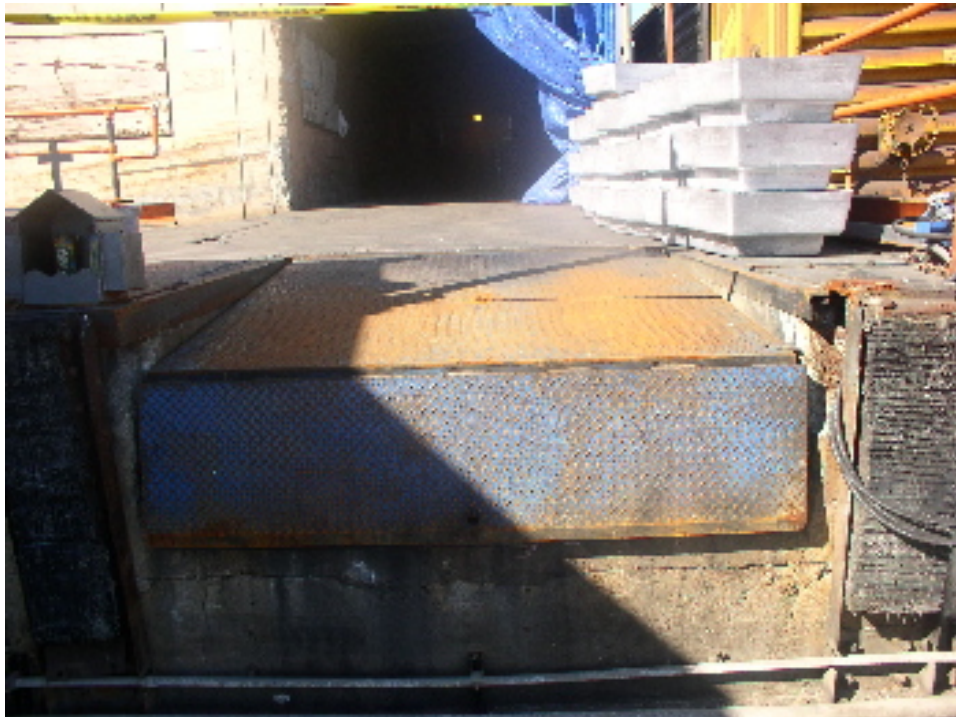
The site of the incident was a loading dock at the rear of the business. The mechanical device involved in this incident was a piece of machinery referred to as a “dock leveler.” Dock levelers allow forklifts to enter and exit the beds of trucks and trailers by bridging the gap between the loading dock and truck beds and trailers. The hydraulic mechanism that raised and lowered the dock plate was underneath the plate. The plate also had a safety bar attached to its underside that, when engaged, supported the plate.

Exhibit 1
The dock leveler involved in this incident

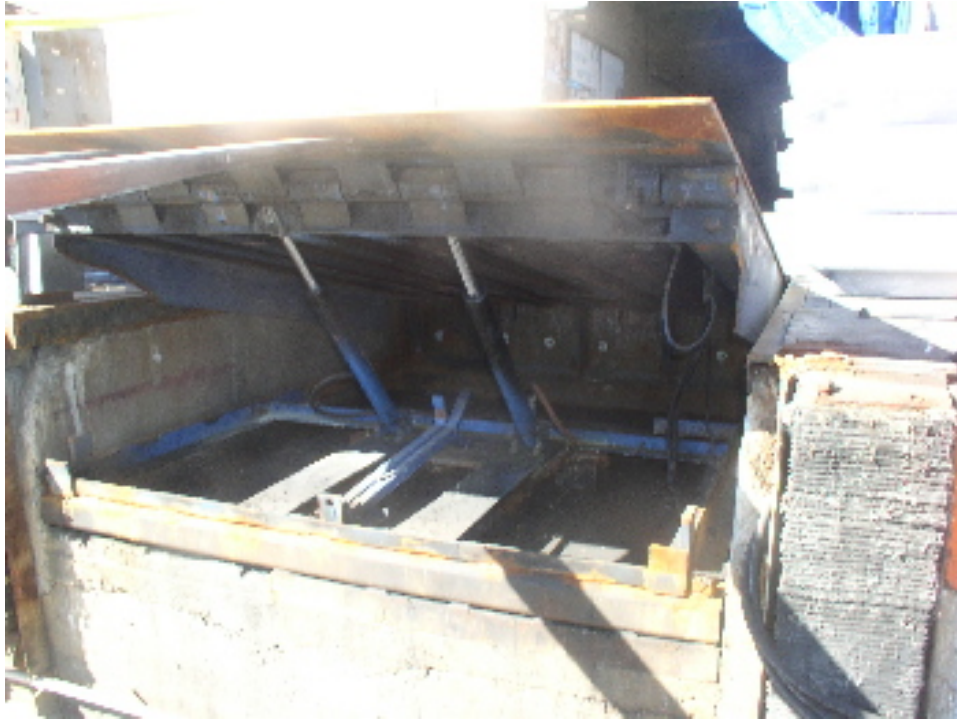
Exhibit 2

The dock leveler in the raised position supported by a forklift showing the area underneath the dock plate.

Discussion: The company had a standard procedure for the removal, repair, and replacement of the dock levelers. The replacement portion of the procedure required the use of a forklift to raise and hold the dock plate until it was secured in place with the built-in safety bar. This procedure was one that had been developed by the dock leveler manufacturer and had been used in the past without incident. If a standard procedure is going to be changed, a thorough analysis of the changes should be performed prior to implementation to ensure that any hazards are abated.

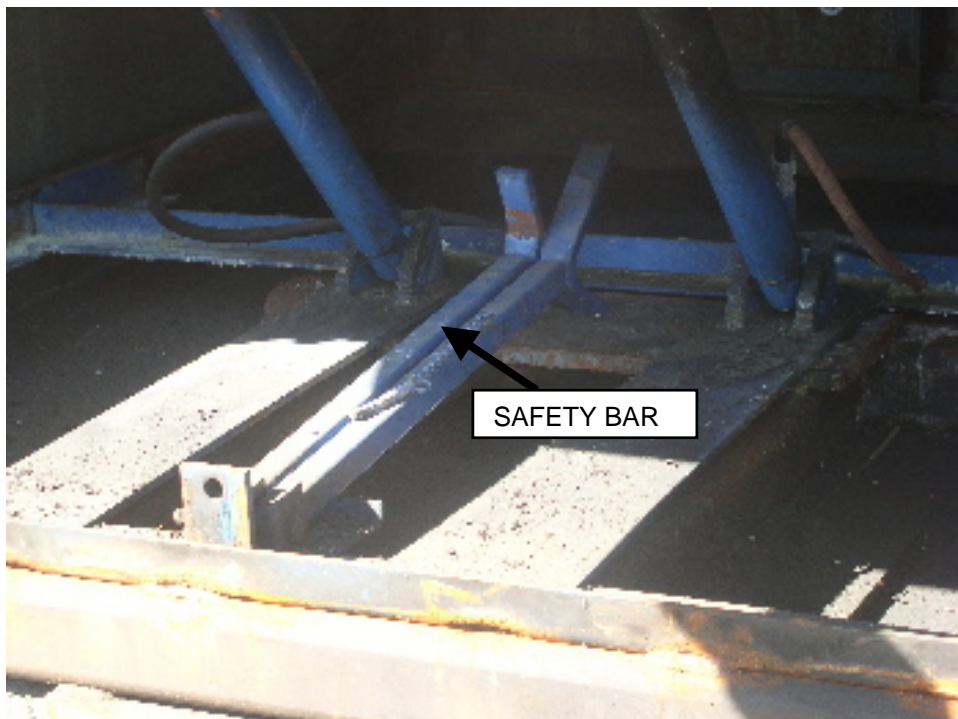
Exhibit 3

The safety bar used to hold the dock plate in the raised position when access is needed underneath.

Discussion: Employees should never place themselves under a suspended load without first securing the load to ensure it will not move or fall. The dock leveler had a safety bar that could have been used to support the dock plate in a raised position. Blocks, chocks, cribbing, and safety bars are all devices used to accomplish this goal. Had the victims used any one of these devices, this incident might have been prevented. Safe work practices can be enhanced through programs of task-specific training, supervision, rewards, and progressive disciplinary measures.

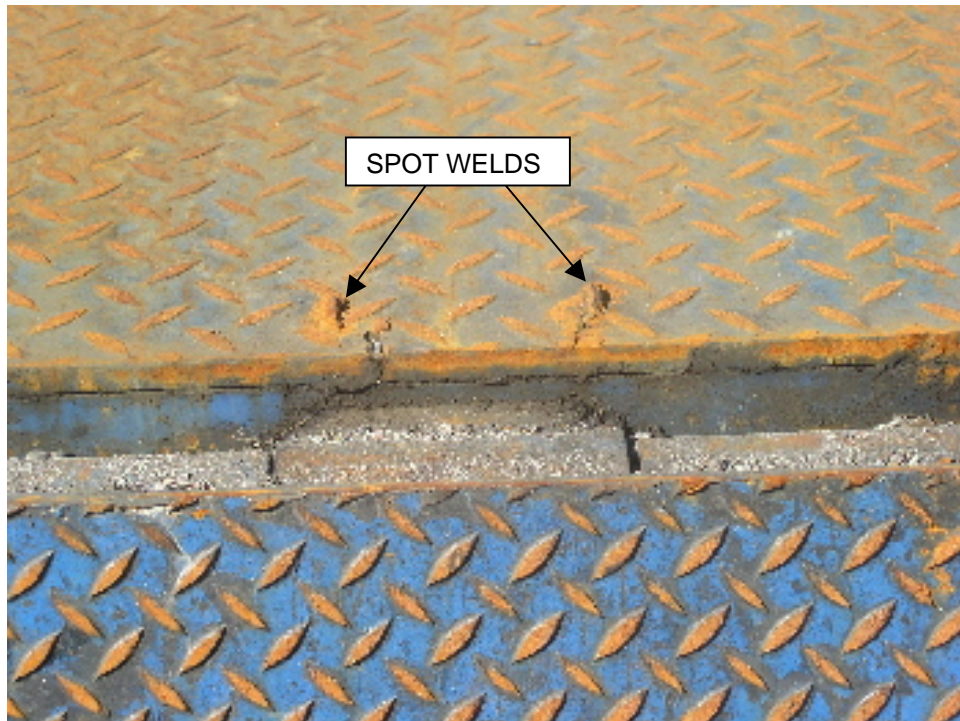
Exhibit 4

While the dock plate remained suspended, the victims moved under the dock plate and started connecting the hydraulic hoses without first engaging the safety bar or blocking the plate in the raised position. The weld that attached the pipe to the top of the dock plate broke and the dock plate fell, striking both victims in the back. One victim was struck but fell away from the dock plate while the other remained trapped underneath. Another employee working in the vicinity heard the loud noise and came over to investigate. The employee used a forklift to raise the dock plate off the trapped victim. The paramedics responded and administered CPR to both victims. One victim was transported to the hospital via ambulance in full cardiac arrest. The other victim was air lifted to the hospital. Both victims died as a result of their injuries.

The spot welds on top of the dock plate where the pipe was welded.
