Iron Production Worker Crushed in Machinery

SUMMARY:

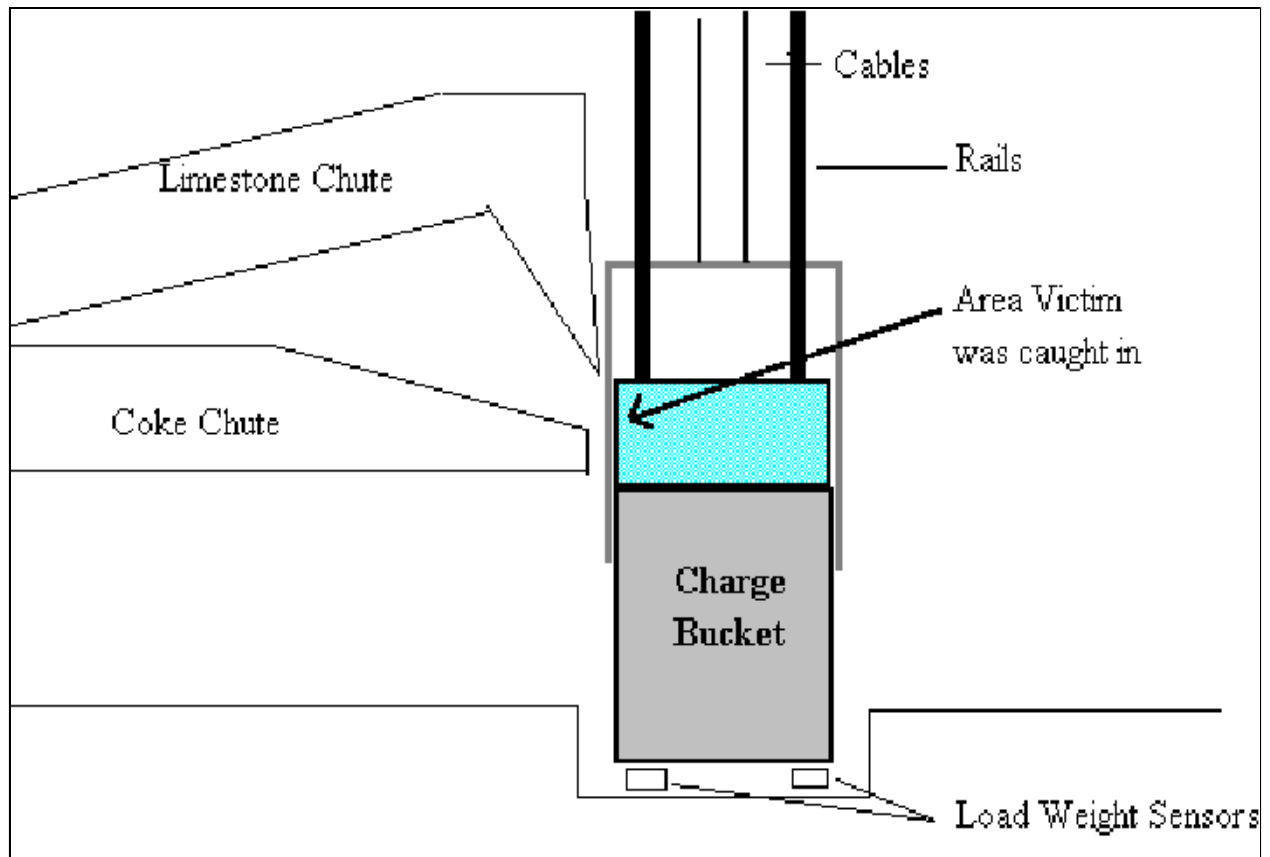
Figure 2. Front View - (Oscillating Conveyor not shown)

There were no witnesses to the incident, but from the physical evidence the following is the most probable scenario. The victim apparently leaned over the bucket positioning himself between the upper left lip of the bucket and the lower edge of the limestone chute (figure 2). The bucket began automatically raising and caught the victim in the chest and continued raising. A coworker inside the building heard the victim scream and ran outside and pushed the emergency stop button for the bucket. By this time (approximately 20 seconds), the bucket had traveled about 2/3 of the way to the top of the rails and the victim was lying in the pit the bucket lowers into. The coworker immediately called 911 who responded and pronounced the victim dead at 8:05 am.

Recommendation #1: Install machine guarding around the charge bucket.

Discussion: Machine guarding around the charge bucket in accordance with 29 CFR 1910.212 (a) could have prevented this fatality. A good guard could include an access door on the right side of the bucket, away from the nip points. This door could be equipped with a microswitch which would remove power to the bucket when the door is opened. This would not be in lieu of proper Lockout/Tagout procedures but an added safety feature.
