SUBJECT: A county employee died when he was crushed between two heavy equipment compaction vehicles.

SUMMARY

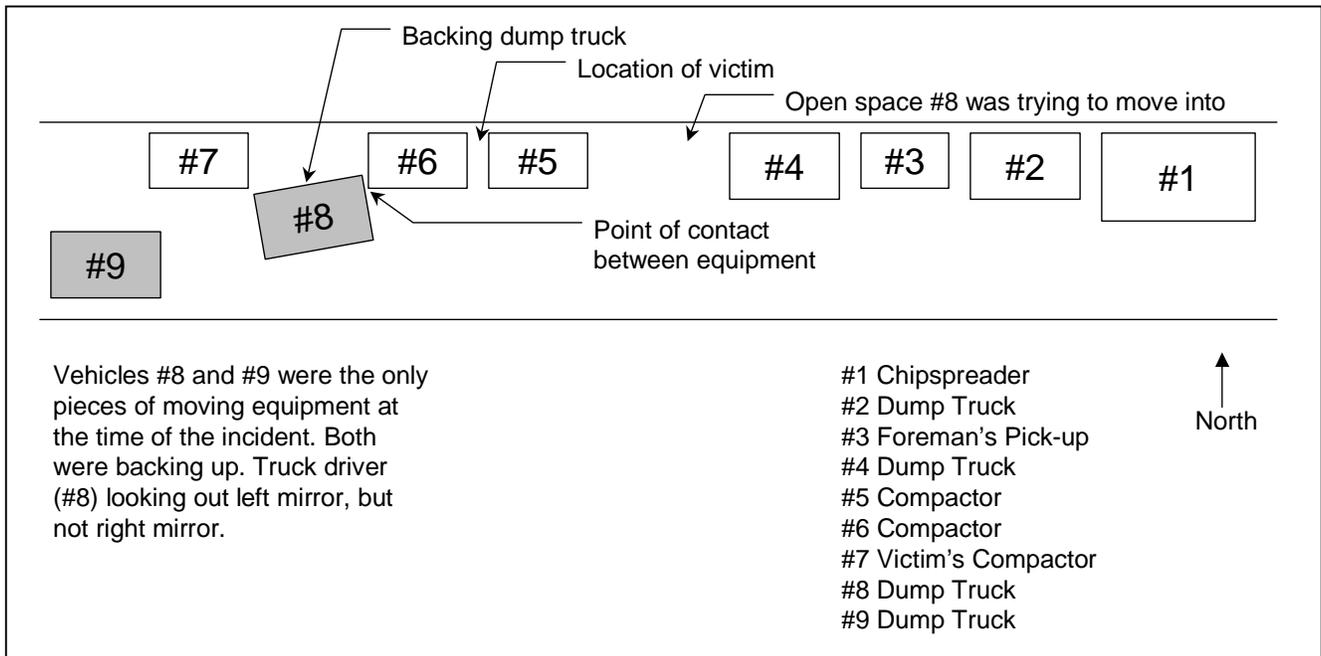
Figure 1. Diagram of Work Zone (not to scale)

secluded area, the decedent walked between the first two compactors (#5 and #6 on Figure 1), blocking his view from co-workers.

At the time of the incident, 8:35 a.m., there were two moving vehicles (#8 and #9 on Figure 1) within the work zone. There was no intrusion from outside of the work zone. While the decedent was between the compactors, one of the dump truck drivers attempted to position his dump truck in line by maneuvering in a narrow space around the line of compactors. As the dump truck driver backed into position, only the driver’s side rear-view mirror was used, not the one on the passenger’s side. As a result, the rear end of the dump truck hit one of the compactors, pushing it into the compactor behind it. The dump truck was equipped with a backup alarm, but it was not functioning on the day of the incident. It was later determined that the alarm had been connected to the reverse lights’ electrical wires. When the lights came on, so did the alarm. At the time of the incident, one of the lights was burned out, which disabled the backup alarm as well. Even though the speed of the dump truck was extremely slow, the massive weight of the vehicle and the lack of a set parking brake on the compactor caused the compactor to move. The compactor rolled straight into the other compactor and crushed the victim.

The second truck driver (#9 on Figure 1) saw the collision about to occur and tried to radio to the driver to stop, but there was not enough time. Another worker on the ground was yelling for the truck to stop, but the driver did not hear. The truck driver was not aware of making contact with the compactor. Co-workers immediately responded to the pinned victim, with one worker starting and moving the compactor, while another lowered the victim to the ground. Emergency medical services responded and transported the victim to a local hospital where he was pronounced dead on arrival.
