SUBJECT: Hispanic laborer died after being struck by a vehicle in a roadway work zone.

SUMMARY

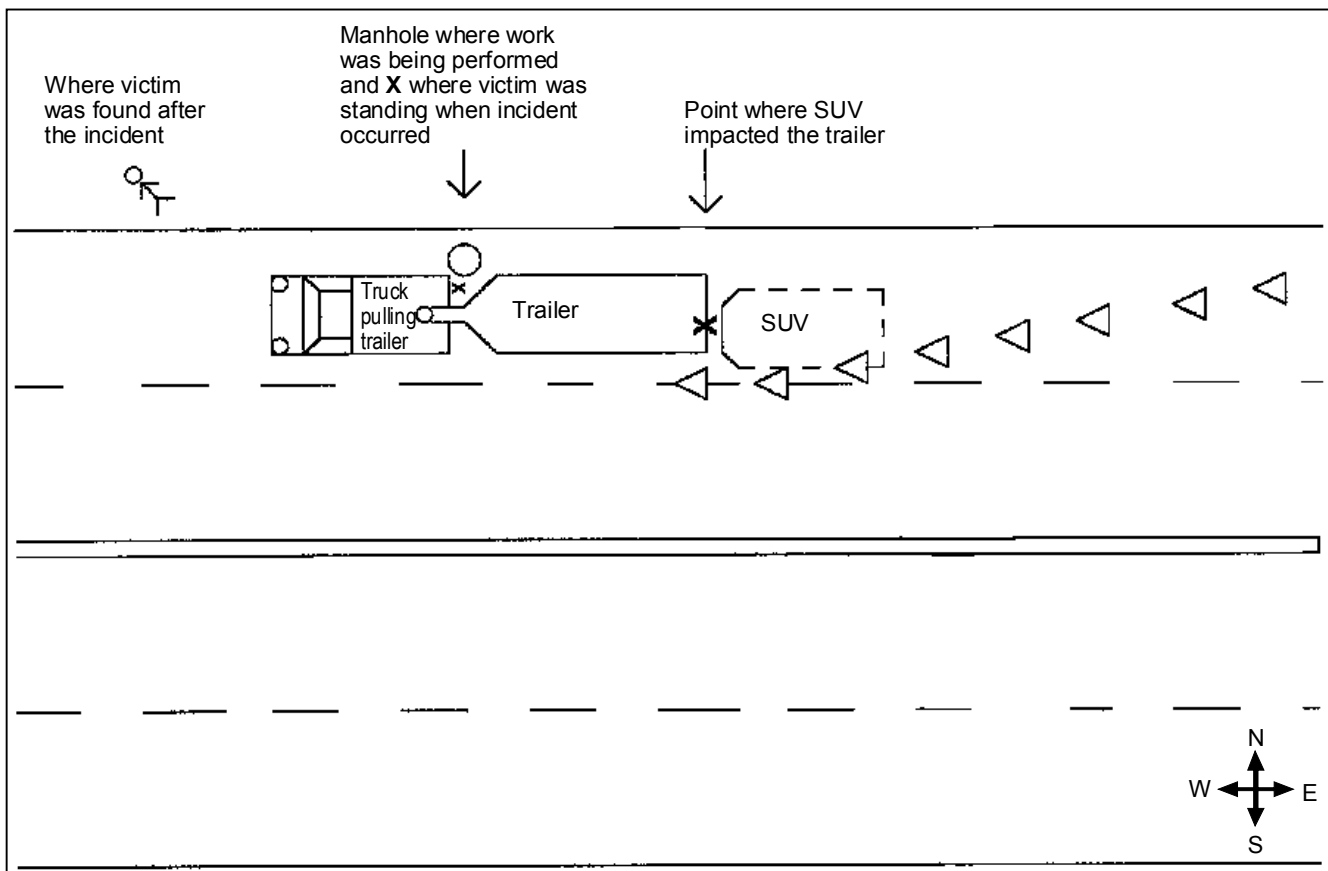
Figure 1. Diagram of Work Zone (not to scale)

With all traffic control signs and devices gone, the foreman tapered the two westbound lanes down to one by placing seven or eight 28-inch traffic cones over 100-120 feet (Figure 1). He also parked the truck and trailer with the gooseneck over the manhole opening in an effort to provide some protection from oncoming vehicles. The flashers, which were regular motor vehicle brake and signal lights, were illuminated and properly functioning on the truck and trailer. No traffic signs were placed to warn motorists of the work zone because there were none available on the truck. The foreman re-entered the manhole and the decedent remained on the street to empty the mud-filled buckets. The decedent stood near the manhole, between the truck and trailer. They resumed working for another 1-2 hours before the incident occurred.

A westbound sport utility vehicle, driving into the sun, failed to merge into the inside lane and was witnessed to crash through the traffic cones tapering the lane and into the back of the workers' trailer. The right side of the vehicle impacted the left rear side of the trailer. The decedent, who was still standing by the manhole, was crushed between the truck and trailer before being thrown from the collision. Both the decedent and the trailer were propelled west, 20 feet down the side of the street. The foreman, who was inside the manhole, heard the crash and immediately climbed out. A witness and an off-duty police officer were first on the scene; however, 911 was called immediately and arrived a short time later.

Discussion: The plastic cones used as channelizing devices to demarcate the work zone did not gain the attention of the driver of the intruding vehicle. The use of barrels as channelizing devices for closing the lane at the entrance to the work zone may serve to better attract the attention of a driver to the impending hazard posed by the roadside work. This type of device must be positioned at a sufficient distance from worker positions so that flying debris does not strike workers should a motor vehicle strike the device. If the employers are not capable of providing sufficient traffic control or do not have adequate equipment, they should contract with a traffic control company to provide the necessary services.
