SUBJECT: A concrete saw operator was killed when he was pinned between the boom and the rear of a backhoe.

SUMMARY

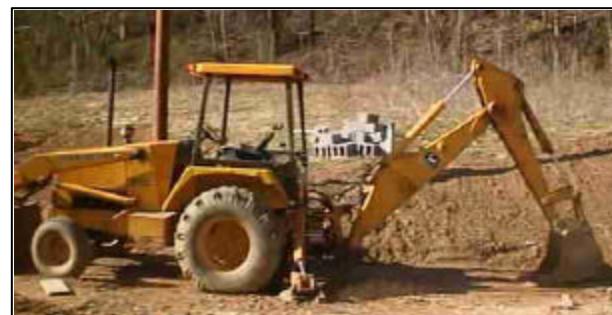
A 56-year old concrete saw operator employed by a construction contracting company died on December 31, 2003, from asphyxiation and compression injuries received when he was pinned between the boom arm and the rear end of a backhoe (Figure 1). OKFACE investigators reviewed the death certificate and reports from the Occupational Safety and Health Administration (OSHA), the Medical Examiner, the investigating police officer, and emergency medical services (EMS). An incident site visit and an interview with a company official at the home office were conducted on March 17, 2004.

Figure 1. Backhoe model involved in incident

Sometime between 2:30 a.m. and 6:30 a.m., the decedent finished sawing the concrete and began to load the backhoe with his tools. From the rear of the backhoe, he proceeded to lay the handheld portable concrete saw on the floor of the cab. The saw was placed on top of the right boom swing foot pedal. With the engine running and the boom swing lock pin not installed, the boom was activated and free to move. The boom swung to the right and crushed the victim between it and the rear of the backhoe. With no witnesses to the incident, the decedent was pinned for an undetermined amount of time. The superintendent, who arrived to work around 6:30 a.m., found the victim.

The decedent was found in a standing position pinned between the boom arm and the back of the vehicle. The superintendent contacted the police, and three officers responded immediately. CPR was initiated and administered until EMS personnel arrived. The victim was transported to a local hospital where he was pronounced dead 35 minutes after being found.

During the investigation, it was determined that the backhoe's factory equipped foot pedal controls had been modified to accommodate an additional set of hand lever controls. When this process was performed, the foot controls were still present and operable; however, the original foot controls became easier to press down than before the installation. With nothing to keep an employee from placing equipment into the operator compartment through the

openings on either side of the boom, it remained very easy to actuate the foot pedals with the weight of the equipment or materials.

Discussion: The equipment in use at the time of the incident was not equipped with the required lock pins, which would have kept the boom arm from swinging. The model-specific operator's manual specifies to install boom and swing lock pins when use of the backhoe boom is complete. Furthermore, removal, installation, and storage procedures for the pins are outlined in the manual.

Recommendation #1: Employers should ensure that machine guarding is in place, and that any additional safeguards needed to eliminate hazards are utilized prior to equipment operation.

Recommendation #4: Employers should review modifications or additions to equipment with the manufacturer and obtain authorization from the manufacturer prior to alteration.

Discussion: It is important to consult with manufacturers prior to making equipment modifications in order to anticipate potential hazards and possible additional safeguards. Some hazards, such as the foot pedals becoming easier to depress with hand lever installation, are known and can be controlled prior to use. All upgrades or alterations should be authorized by the manufacturer and should meet all mandatory safety guidelines established for the upgrading or alteration.
