SUBJECT: A road construction worker was killed when he was run over by an asphalt dump truck.

SUMMARY

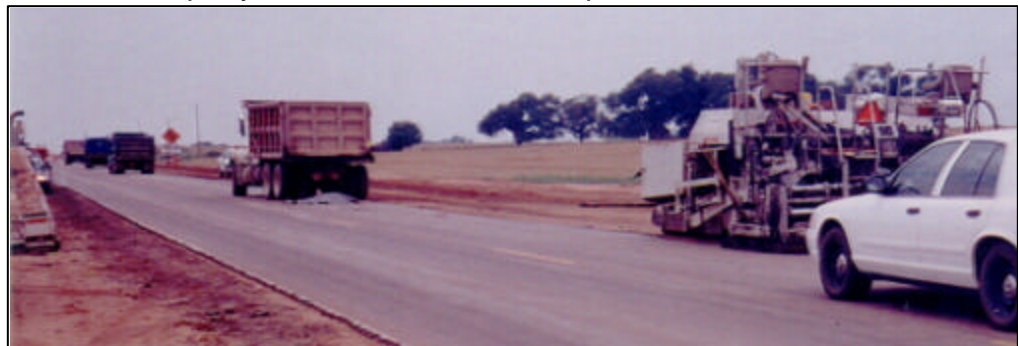
Figure 1. Photo of the Back of the Asphalt Truck

Shortly before 1:00 p.m. on the day of the incident, five dump trucks loaded with asphalt were lined up on the westbound driving lane, waiting to unload into the paver. As the first dump truck unloaded its asphalt into the paver, the victim was sent to repair a break in the paver guide string. The break was located approximately 10 feet behind the second dump truck. The victim was kneeling down, approximately 90 feet west of the paver. Although the company's safety officer reported training the victim to face the fastest moving vehicle in the work zone (the dump trucks in this case) and to stay outside the string line, he had his back to the dump trucks and was inside the string line as he repaired it. His supervisor was in another area of the work zone, operating another piece of equipment. When the first dump truck moved clear of the work site, the second dump truck driver, who had 10 years of experience, began to back up into position for unloading. The asphalt truck's back up warning signal was in full operation at 97 decibels, and at least one other person in the work zone reported hearing it. The victim was behind the inside rear dual wheel of the truck in a blind spot that the driver's mirrors did not cover. One co-worker who noticed the hazard ran toward the victim and yelled to him. The paver operator also yelled and beeped his horn to try to warn the victim. Despite their efforts, the victim was run over by the truck, which was estimated to weigh 27 tons. Employees called emergency medical services immediately.

Recommendation #2: Employers should consider the use of a spotter to direct vehicles that are backing up in a work zone.

Discussion: OSHA regulations prohibit the use of motor vehicle equipment that has an obstructed view to the rear unless 1) the vehicle has a reverse signal alarm that can be heard above the surrounding noise level; or 2) the vehicle is backed up only when a spotter indicates that it is safe to do so. The vehicle may be used if either of these conditions is met. In this incident, the dump truck did have a reverse signal alarm; however, the alarm alone was not sufficient to warn the victim. In addition to the reverse signal alarm, using a spotter to guide the dump truck as it backed up may have prevented this incident.

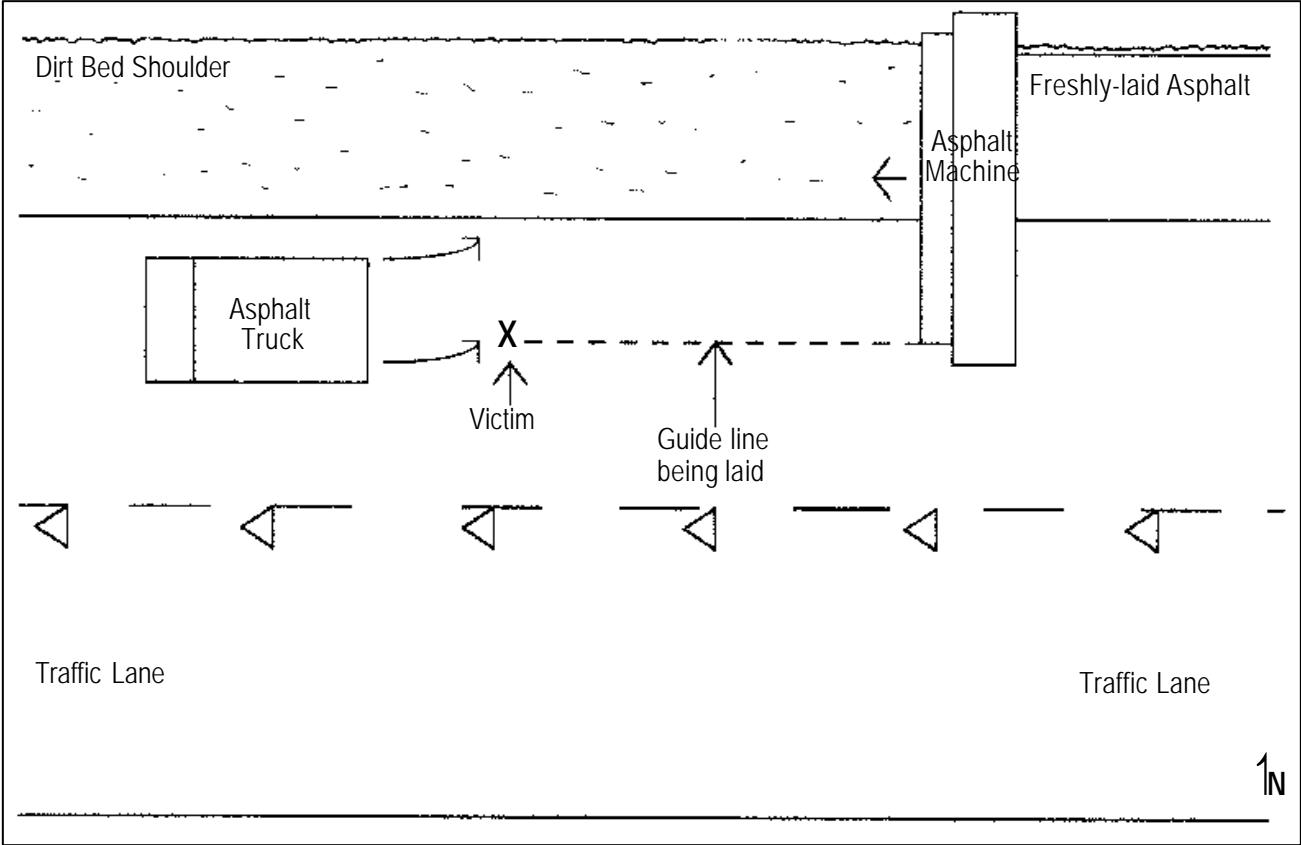
Figure 2. Diagram of Work Zone (not drawn to scale)

The road construction company was in the process of paving the shoulder of the westbound lane of a recently repaved two lane rural highway (Figure 2). The shoulder was being paved over a dirt surface. The shoulder area was 8 feet wide, and the asphalt paver was 12 feet wide. Thus, the paver guide string, which was necessary for the asphalt paver to use as a guide to maintain a straight path for applying fresh asphalt, had to be nailed 4 feet into the westbound driving lane of the highway. The westbound driving lane was closed, and all traffic was directed to the eastbound lane of the highway using pilot cars and flaggers. Cones were used to separate the redirected traffic lane from the work zone area.

Recommendation #1: Employers should develop and implement a written program that includes policies and procedures regarding the positioning of employees during all phases of the asphalt laying process.

Discussion: Employers should establish written training programs, policies, and procedures, including job safety analysis, on all jobs where there is a potential for employees to be exposed to a work-related hazard. In work zone areas, workers on foot should be separated from equipment as much as possible. The work space for dump trucks should be identified and workers on foot should be kept out of this space until the dump trucks have cleared the area. In this incident, the worker was repairing the paver guide string in an area where dump trucks were backing up. This incident may have been prevented if the worker repaired the string when the dump trucks had cleared the work zone area.
